**FACILITY COMPLIANCE INSPECTION REPORT**  
**Division of Waste Management**  
**Solid Waste Section**

Craven County Landfill  
 7400 Old Highway 70  
 New Bern, NC

Closed MSWLF under Subtitle D

2503-20130822INSP

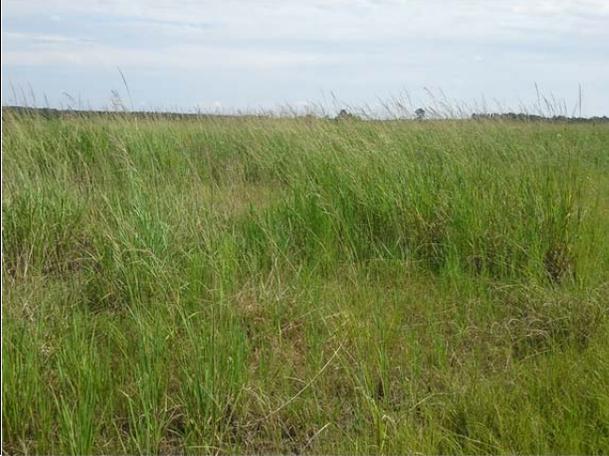
11) \*Plans need to be underway for the mowing of the cover crop.

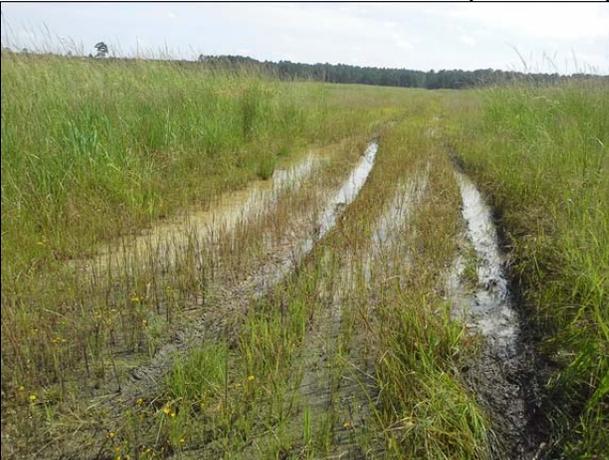
13) Ponded water was observed in several areas around the landfill. \*Please fill and grade these areas to promote positive drainage of all surface waters away from the landfill. All filled areas should be graded at a slope not greater than 3:1 and seeded and mulched to establish a cover crop suitable to prevent erosion of your landfill cap system.
