FACILITY COMPLIANCE INSPECTION REPORT
Division of Waste Management
Solid Waste Section

Craven Land Clearing and Inert Debris Landfill (LCID Landfill)
 356 Sanders Lane
 Clarks, NC

Comprehensive Facility Compliance Inspection

2513-20140508INSP

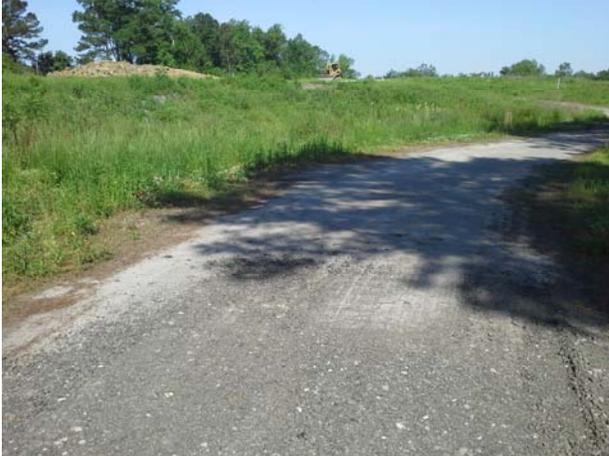
- 5) The access road to the Facility is of all-weather construction and is being managed properly at this time.

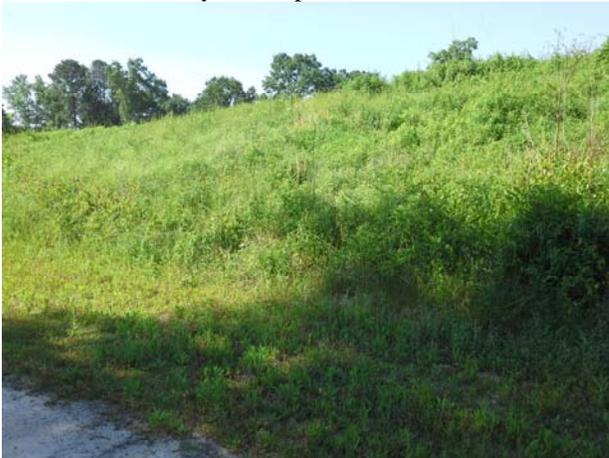
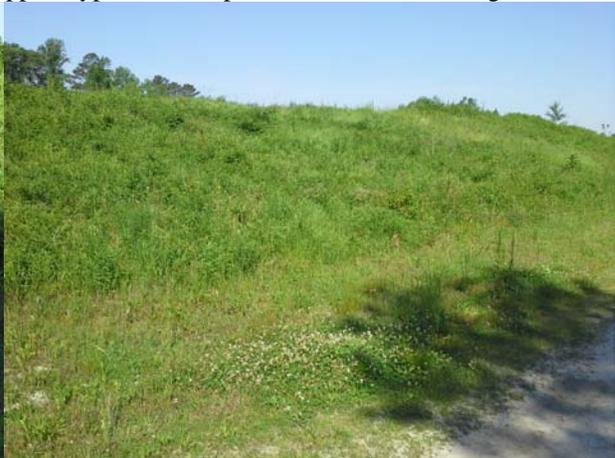
- 6) Permanent, highly visible, edge-of-waste markers have been placed delineating the landfill waste disposal area.
7) Overall, the Facility sideslopes have a well-established coppice-type cover crop of native warm season grasses.

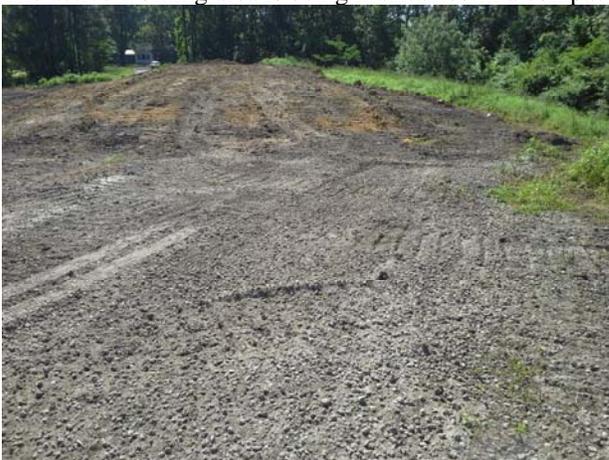
- 8) Clean soil has been stockpiled at the Facility for use as cover and in cap repair projects.
9) The active working area is being maintained in a compact and manageable size.
