**FACILITY COMPLIANCE INSPECTION REPORT**  
**Division of Waste Management**  
**Solid Waste Section**

**Date of Site Inspection:** 5 September 2013    **Date of Last Site Inspection:** 9 May 2013

Cieszko Construction Company LCID Landfill  
 NC Hwy 101 Havelock, NC

25I-20130905INSP

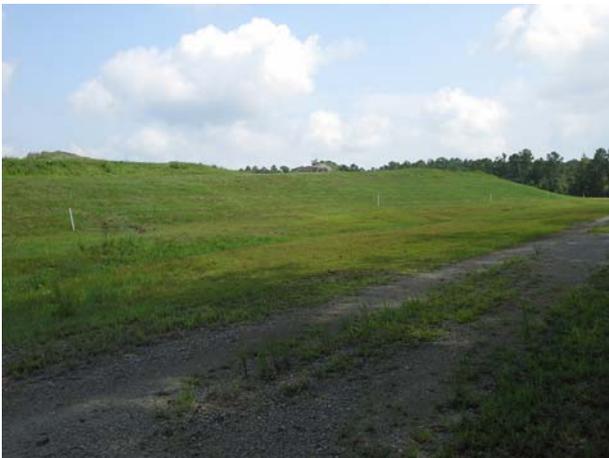
- 8) The northern and eastern sideslopes have been covered, graded, and sloped. \*Please ensure that all recently covered and graded areas are seeded and mulched to establish a groundcover suitable to prevent erosion of your landfill cap system.
- 9) This Facility has highly visible, permanent, edge-of-waste markers in place delineating the landfill waste disposal footprint.
- 10) The waste type being disposed is LCID waste only. There were no unacceptable waste streams noted during this Facility Compliance Inspection.
- 11) The active working area is compact and well managed.

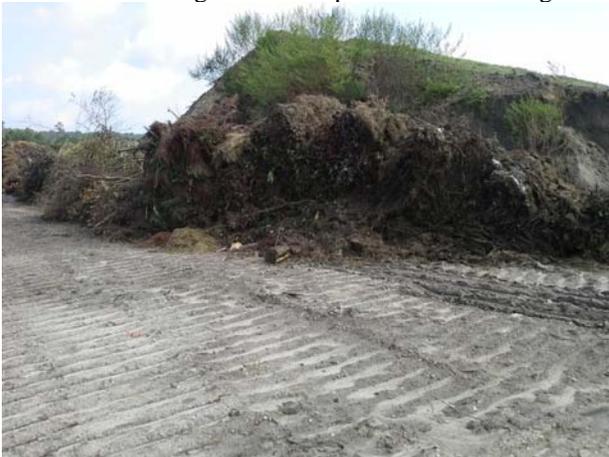
- 12) Soil is stockpiled adjacent to the landfill and the active working face for use as cover.

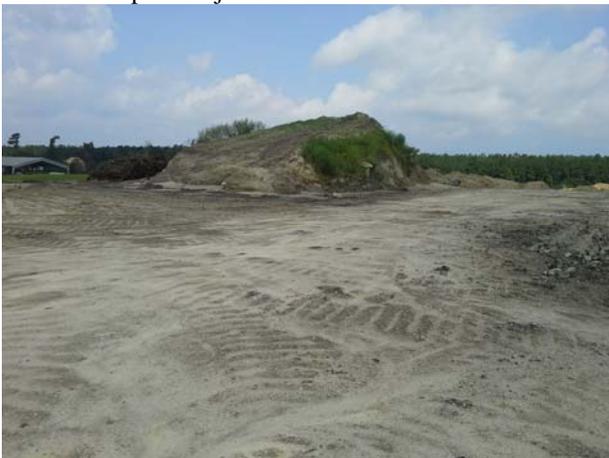
- 13) The active working area is being covered monthly or when it reaches one acre in size, whichever occurs first.
- 14) No violations were observed during this Facility Compliance Inspection.
- 15) \*Corrective measures are required as a result of this Facility Compliance Inspection.
