FACILITY COMPLIANCE INSPECTION REPORT
Division of Waste Management
Solid Waste Section

Date of Site Inspection: 14 May 2014

Dare County C&D Landfill
 1603 Cub Road
 Manns Harbor, NC 27953

2803-20140514INSP

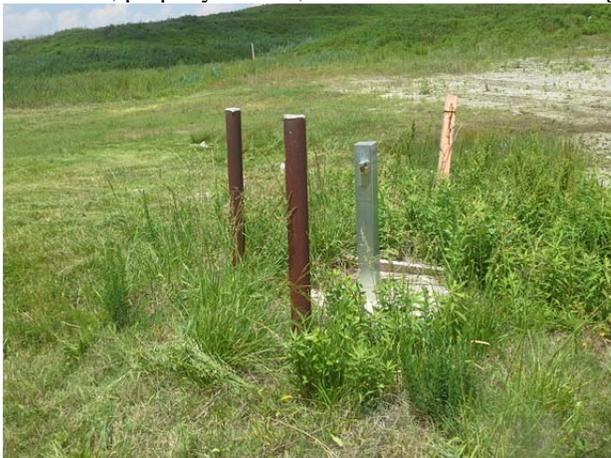
- 11) Facility monitoring wells were reviewed during this Facility Compliance Inspection. All the wells were readily accessible, properly labeled, and secured with functioning locks.

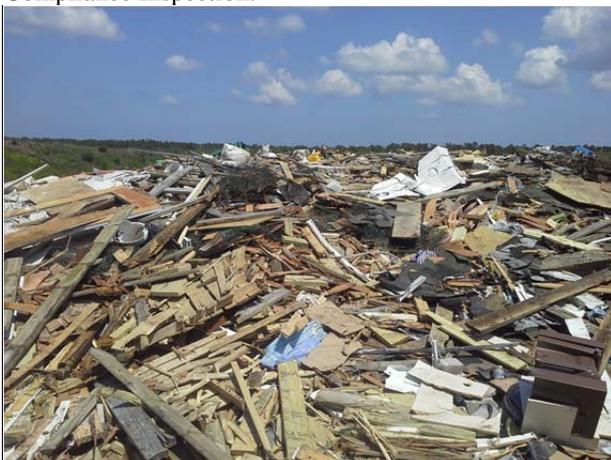
- 12) Vegetative waste is staged in an area adjacent to the Cell #4 access road for future grinding and removal from the site for use as boiler fuel.
- 13) The waste type in the landfill was reviewed; no unpermitted wastes were noted at the working face during this Facility Compliance Inspection.

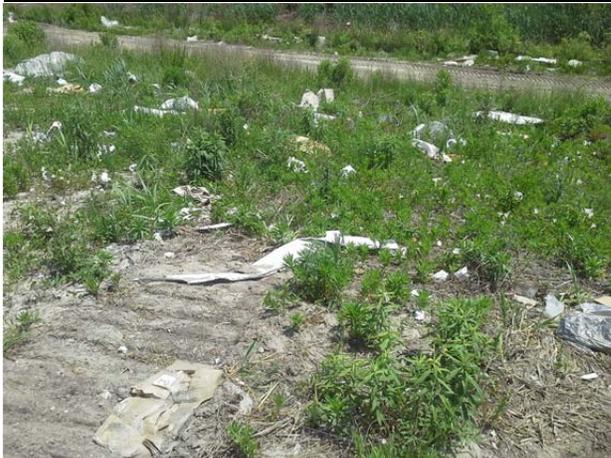
- 14) *Please ensure that the working face is covered weekly or when it reaches ½ acre in size, whichever occurs first.
- 15) A large amount of windblown litter was observed on the sideslopes and around the toe of Cell #4. *Please ensure that all windblown materials are collected and returned to the working face at the end of each workday.

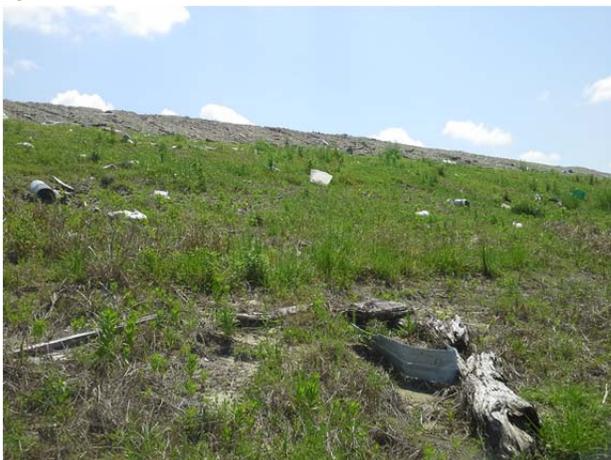
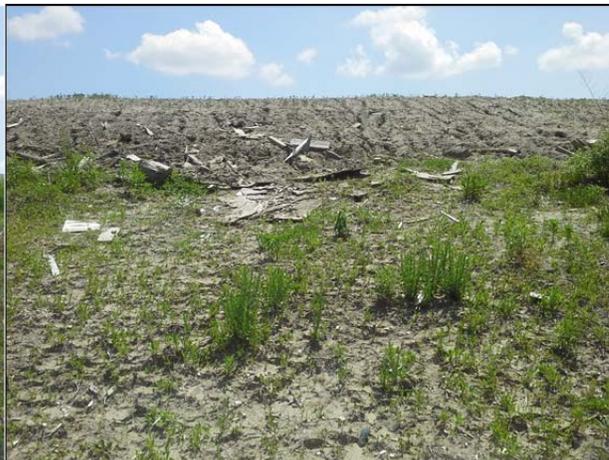
- 16) Uncovered waste was observed on the sideslopes of Cell #4 at the transition to the current active lift. *Please ensure that all waste is adequately covered and that the soil cover is maintained on all Facility sideslopes.

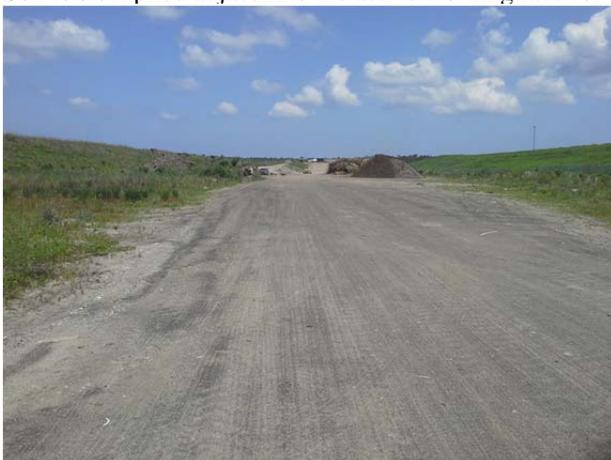
- 17) Ground wood waste mixed with soil has been staged adjacent to the Cell #4 access ramp for use in erosion repair/control.
- 18) The active working face is being maintained in a compact and manageable size.
- 19) Soil is stockpiled adjacent to the active working face for use as cover.

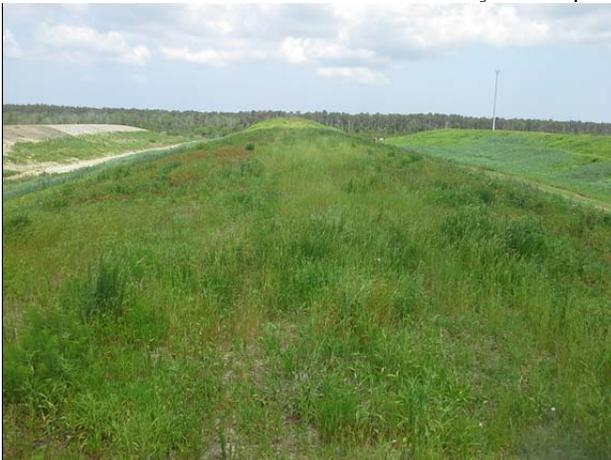
- 20) All recyclable metals and white goods are screened from incoming waste, removed from the working face, and transported to the white goods/metal recycling area daily.
- 21) The white goods/metal recycling area is being well managed at this time. All recyclable metals are maintained within the concrete bunkers. All Freon containing white goods are maintained in an upright condition until the Freon is collected.
- 22) Overall, the closed areas of the landfill have a well-established cover crop of native warm season type grasses and no areas of erosion were observed on the Facility sideslopes during this Facility Compliance Inspection.

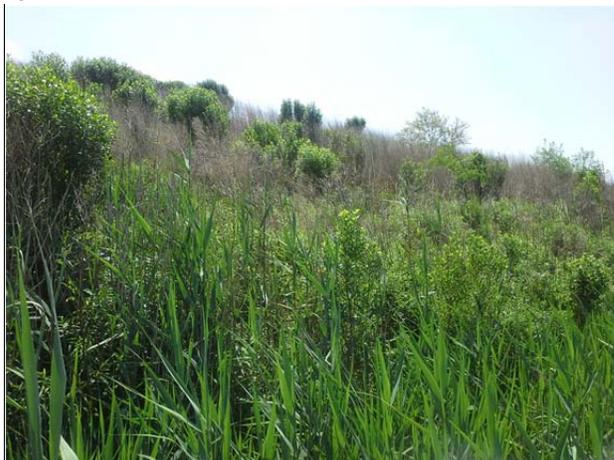
- 23) Mowing operations have been completed on Cells #1 and #2.
- 24) Brush and other woody vegetation was observed growing on the sideslopes of closed Cells #3. *Please complete mowing operations by mowing all Facility sideslopes.

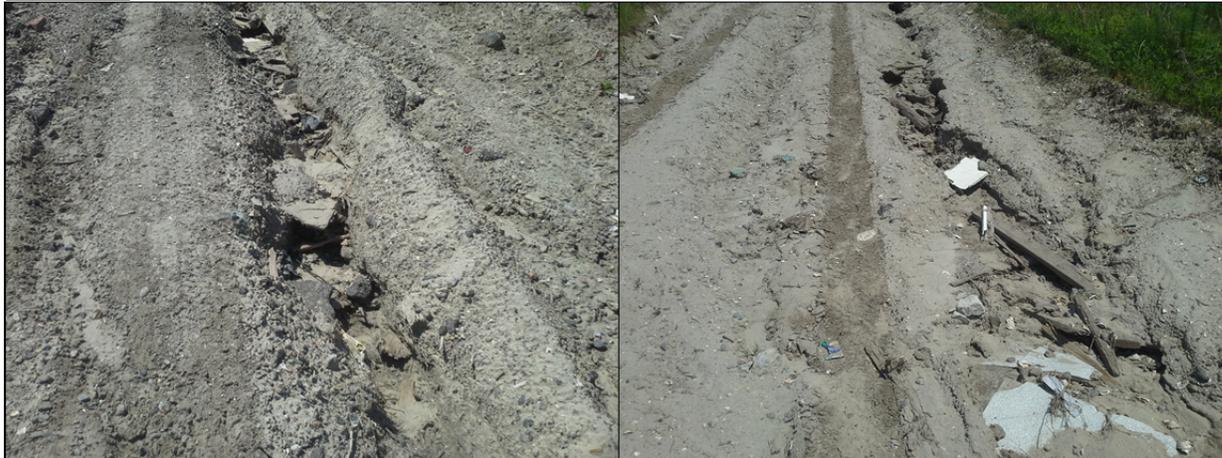
- 25) Erosion was observed on the access road to the top of Cell #3 on both the eastern and western ends of the cell. *Please fill and grade this area to prevent further erosion of your landfill cap system. All repaired areas should be graded at a slope not greater than 3:1 and seeded and mulched to establish a groundcover suitable to prevent erosion of your landfill cap system.

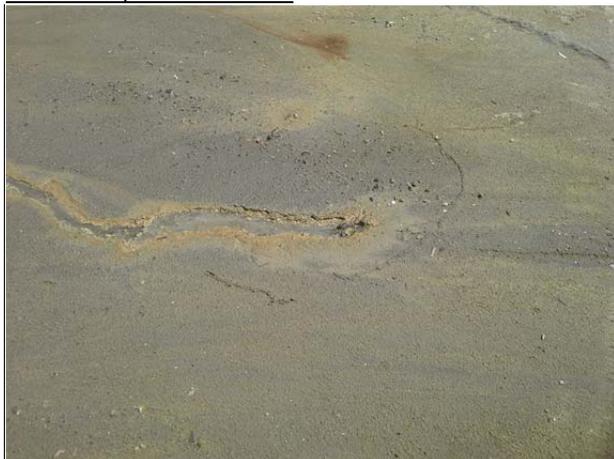
- 26) A possible leachate seep was observed near the western access road at the toe of Cell #3. No leachate was observed leaving the Facility. *Measures need to be taken to prevent leachate from leaving the Facility. Please repair this area to prevent the further release of leachate. All repaired areas should be seeded and mulched to establish a groundcover suitable to prevent erosion.
