FACILITY COMPLIANCE INSPECTION REPORT
Division of Waste Management
Solid Waste Section

Date of Site Inspection: 2 August 2013

Dare County C&D Landfill
 1603 Cub Road
 Manns Harbor, NC 27953

Partial Facility Compliance Inspection

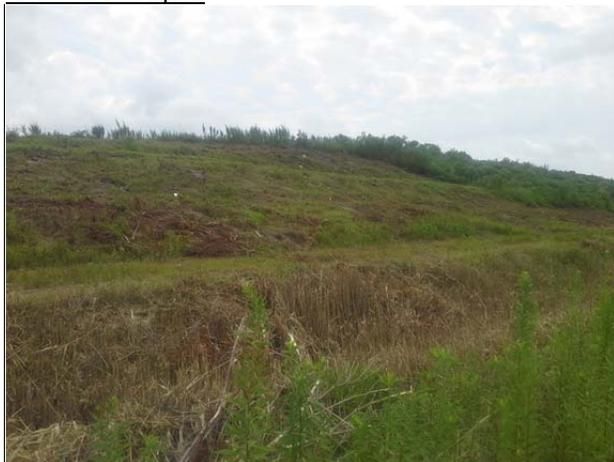
- 23) Brush and woody vegetation were observed growing on the sideslopes of closed Cells #1, # 2, and #3. Mowing operations were underway during this Facility Compliance Inspection. *To protect the integrity of your landfill cap system, please finish the mowing project in these areas and remove all brush and other woody vegetation from the landfill sideslopes.

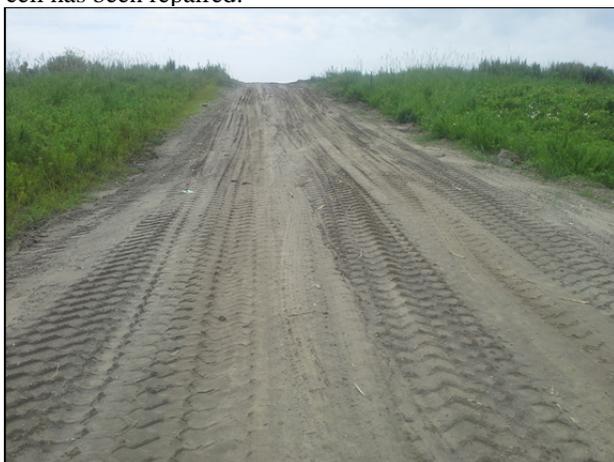
- 24) The erosion observed in the previous Inspection Report on the access road to the top of Cell #3 on the western end of the cell has been repaired.

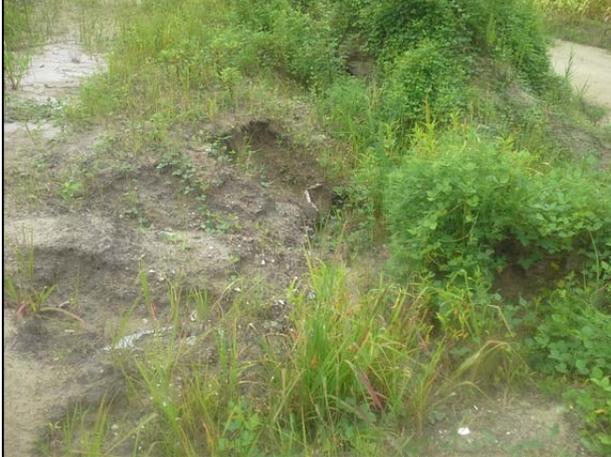
- 25) Erosion of the Cell #3 perimeter access road at the toe of the southern sideslope approximately 200 yards from the western end of the cell. *Please fill and grade this area to promote the positive flow of surface waters away from the toe of the landfill.

26) *Corrective actions are required as a result of this Facility Compliance Inspection Report.
