FACILITY COMPLIANCE INSPECTION REPORT
Division of Waste Management
Solid Waste Section

Date of Site Inspection: 29 October 2013

Dare County C&D Landfill
 1603 Cub Road
 Manns Harbor, NC 27953

Partial Facility Compliance Inspection

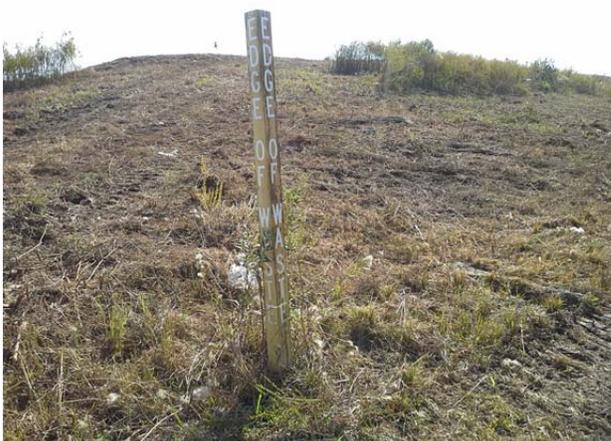
- 11) The waste type in the landfill was reviewed; no unpermitted wastes were noted at the working face during this Facility Compliance Inspection.
- 12) All recyclable metals and white goods are screened from incoming waste, removed from the working face, and transported to the white goods/metal recycling area daily.
- 13) The white goods/metal recycling area is being well managed at this time.
- 14) Facility monitoring wells were reviewed during this Facility Compliance Inspection. All the wells were secured with functioning locks.
- 15) Overall, the closed areas of the landfill have a well-established cover crop of native warm season type grasses and no areas of erosion were observed during this Facility Compliance Inspection.

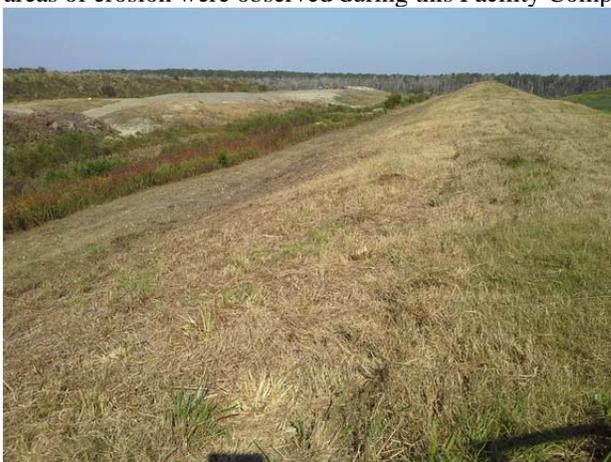
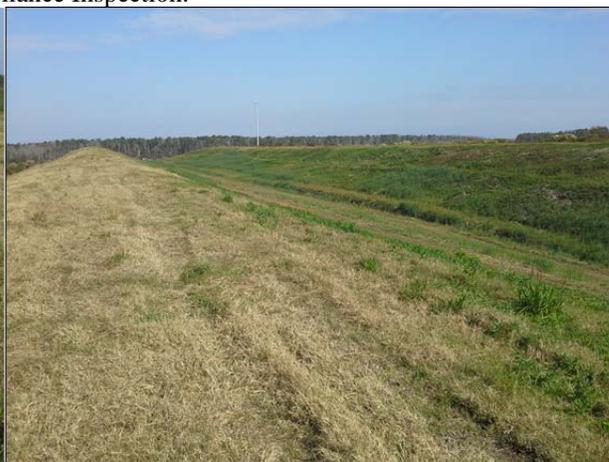
- 16) Brush and other woody vegetation were observed growing on the sideslopes of closed Cells #1, #2, and #3. Mowing operations were underway during this Facility Compliance Inspection.

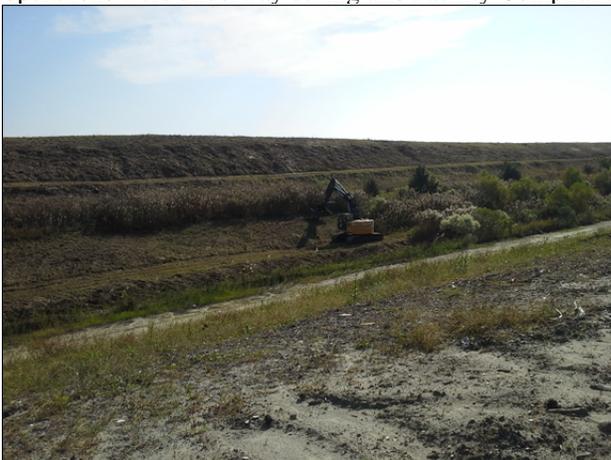
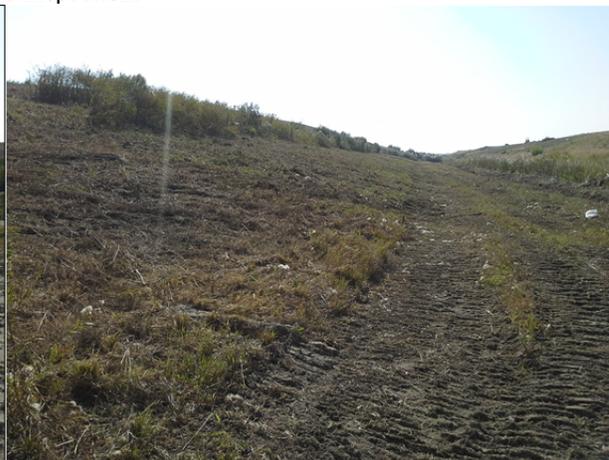
- 17) Ground wood waste mixed with soil has been staged adjacent to the Cell 4 access ramp for use in erosion repair/control.
- 18) Vegetative waste is staged in an area adjacent to Cell 4 for future grinding and removal from the site for use as boiler
