September 2013 Semi-Annual Groundwater Monitoring Report

Davidson County Construction and Demolition Debris Landfill NC Solid Waste Permit No. 29-06

September 2013 Groundwater Monitoring Report

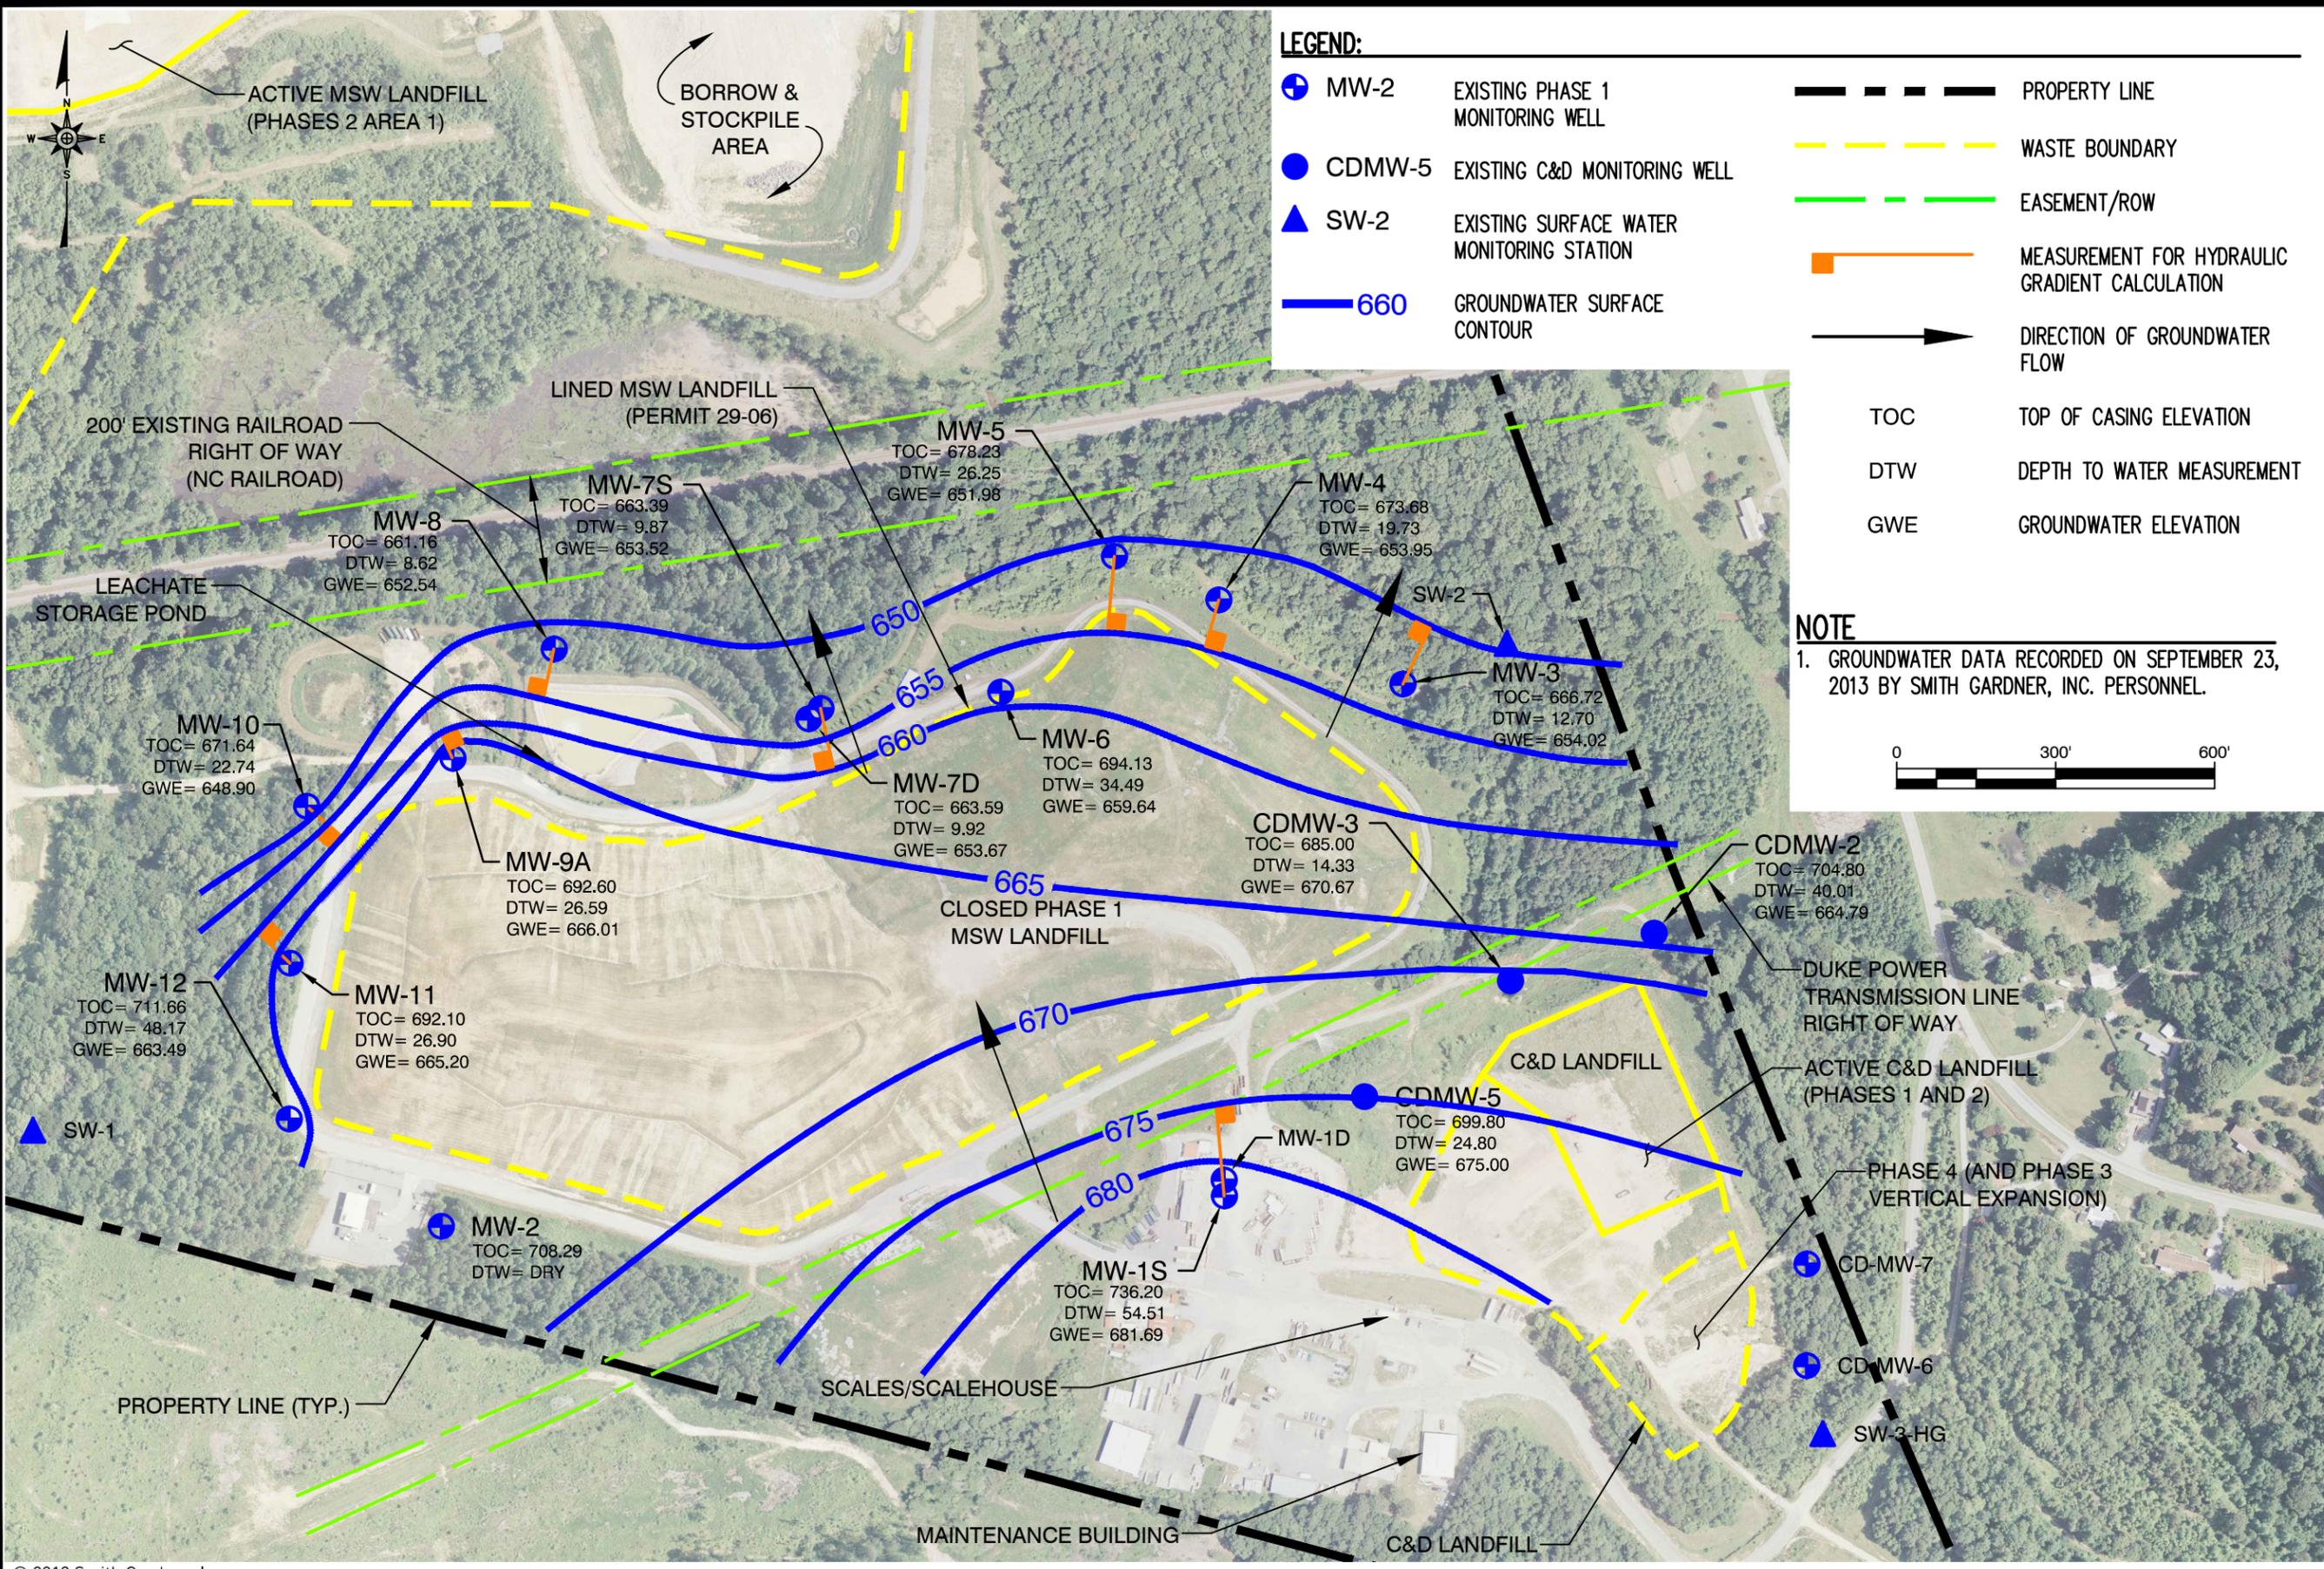
| SCALE: | AS SHOWN | FIGURE NO.: | 1 |

A potentiometric surface map was prepared from ground water data from this sampling event. Ground water at the C&D landfill flows in a generally northern direction. An ephemeral stream is located east and northeast of the C&D landfill. The potentiometric surface for the landfill property is shown on **Figure 1**.

1. GROUNDWATER DATA RECORDED ON SEPTEMBER 23, 2013 BY SMITH GARDNER, INC. PERSONNEL.

POTENTIOMETRIC SURFACE MAP
SEPTEMBER 2013
CLOSED PHASE 1 AND C&D
DAVIDSON COUNTY, NC

Sampling locations are shown on **Figure 1**. Boring logs and construction records are provided in **Appendix B**.
