PHASE 2 COVER SYSTEM INVESTIGATION REPORT

PIEDMONT LANDFILL KERNERSVILLE, NORTH CAROLINA

Subject: Submittal of Site Investigation Report
Piedmont Landfill and Recycling Center, Kernersville, North Carolina
Permit Number 34-06

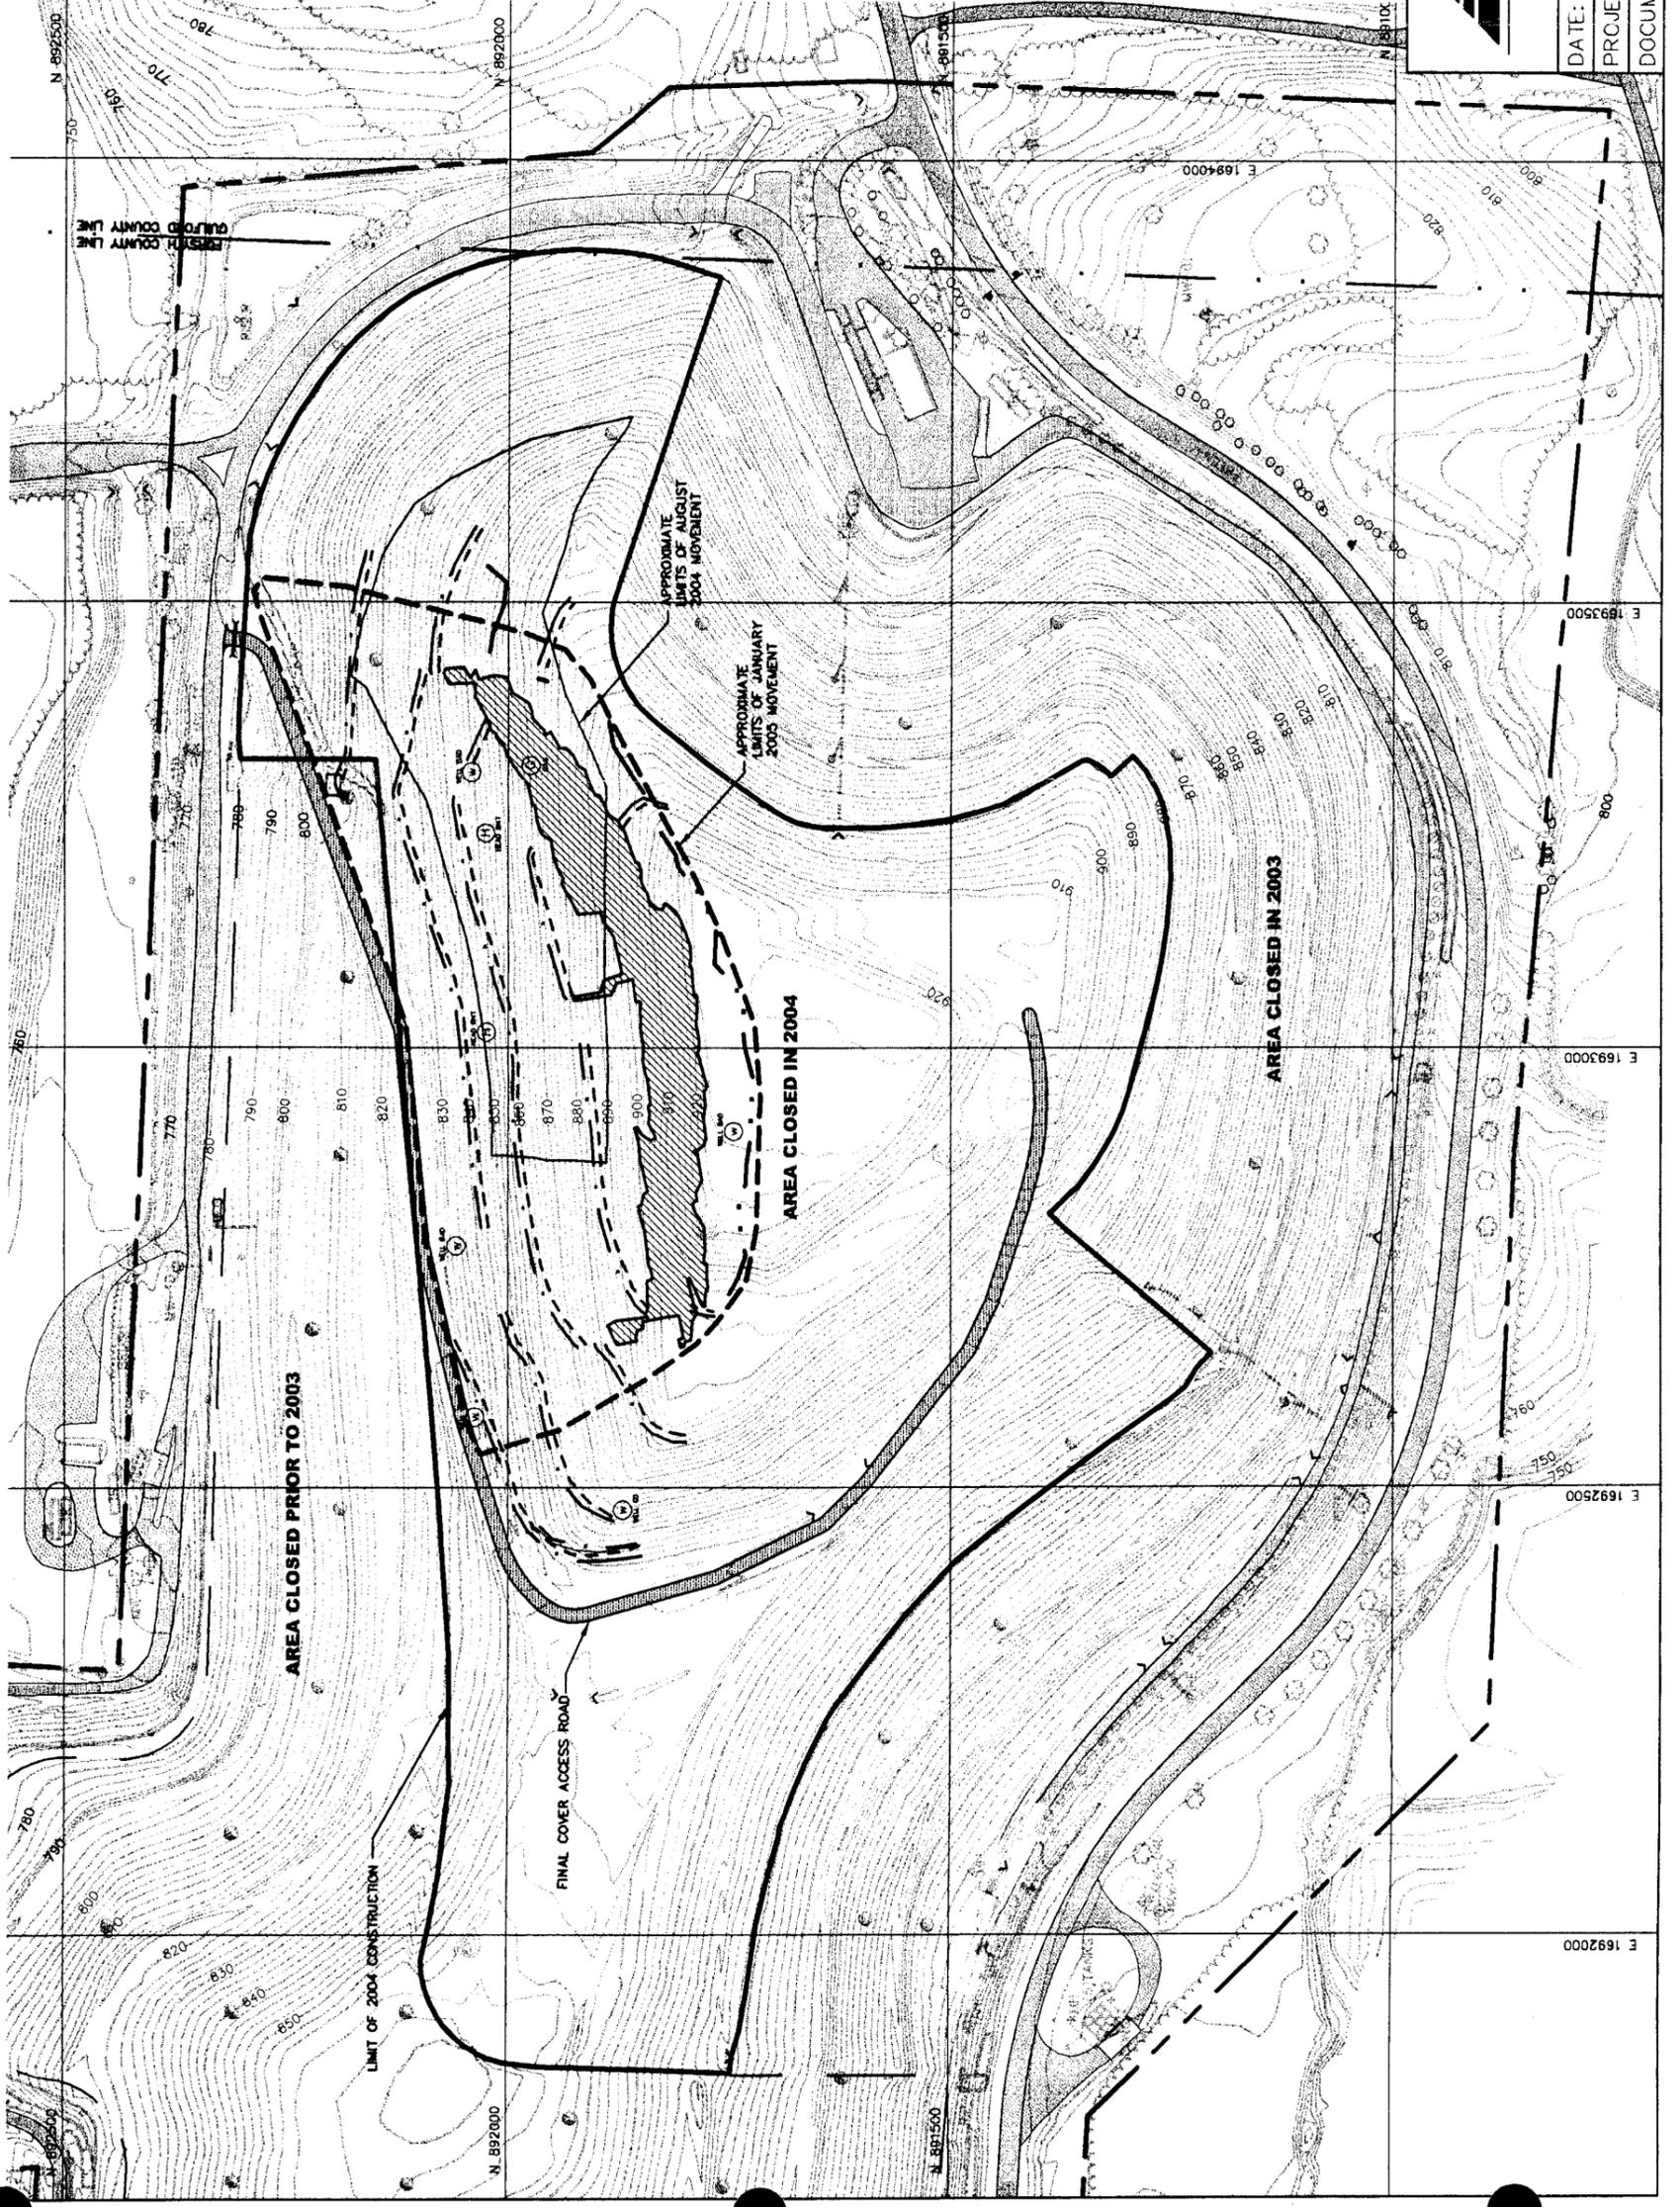
INVESTIGATION REPORT PIEDMONT LANDFILL APPROXIMATE LIMIT OF COVER SYSTEM MOVEMENT - JANUARY 2005

As already noted, in mid January 2005, an approximate seven acre portion of the Phase 2 final cover system underwent downslope movement in the area shown on Figure 2-4.

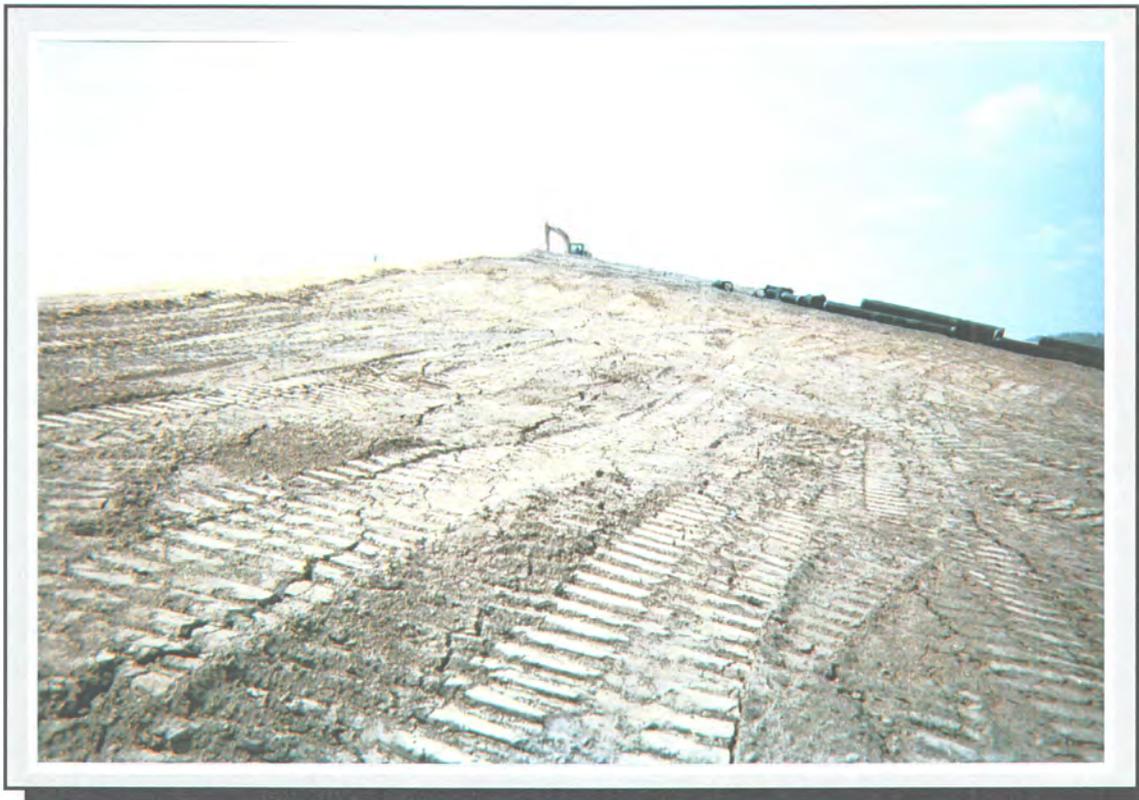
Photograph 3: Cracking within protective cover due to slope movement.
Date: 28 August 2004

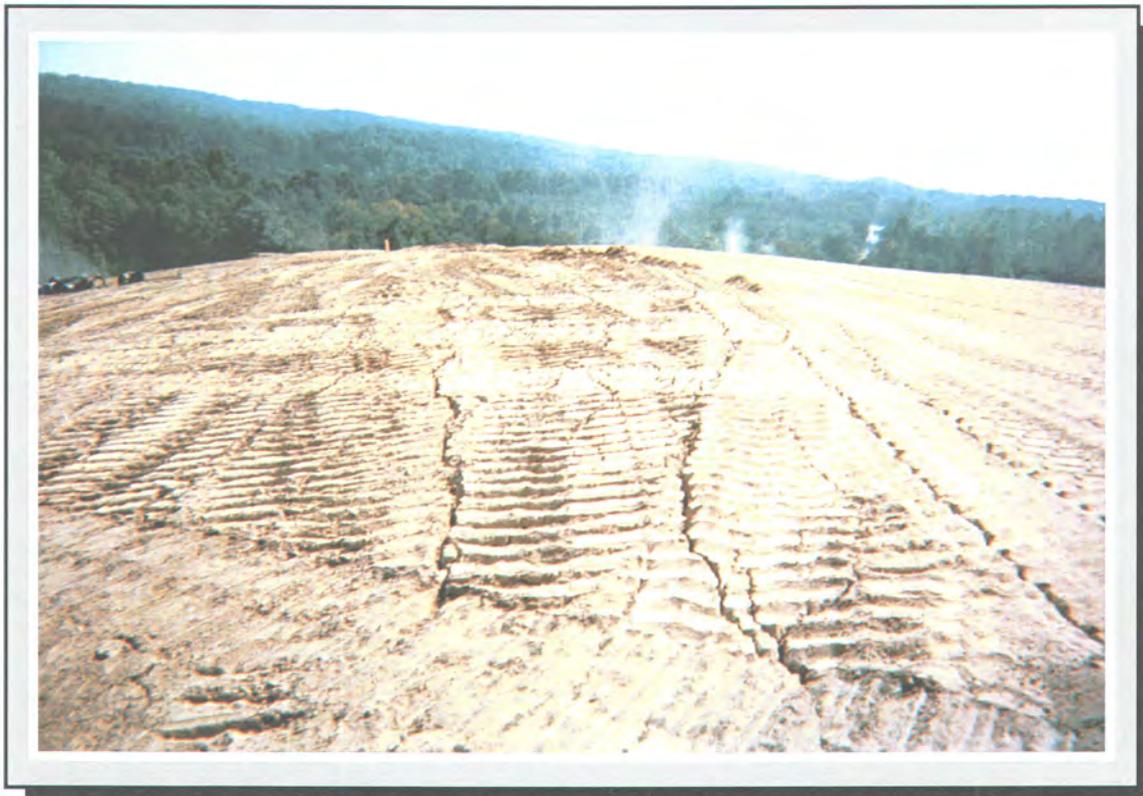
Photograph 4: Cracking within protective cover due to slope movement.
Date: 28 August 2004

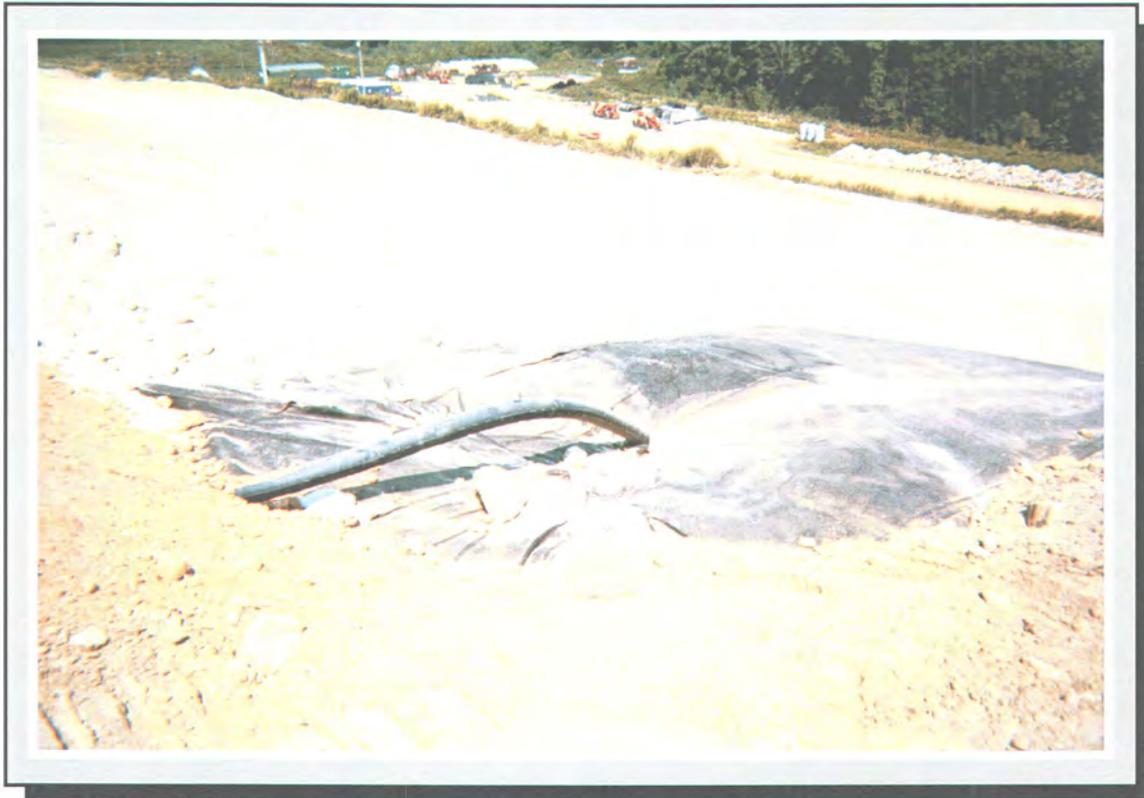
Photograph 5: Gas header pipe shown deforming during slope movement.
Date: 28 August 2004

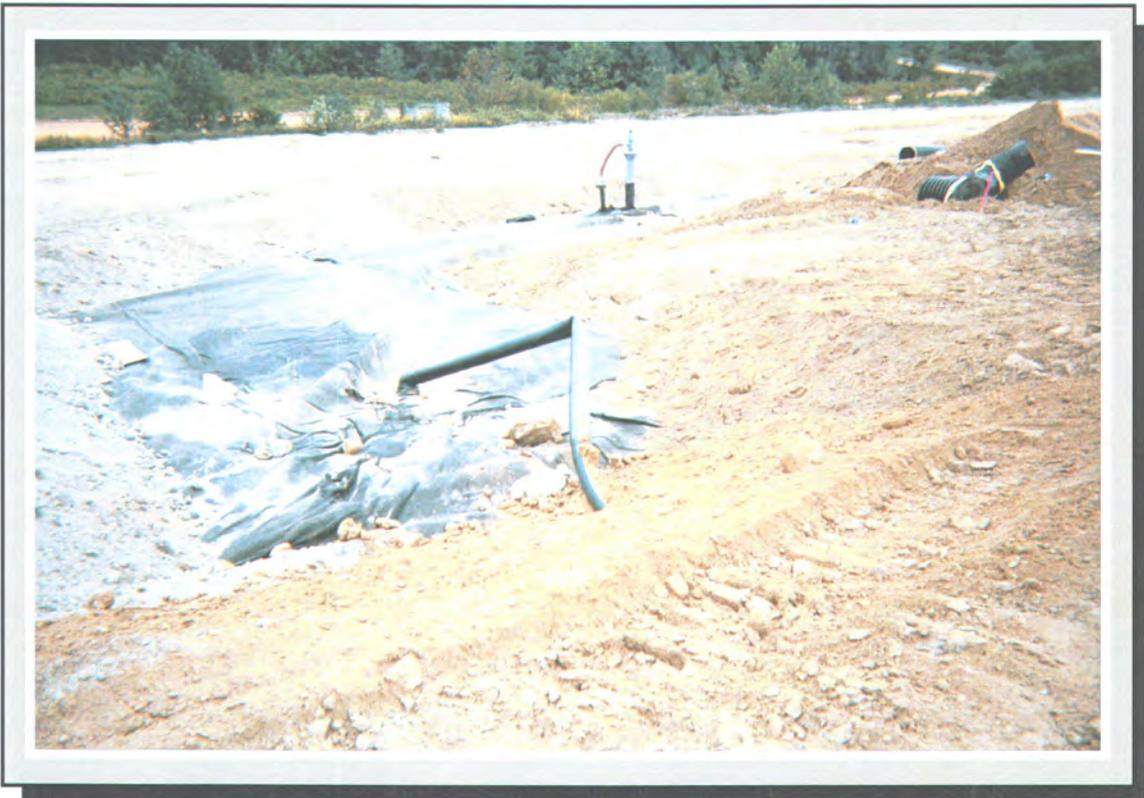
Photograph 6: Gas header pipe shown fully deformed during slope movement.
Date: 28 August 2004

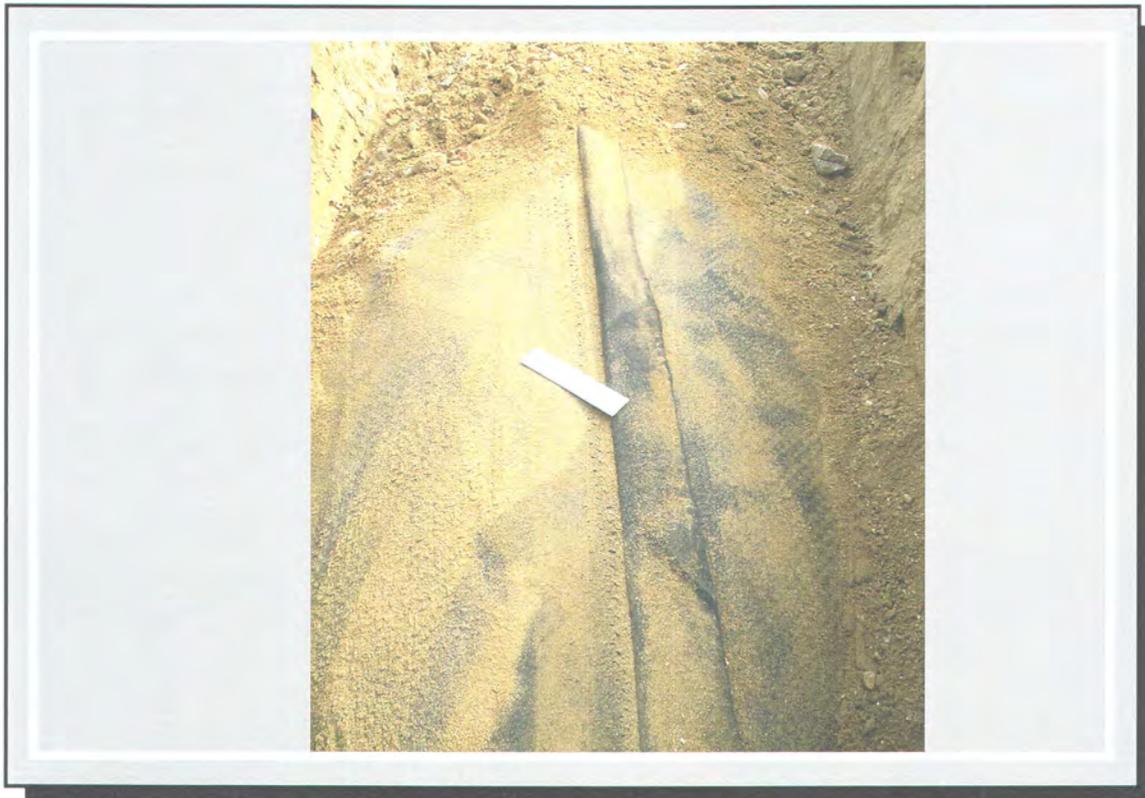
Photograph 8: Landfill gas uplifting geosynthetic cap during excavation of exploratory trench through the protective cover layer after the slope movement
Date: 31 August 2004.

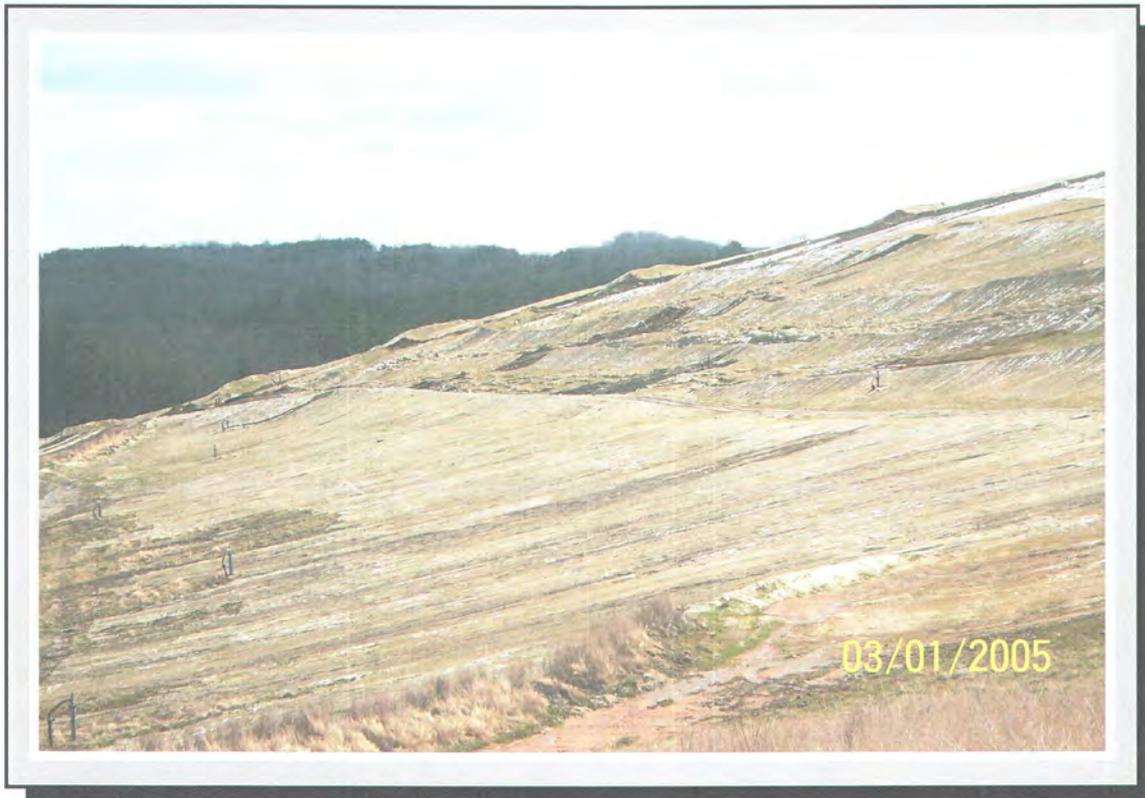
Photograph 11: Area of cover system movement down slope of exposed geosynthetic clay liner area and upslope of sideslope haul road.

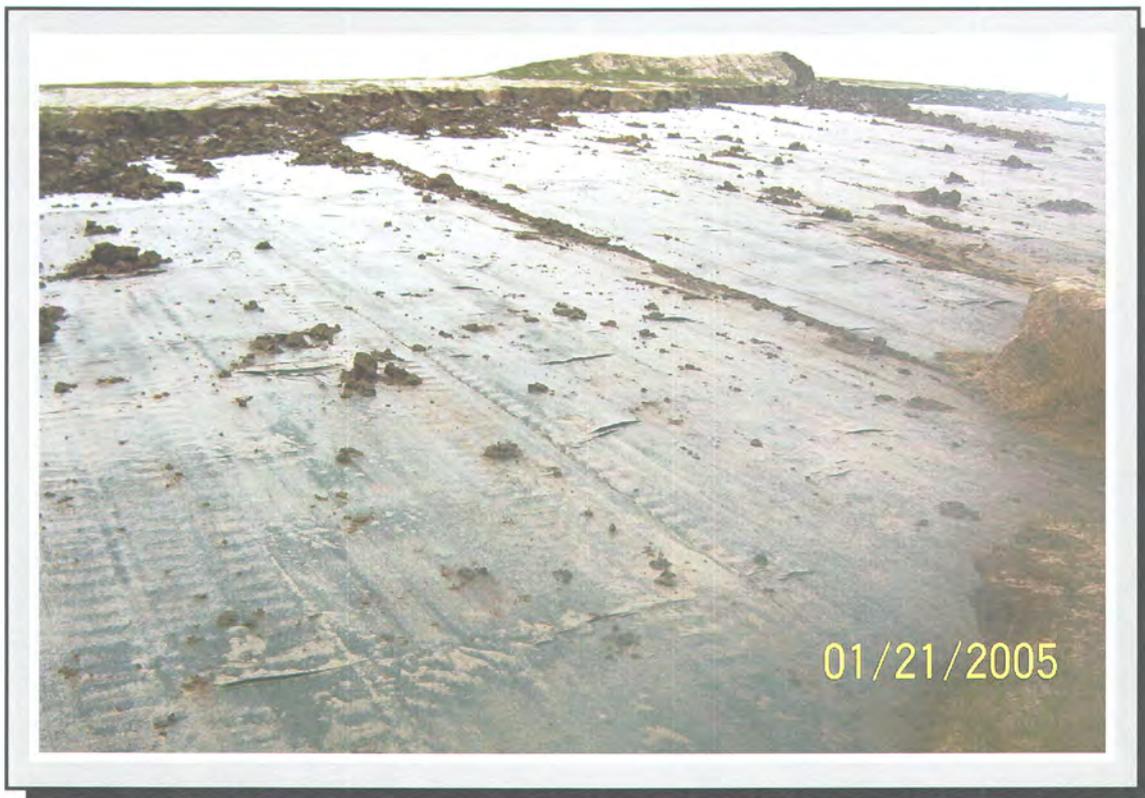
Photograph 16: Exposed geosynthetic clay liner and protective cover layer looking upslope from eastern edge of cover system movement to south west.

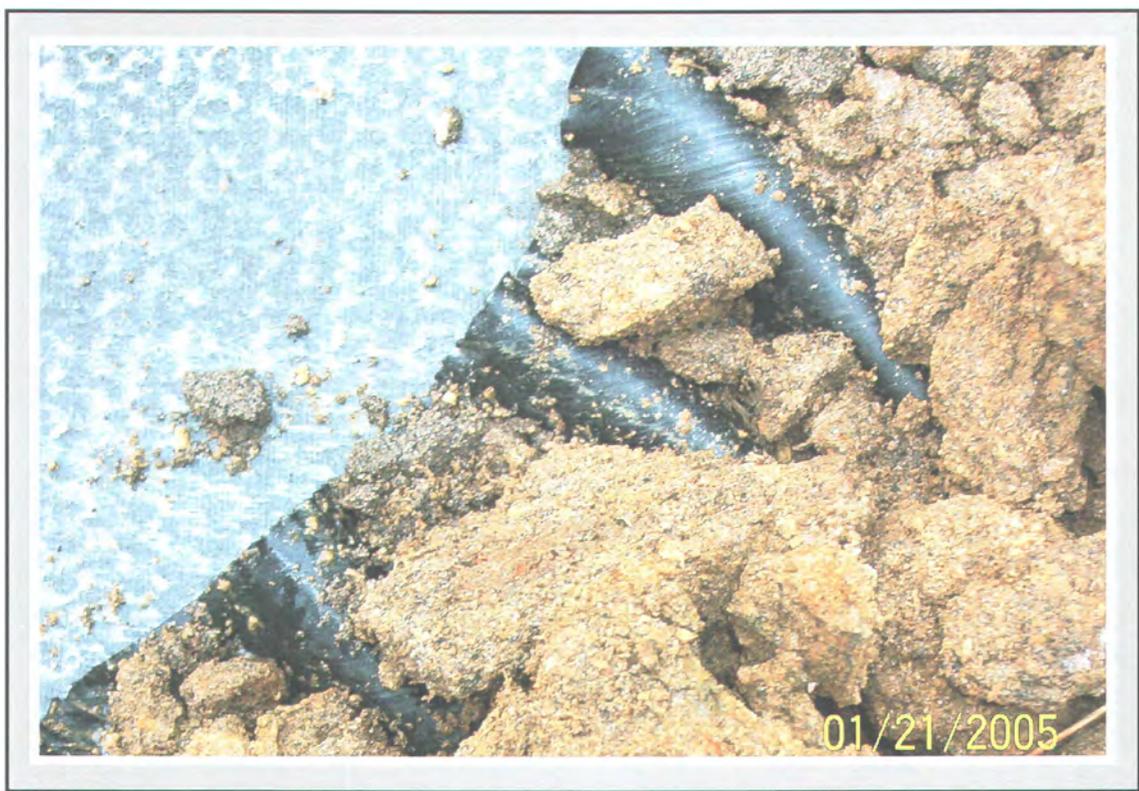
Photograph 20: Close-up view of upslope ruptured geomembrane edge (typical for geomembrane that is exposed).

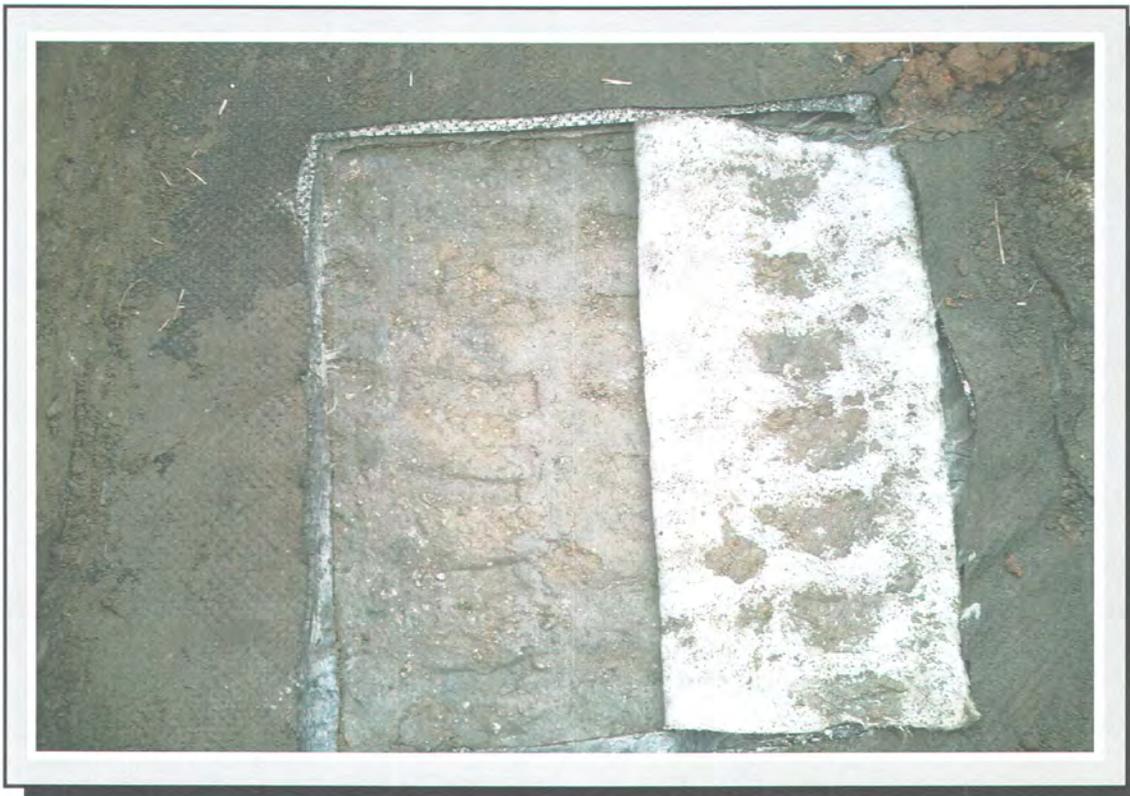
Photograph 37: Test Pit 2 - top of GCL surface with bentonite film.
Date: 2 February 2005

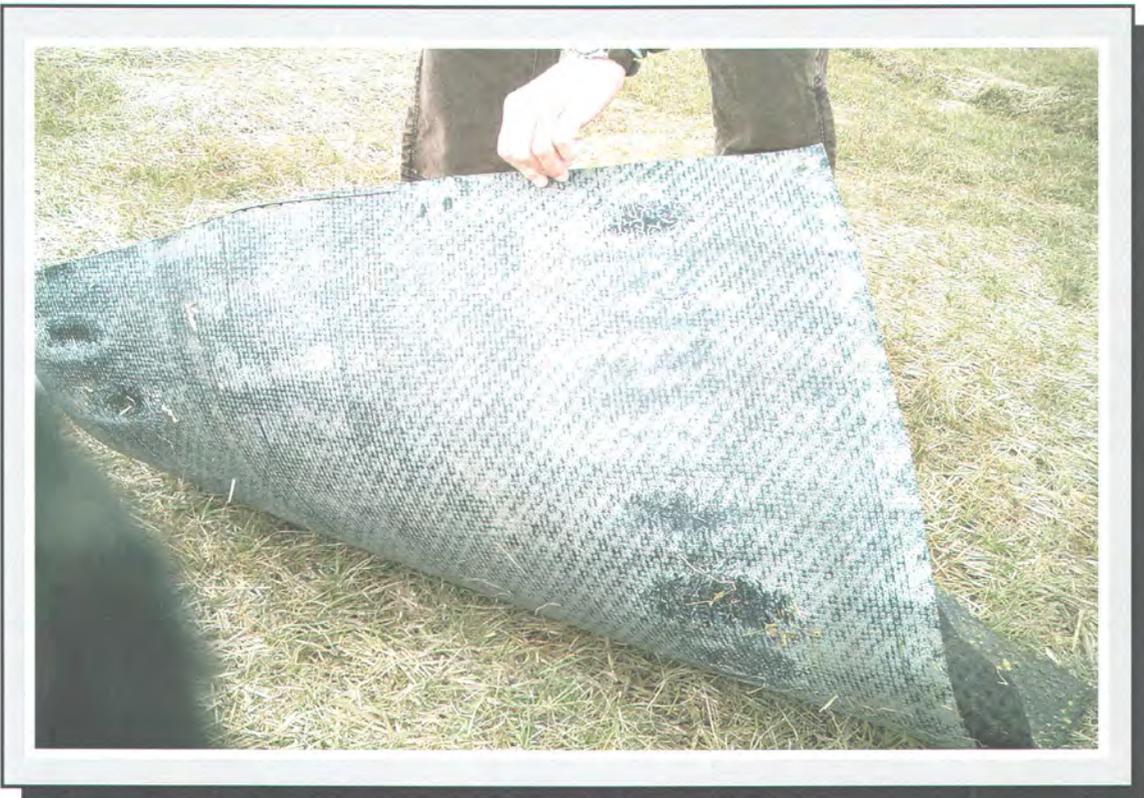
Photograph 50: Test Pit 3 - bottom of geomembrane - bentonite film.
Date: 2 February 2005
