Subject: Allen Steam Station
Retired Ash Basin (RAB) Ash Landfill (Permit No. 3612)
Notice of Release Beyond Edge of Liner

Allen RAB Ash Landfill (Permit # 3612)

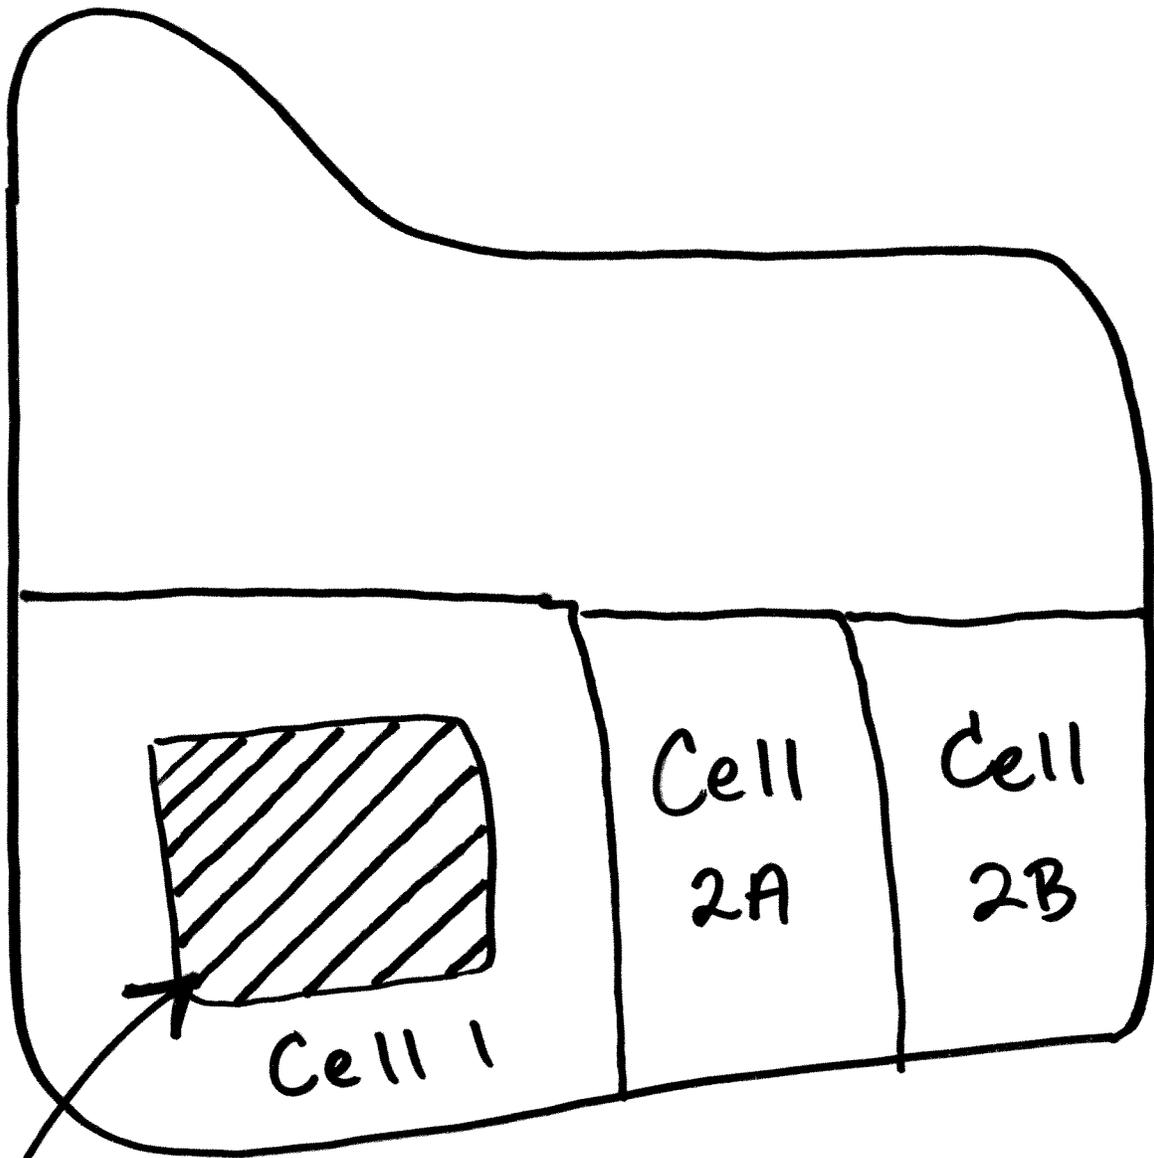
Figure 1

Cell 1 top deck

As discussed during our phone conversation this morning, a release of ash and soil from the Allen RAB Ash Landfill beyond the edge of liner was discovered at approximately 7:15 a.m. on Monday, December 23, 2013. For your convenience, hand sketches of the landfill and release areas have been attached as Figures 1 and 2. Photos taken on December 21-22, 2013 before the incident are provided in Attachment A. Photos taken on December 23, 2013 after the incident are provided in Attachment B.

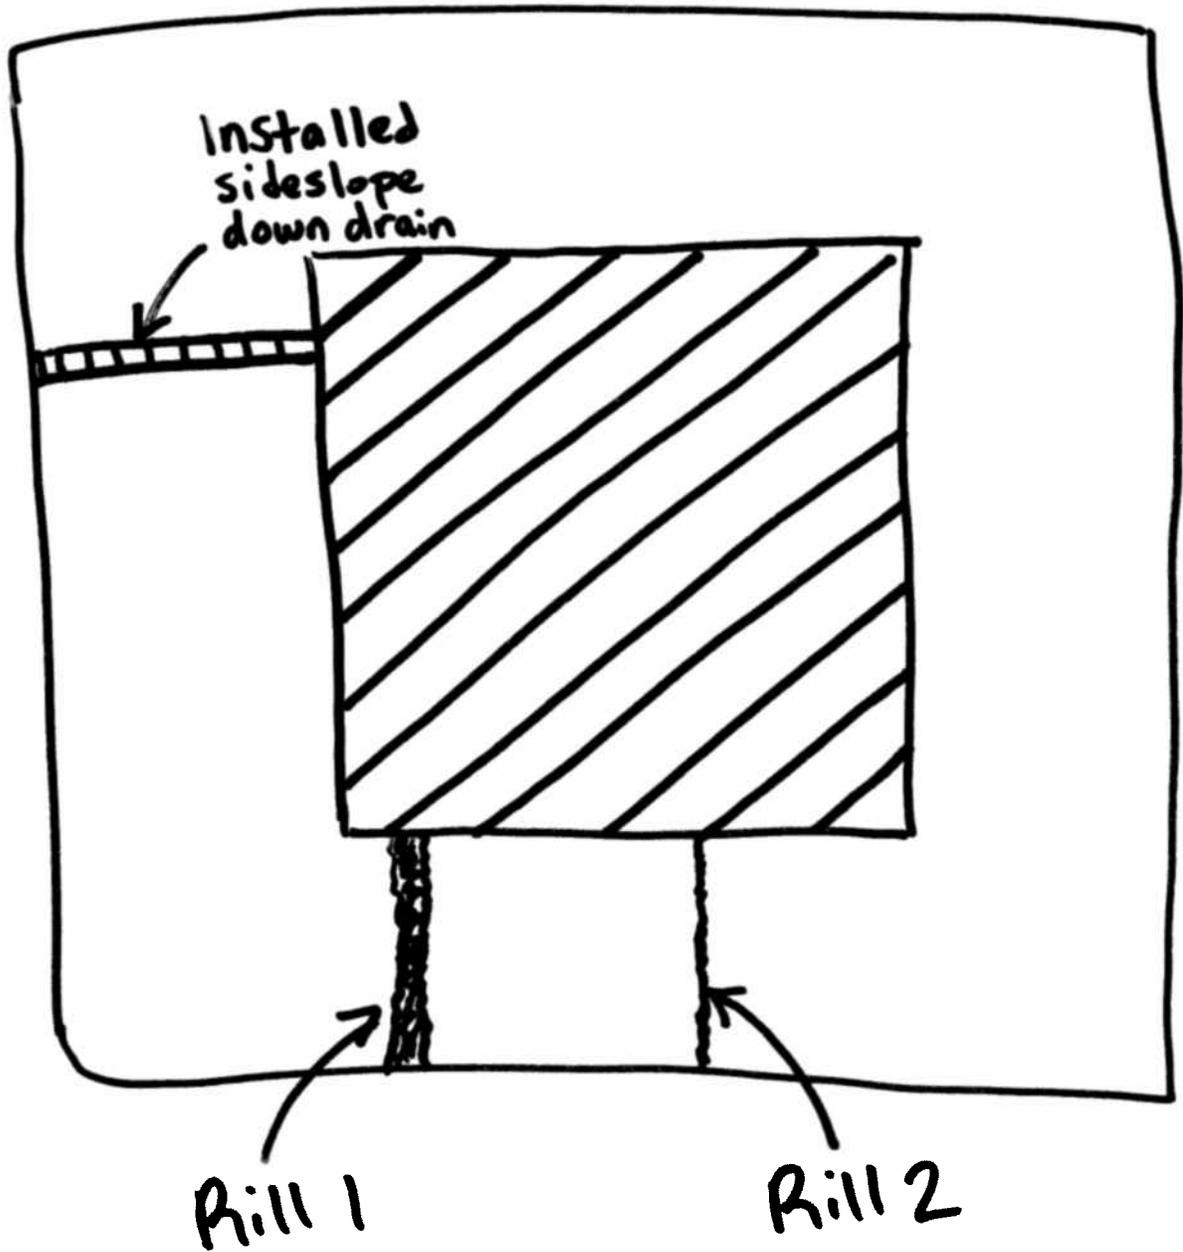
Figure 2 ^{12/23/13}
smd

Cell 1 top deck

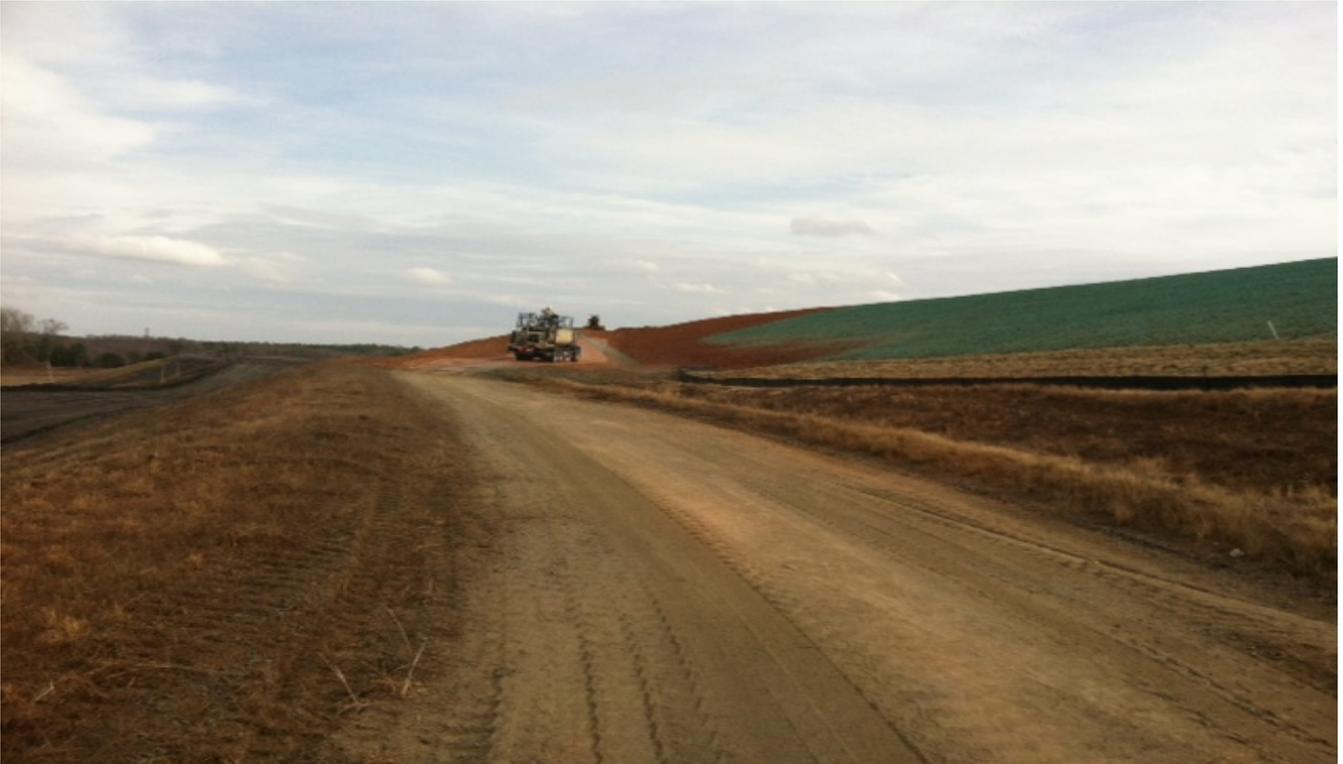
North Slope

12/21/2013

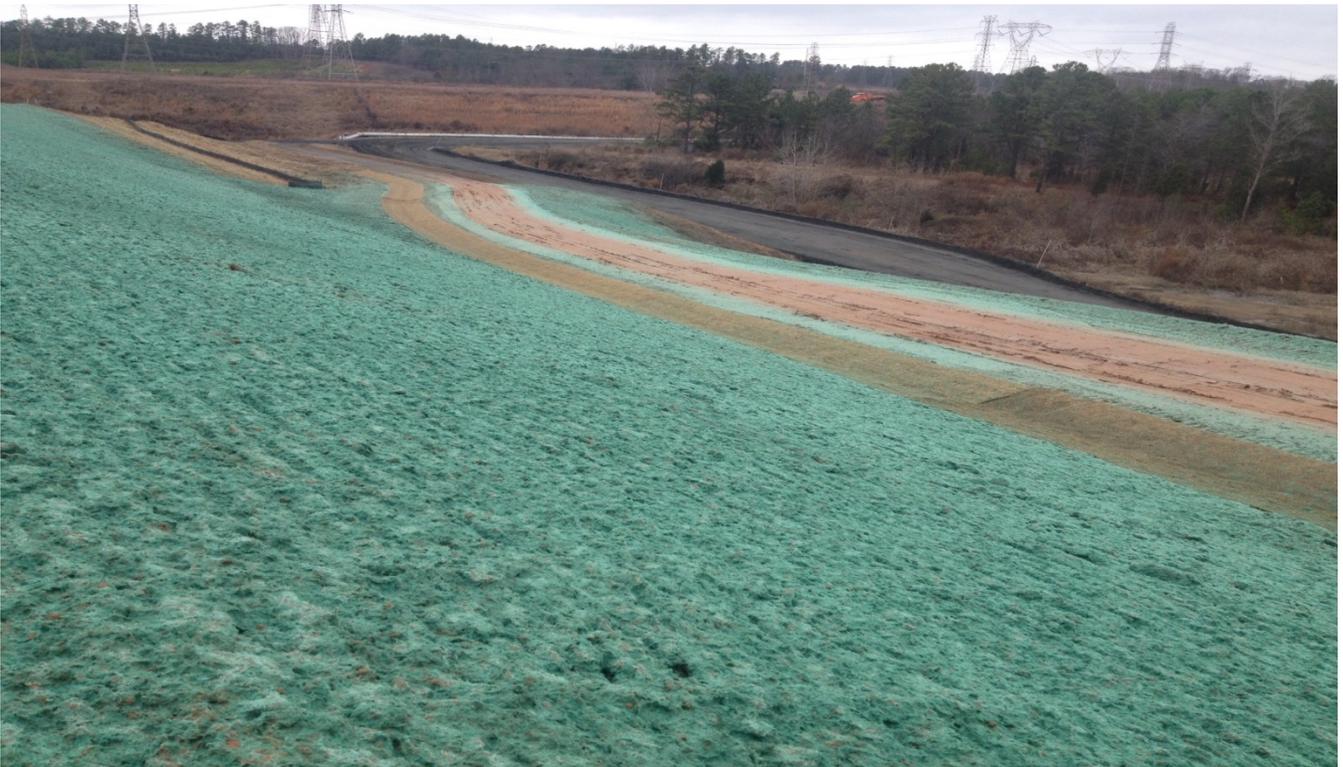
North Slope

12/22/2013

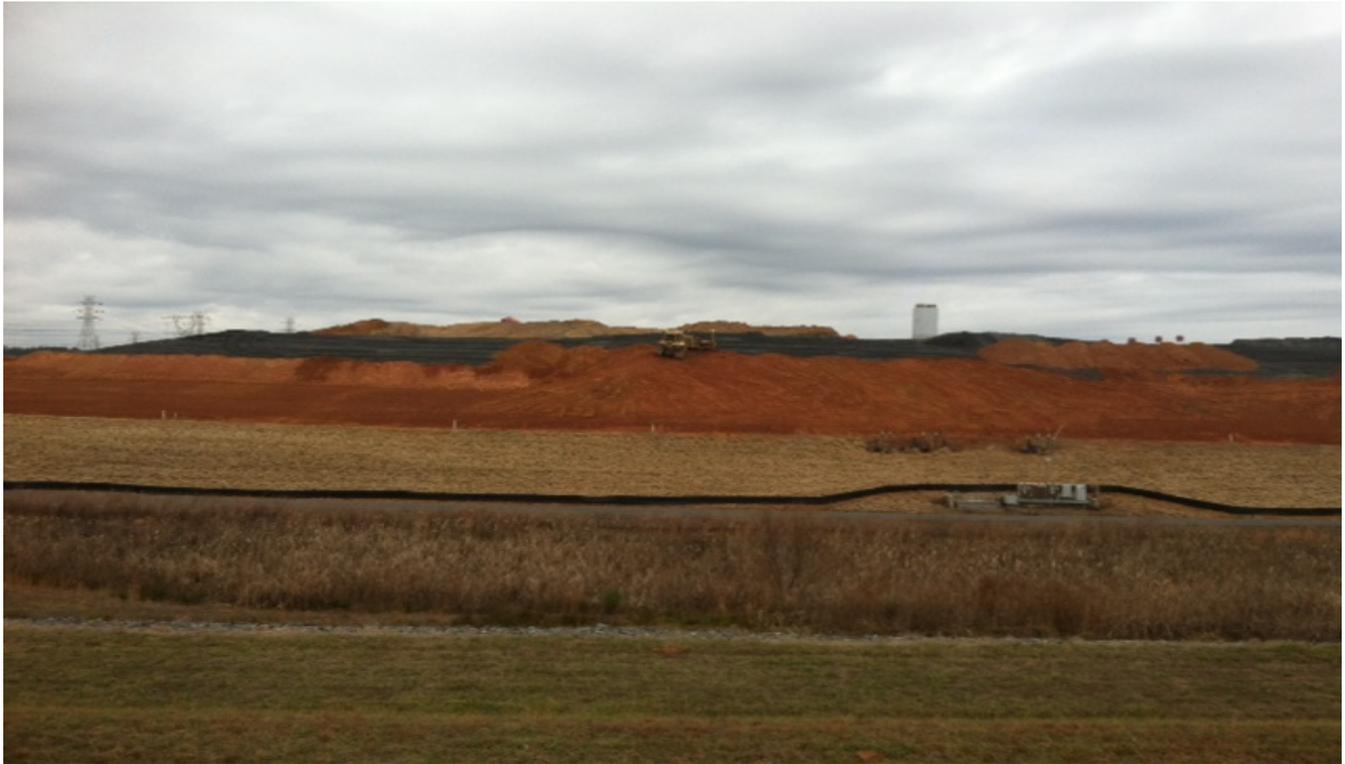
South Slope

12/21/2013

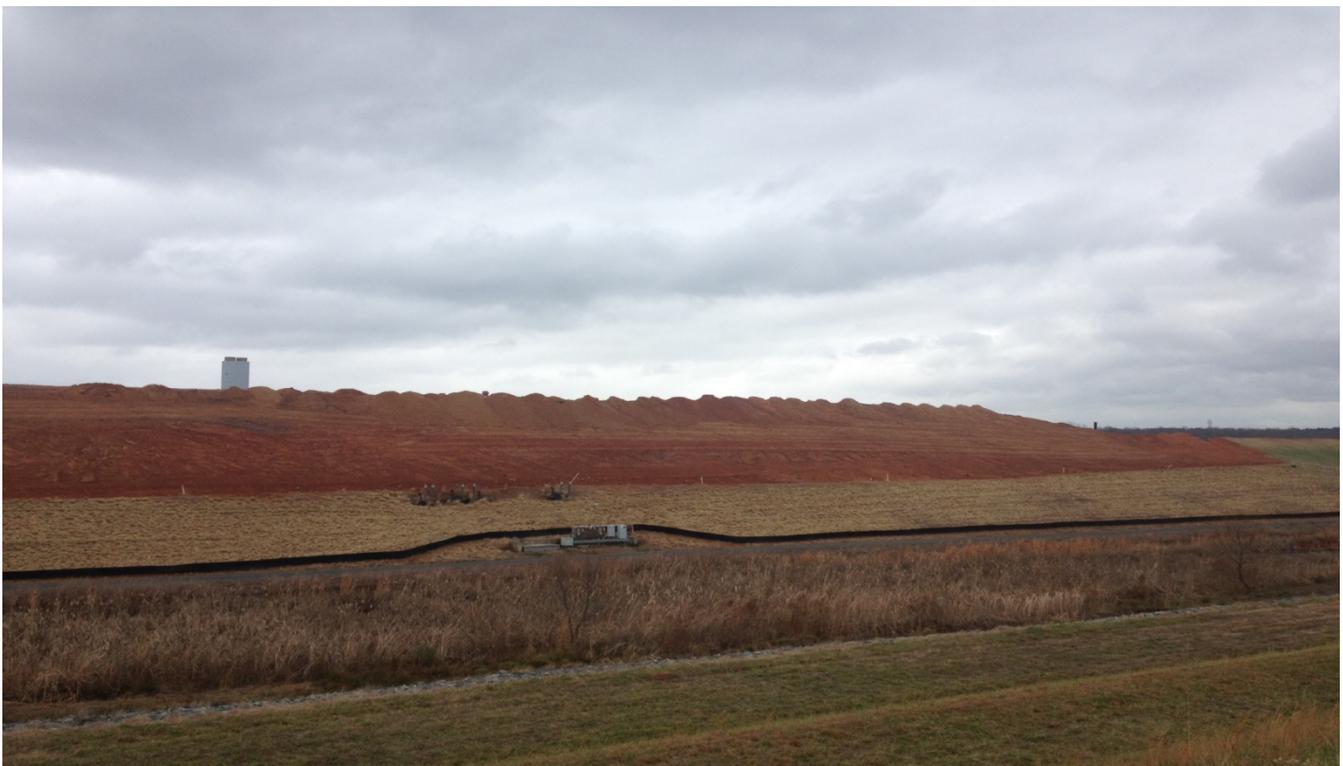
South Slope

12/22/2013

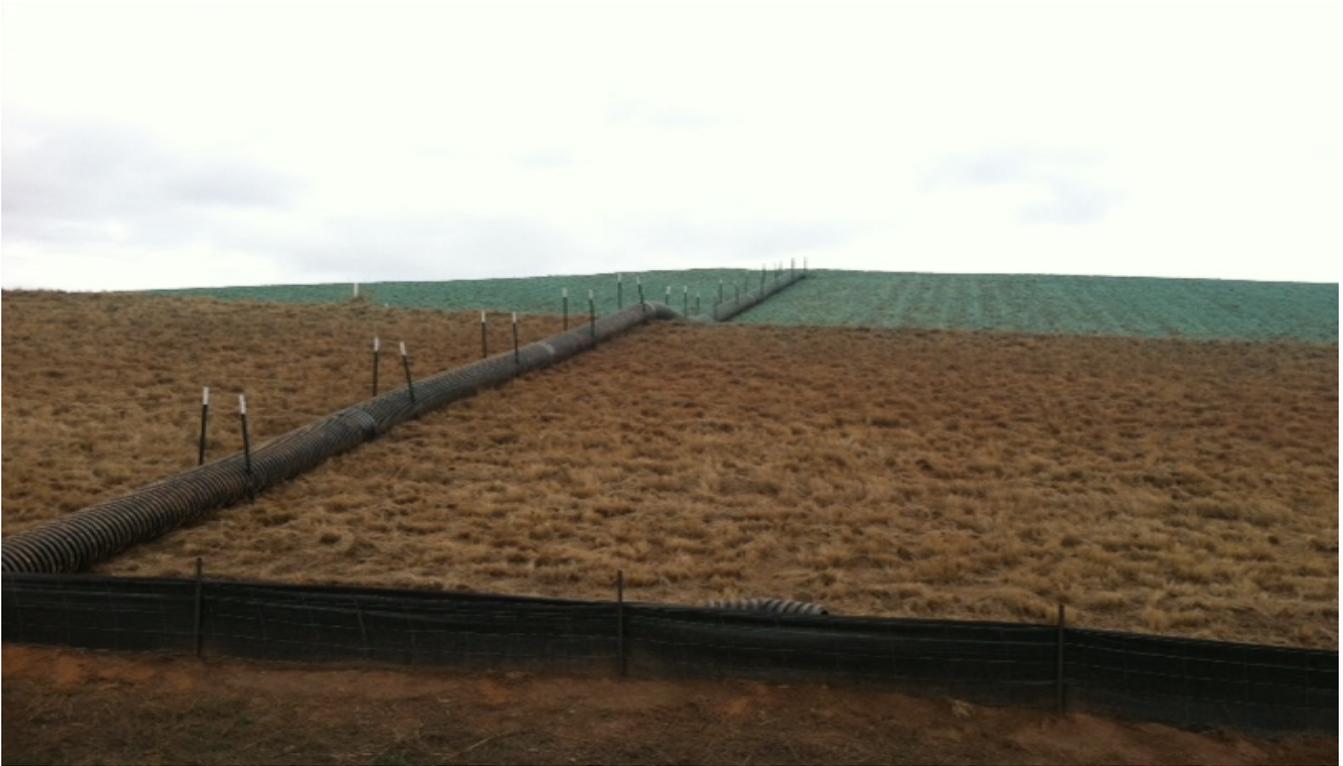
West Slope Down Drain

12/21/2013

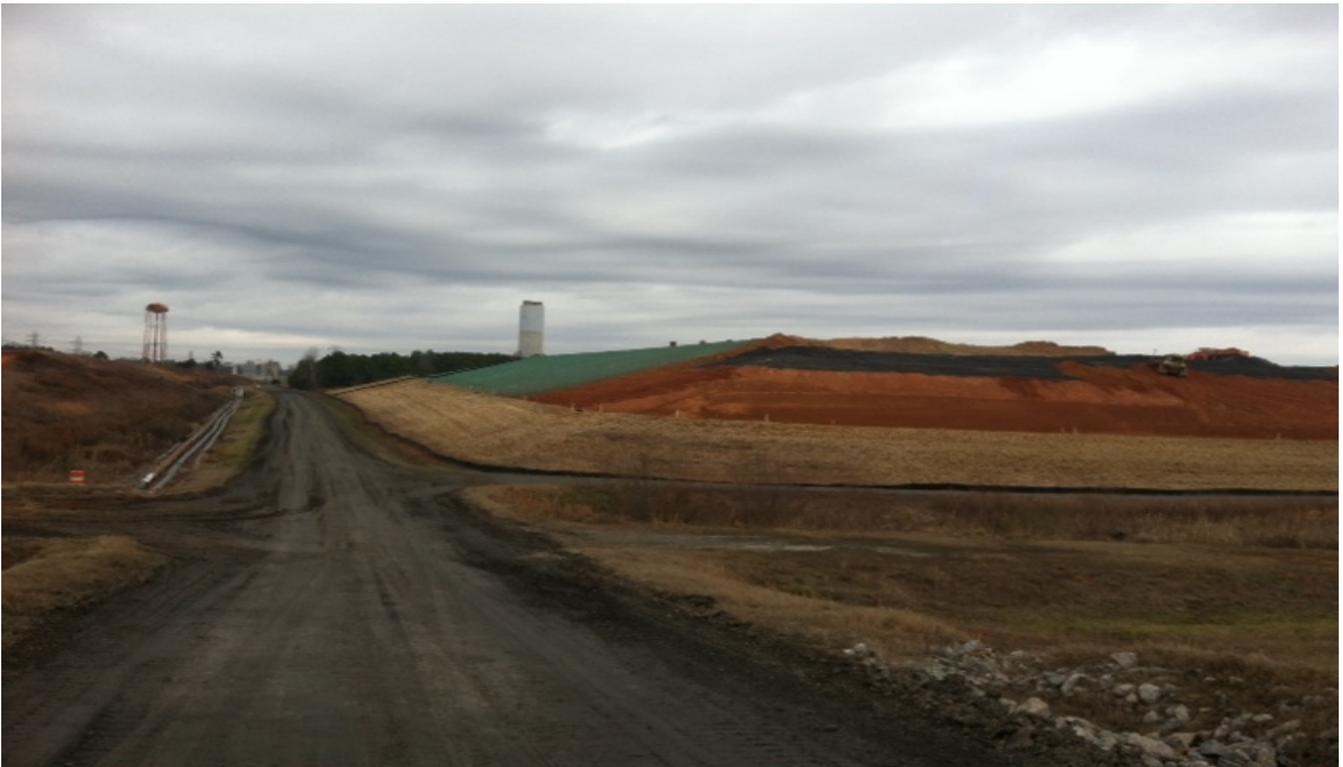
Southwest Corner of Cell 1

12/21/2013

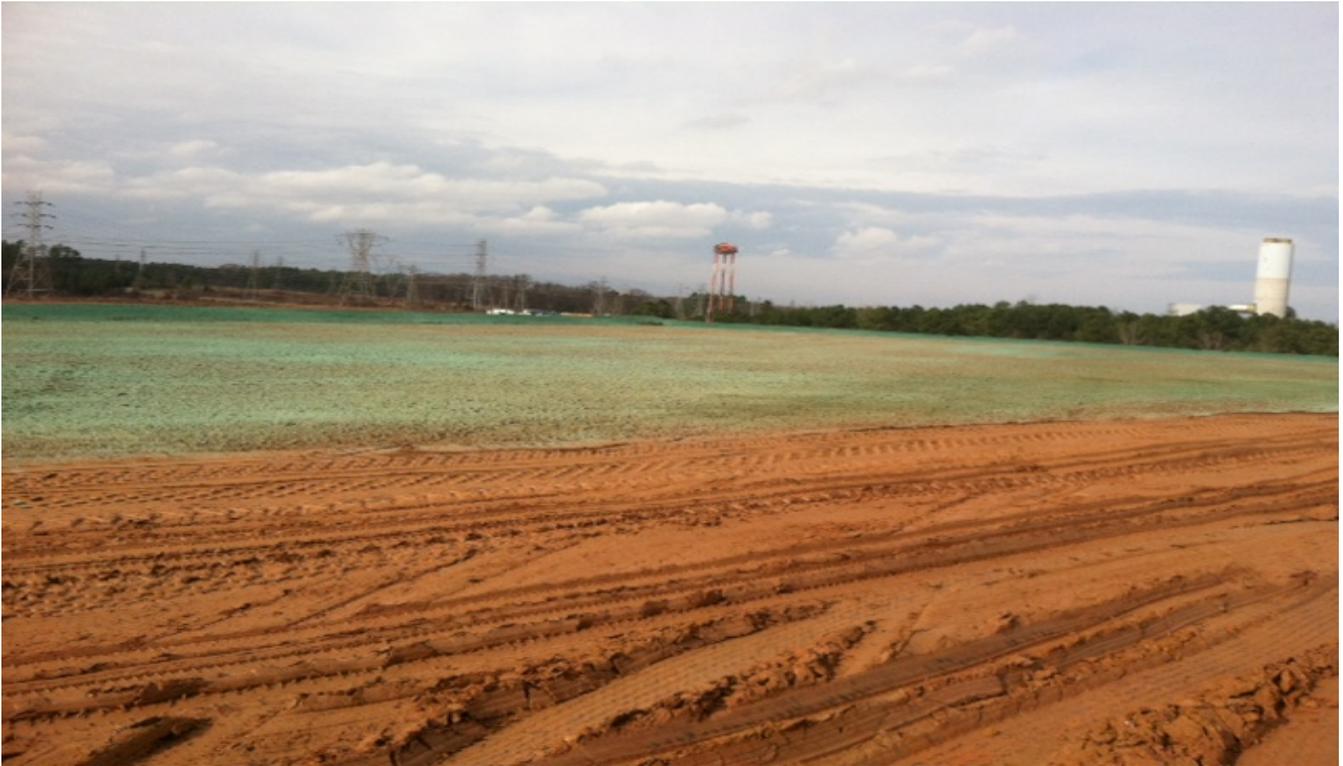
Top Deck of Cell 1

12/21/2013

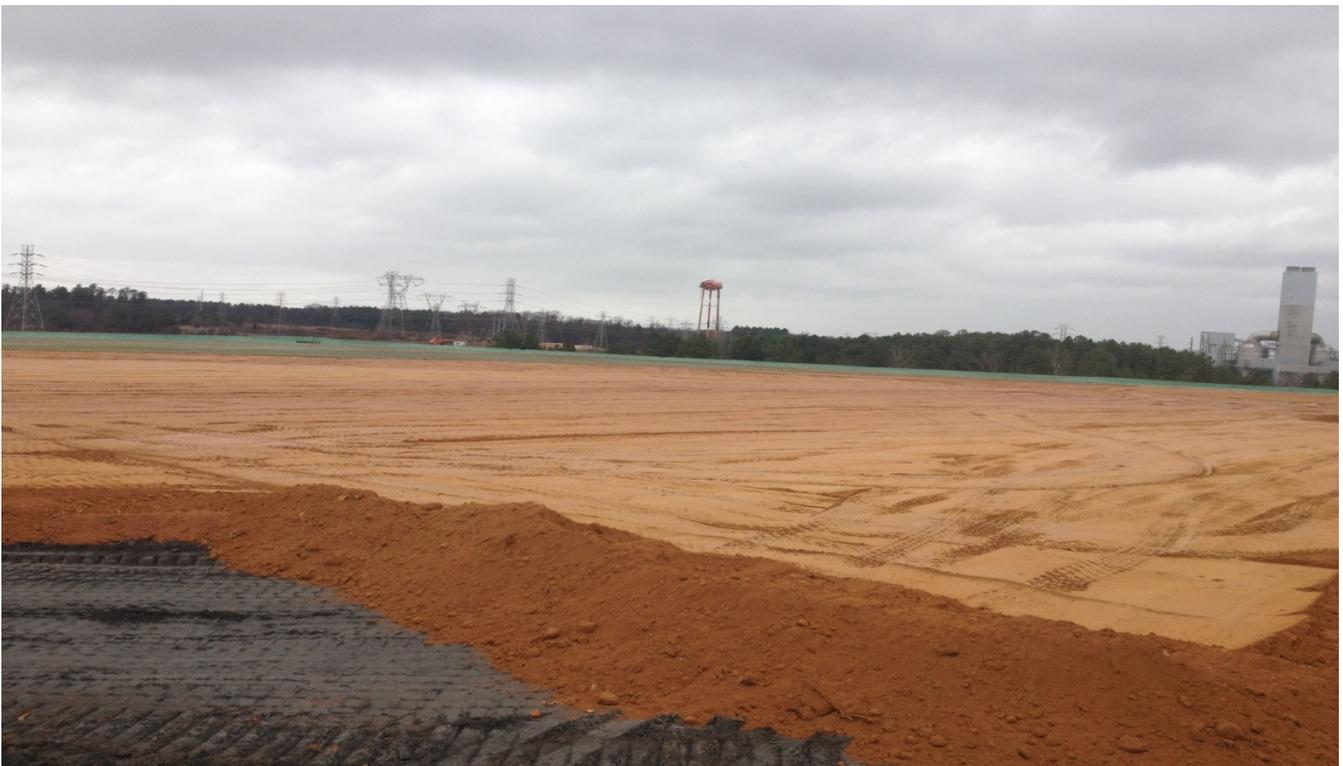
Top Deck of Cell 1

12/22/2013

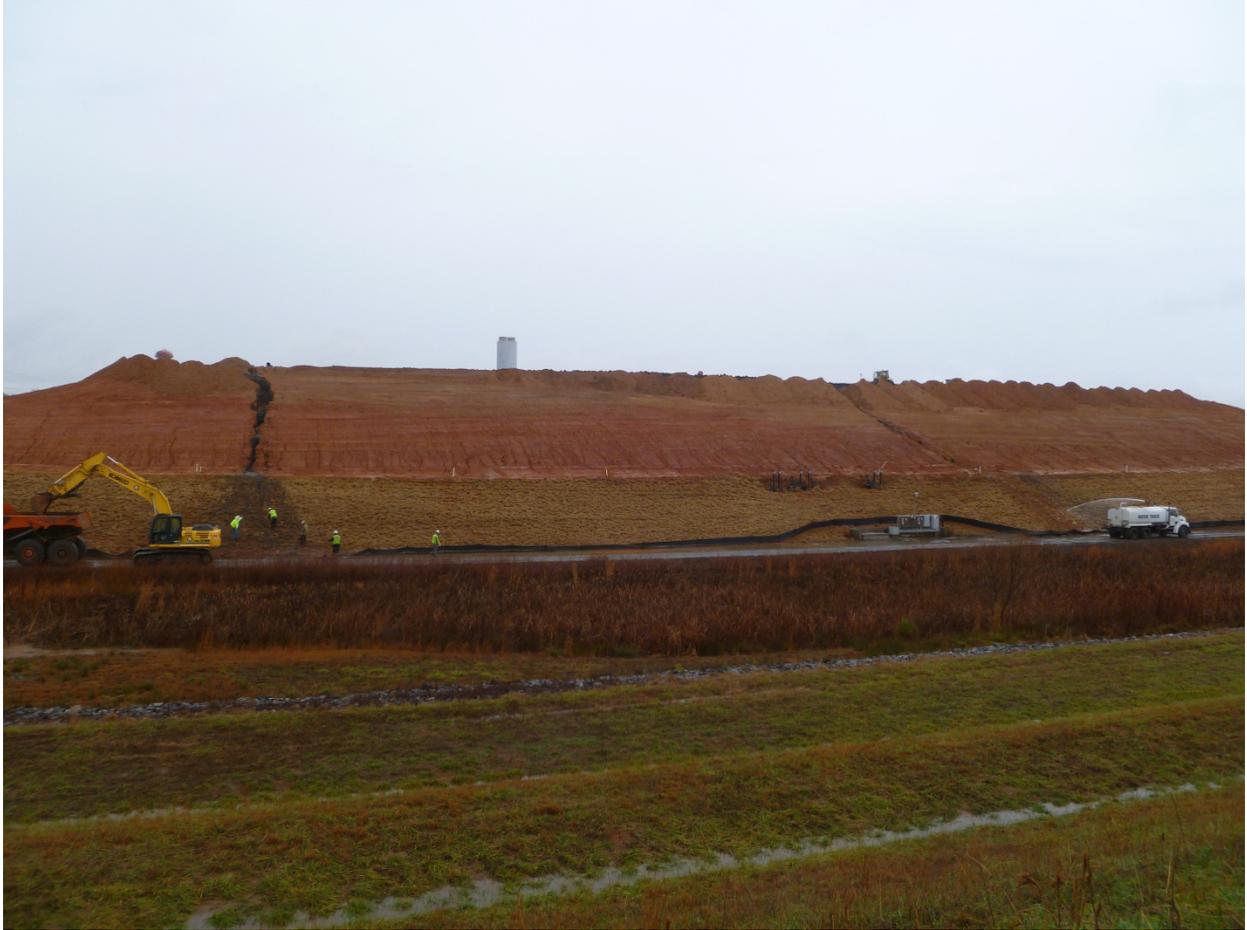
The release occurred on the southern sideslope of Cell 1, where two significant erosion rills were formed as a result of heavy rainfall. The western erosion rill (Rill 1) was more significant, and it is estimated that 20 cubic yards of ash/soil mixture was eroded away from Rill 1 at an approximate ash-to-soil ratio of 3-to-2 (i.e., approximately 12 cubic yards of ash). The eastern erosion rill (Rill 2) was less significant, and it is estimated that 5 cubic yards of ash/soil mixture was eroded away from Rill 2 at an approximate ash-to-soil ratio of 1-4 (i.e., approximately 1 cubic yard of ash). During the release event, the ash/soil mixture flowed down the remainder of the sideslope and into the drainage ditch that runs west-to-east along the landfill's southern perimeter. Contact stormwater also released to the stormwater channel south of the landfill, which ultimately drains to the Catawba River. Allen Stowe (Duke Energy) notified Wes Bell (NCDENR, DWR) this morning of this release from a surface water perspective.

Southern sideslope of Cell 1 showing Rill 1, Rill 2 , and remedial work (taken from ash pond Cell 2 dike)

Crews immediately mobilized and began removing the released material beyond the edge of landfill liner, along the sideslopes, and in the drainage ditch. When remedial activities were observed at approximately 10:30 a.m. today, there were observed an excavator, dump truck, water truck, and four crewmembers with shovels addressing the released material. Meanwhile, several pieces of construction equipment were operating on the top deck addressing the root cause of the incident.

The remedial activities will continue until visual signs of the released material have been satisfied. All recovered material will be replaced in the landfill. Reworking, repairing, regrading, and soil covering of the southern sideslope will be immediately conducted, and the remaining 10% of the top deck will be filled, graded and soil covered (as was planned to finalize the repair project prior to this most recent incident). The two remaining down drains will then be installed, and the Cell 1 repair project will be completed. Completion of the repair project is still anticipated to be around December 31, 2013 and will prevent another such incident as well as the root causes of the September 2011 and October 2013 release events.

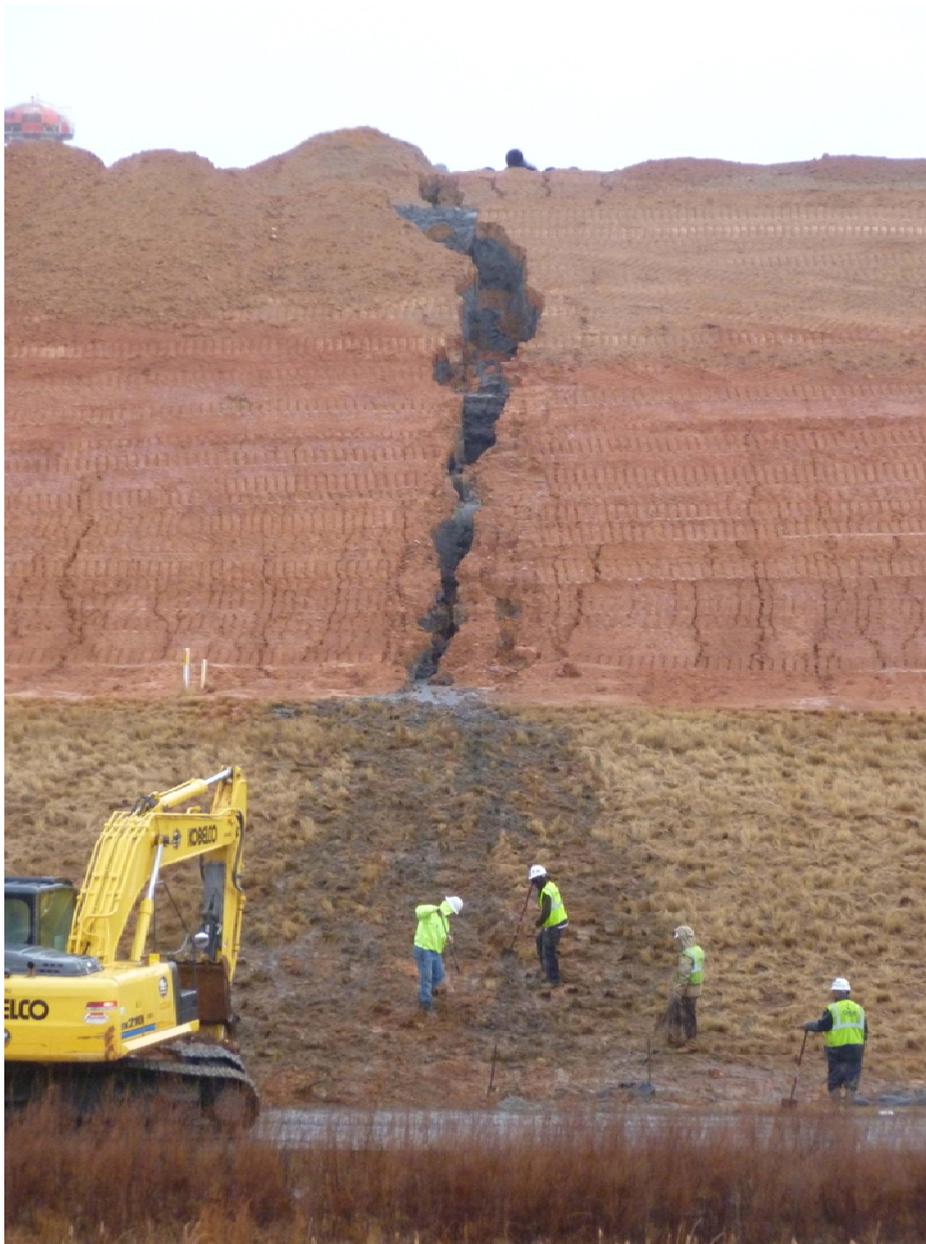
Rill 1 and remedial work (taken from ash pond Cell 2 dike)

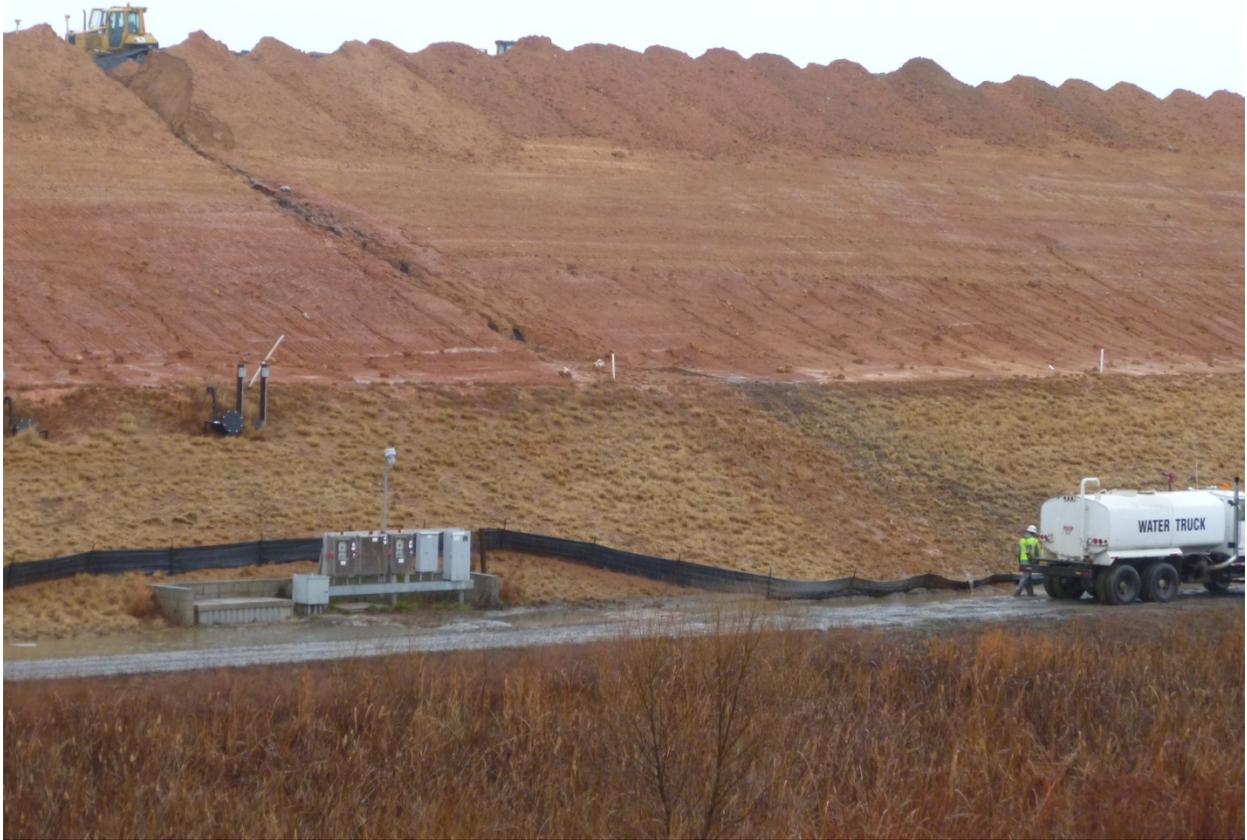
Rill 2 and remedial work, including loader on the top deck (taken from ash pond Cell 2 dike)

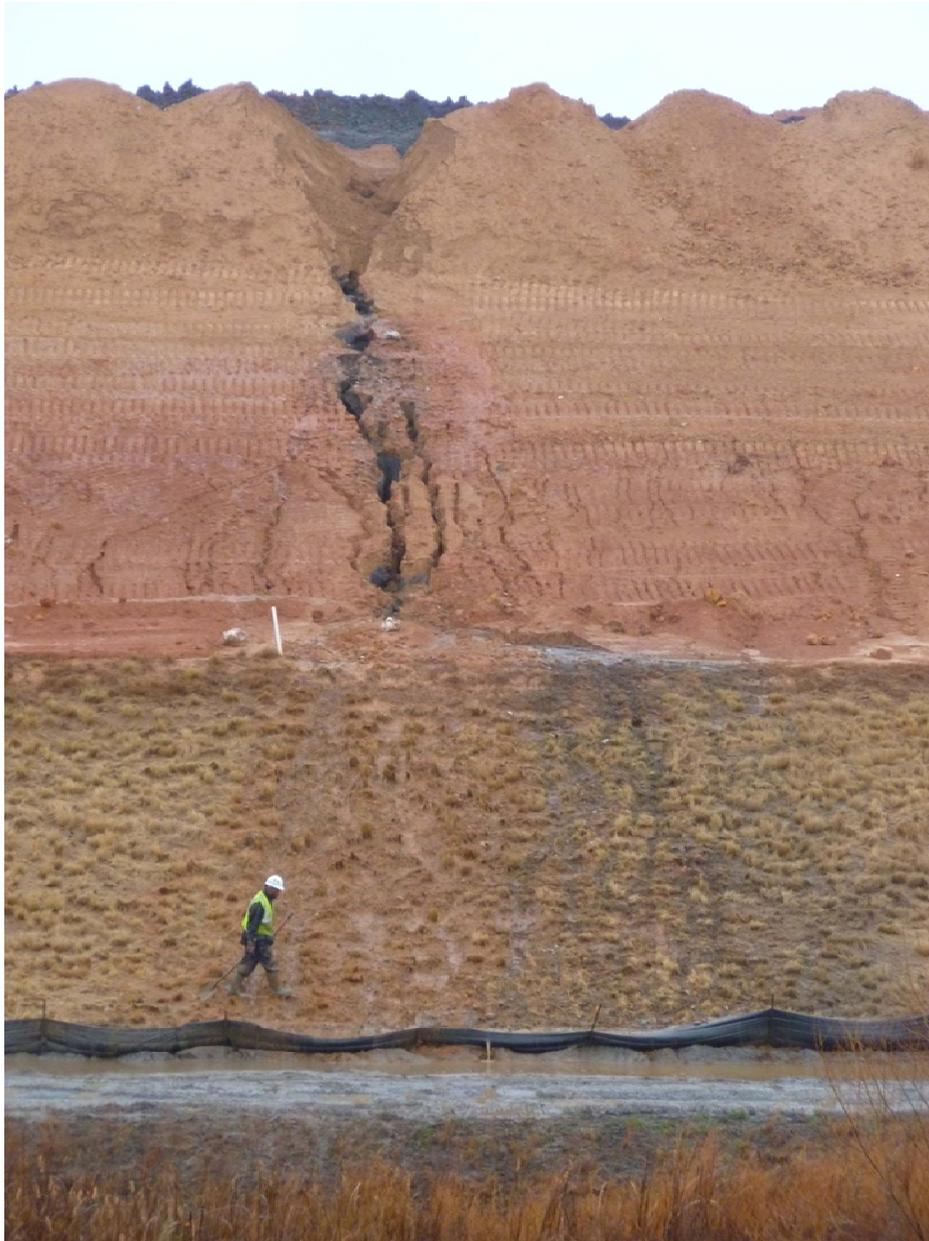
Rill 2 and remedial work (taken from ash pond Cell 2 dike)

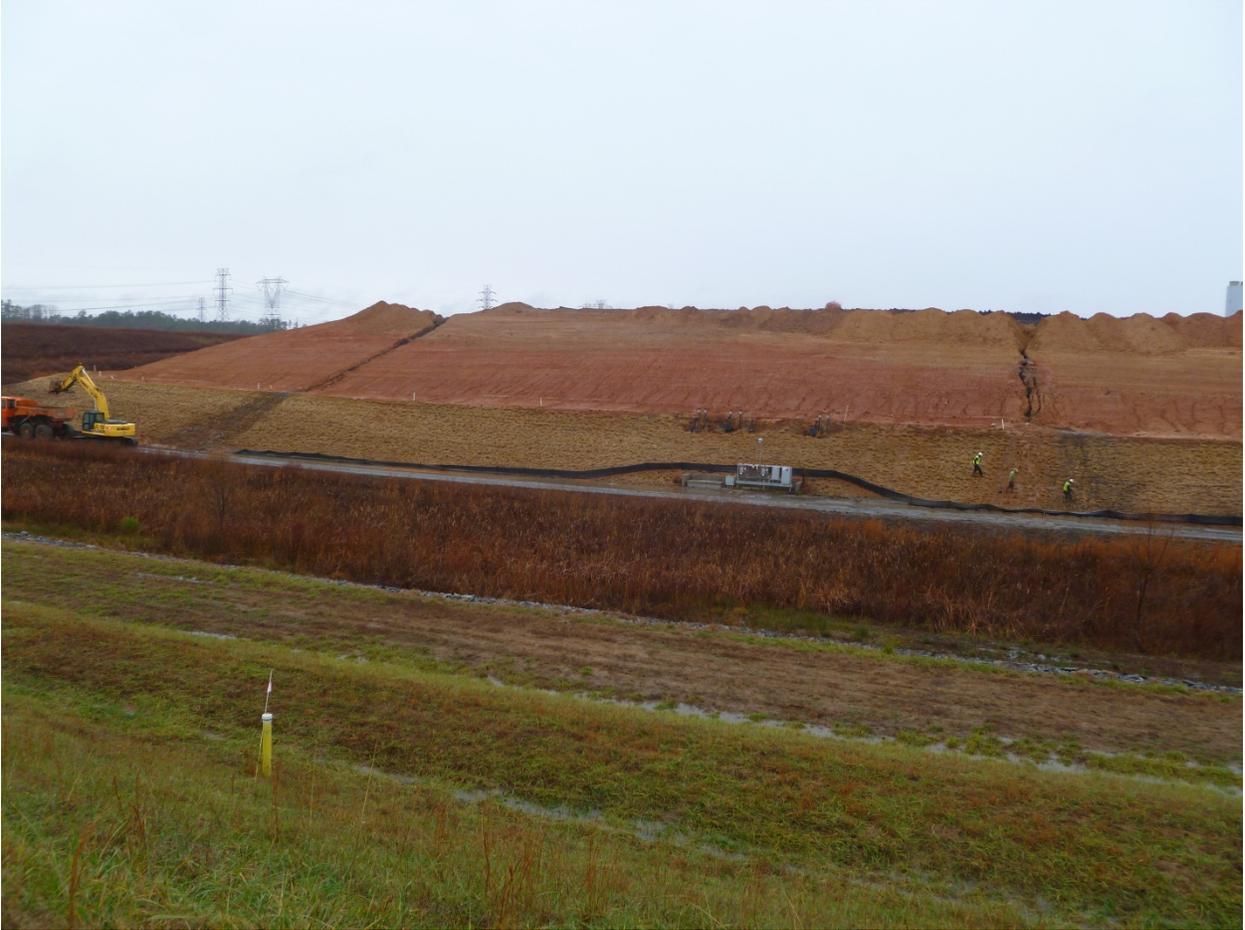
Southern sideslope of Cell 1 showing Rill 1, Rill 2 , and remedial work (taken from ash pond Cell 2 dike)
