FACILITY COMPLIANCE INSPECTION REPORT
Division of Waste Management
Solid Waste Section

Fontana Village Resort Landfill
 Gold Village Branch Court
 Fontana Dam, NC 28733

Comprehensive Inspection of Closed MSW Landfill

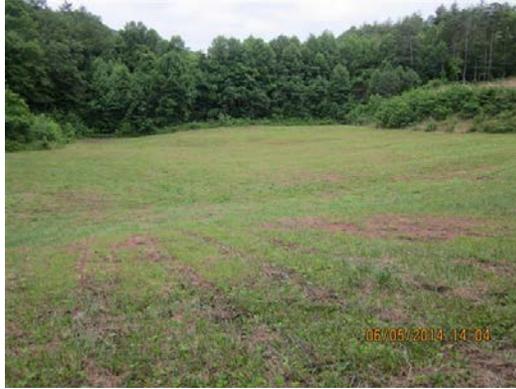
3. Vegetation was well established and the cap recently mowed. No evidence of leachate seeps were observed. No ponded water was observed on the cap of the landfill. **Some of the “Edge of Waste” markers were destroyed and need to be replaced.**

Landfill Cap

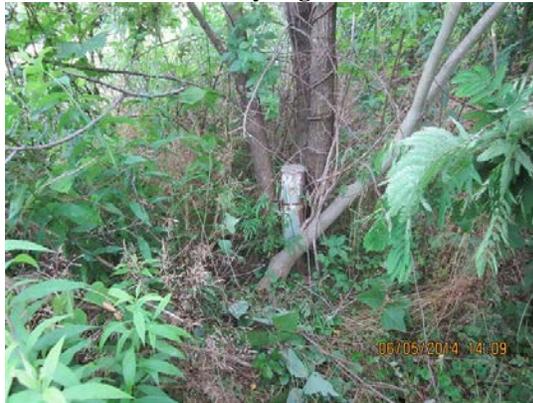
4. A letter, dated June 18, 2002, from Mr. Larry Rose, Groundwater Compliance Unit/Solid Waste Section approved the cessation of water quality monitoring requirements. **There are three groundwater monitoring wells (wells) surrounding the landfill; however access was blocked by vegetation and will need to be cleared.**

Background Well with woody Vegetation
