FACILITY COMPLIANCE INSPECTION REPORT
Division of Waste Management
Solid Waste Section

Date of Site Inspection: February 27, 2014

Greene County Construction and Demolition Landfill and Closed MSWLF
 105 Landfill Rd.
 Walstonburg, North Carolina 27888

Comprehensive Inspection

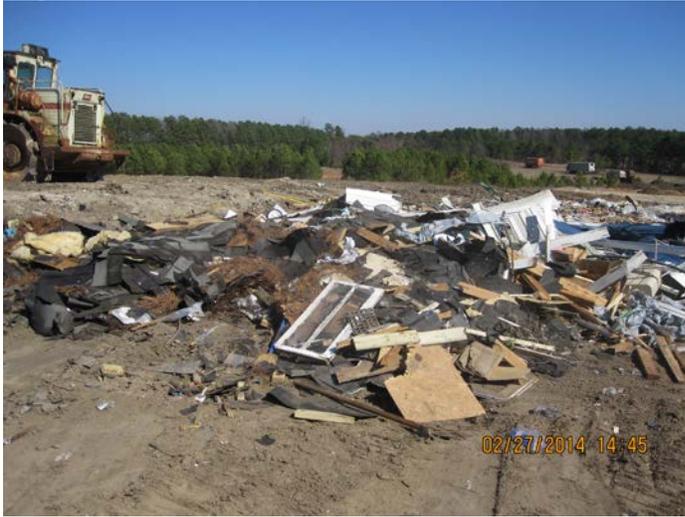
waste was observed.

The working face in kept small, no non-conforming

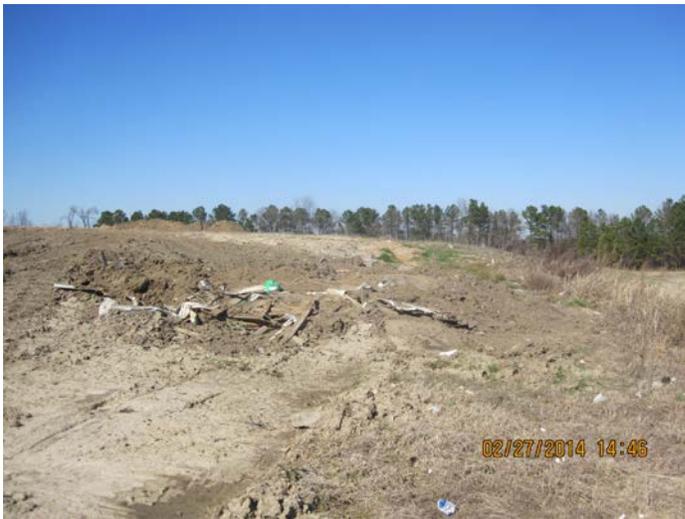
exposed waste was observed.

The cover is generally good, a small amount of

9. Cover was generally good. A cover log was being kept and included date and time of cover. **The log indicates waste cover is occurring twice a month rather than weekly as required. Waste must be covered weekly.**

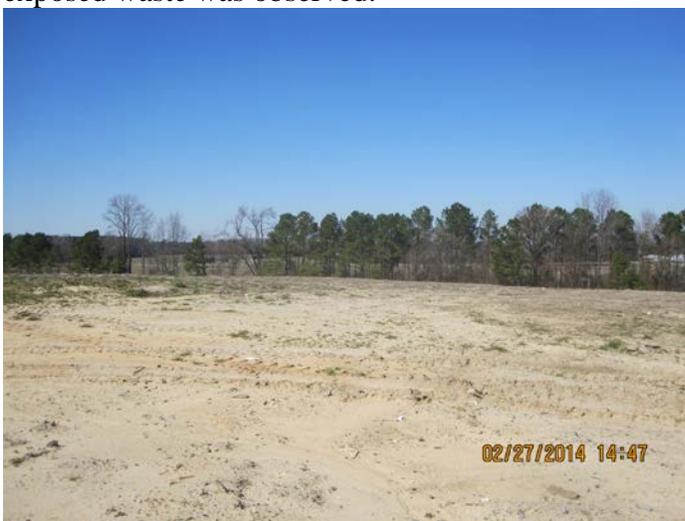
Good cover on top of landfill.

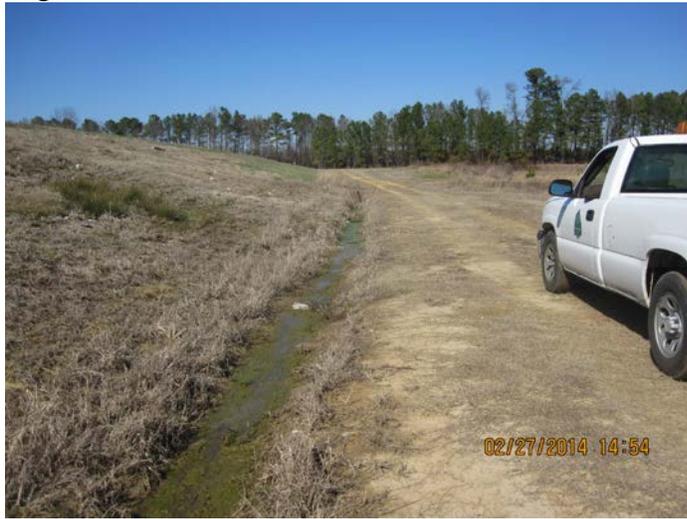
19. The slopes and top of the closed MSWLF appear to be well covered and stabilized with grass. No woody vegetation was observed.
20. The drainage swale on the eastern side of the closed MSW needs re-grading. Runoff was not flowing properly.

Drainage swale at the base of the closed part of the landfill needs re-grading.

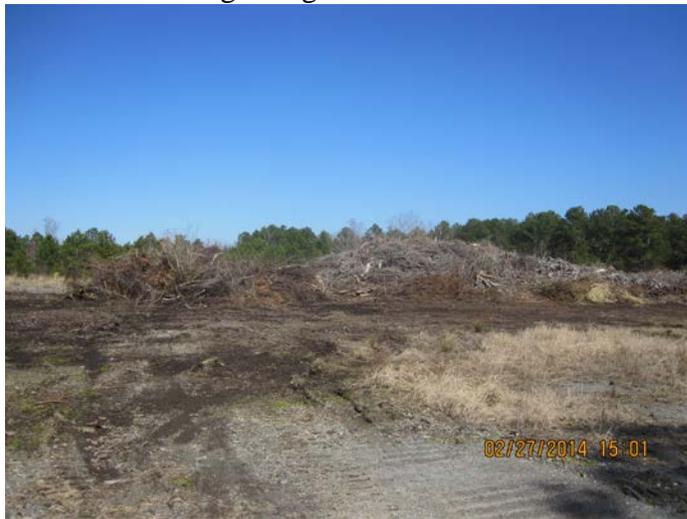
Yard waste has been on the site for sometime Jones indicated plans are to grind soon.

11. Yard waste facilities shall follow the time and temperature requirements listed in 15A NCAC 13B .1406(10) for all yard trash feed stocks. The temperature requirements include the compost process being maintained at or above 55 degrees Celsius (131 degrees F) for 3 days and aerated to maintain elevated temperatures. Yard trash is defined within 130A-290(a)(45) as solid waste consisting solely of vegetative matter resulting from landscaping maintenance. Leaves from landscaping maintenance and grass clippings are considered yard trash. **The yard waste on site needs to be ground.**

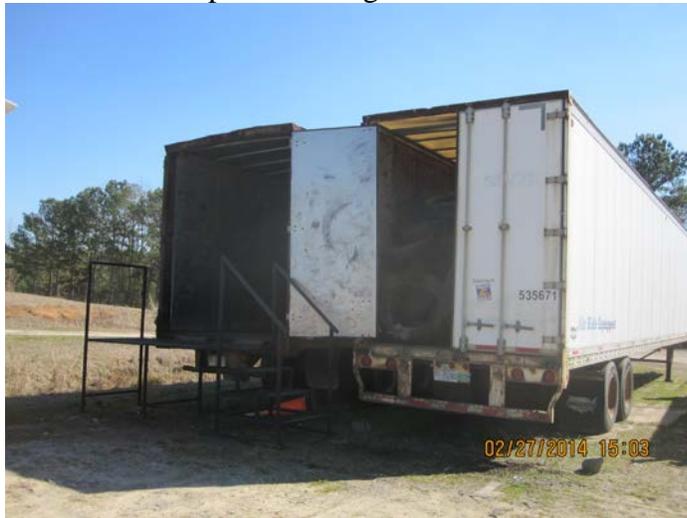
Tires are being stored in trailers.

13. Scrap tire collection is by Central Carolina Tire. Tires are temporarily stored on the in trailers on the site. **Make sure the scrap tire hauler forms are completely filled out.**

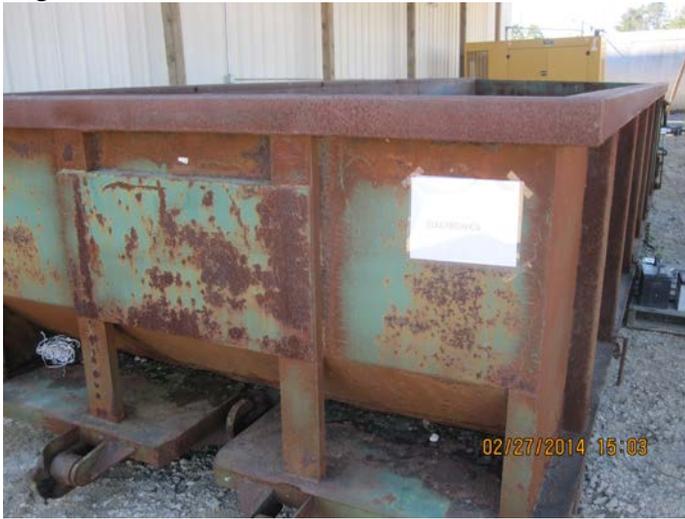
14. The working face was small, no non-approved waste was observed.
15. Storage of electronics has improved are now being kept in a roll-off under a shelter. **From previous inspection report.**

Better storage of electronics since the last inspection. Container is under a shelter so rainwater should not be much of an issue.

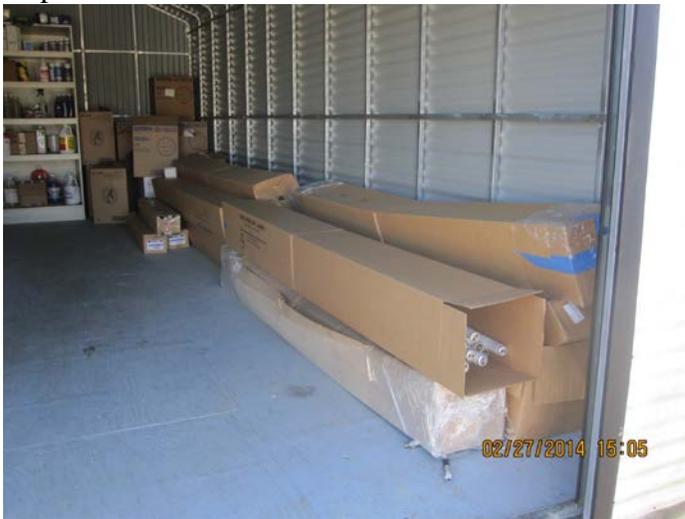
16. Fluorescent tubes are now being stored in boxes inside a metal building. **From previous inspection report.**
17. Jones indicated that the facility does not normally accept regulated asbestos.

Very good storage of fluorescent tubes was observed, in boxes and under a shelter.

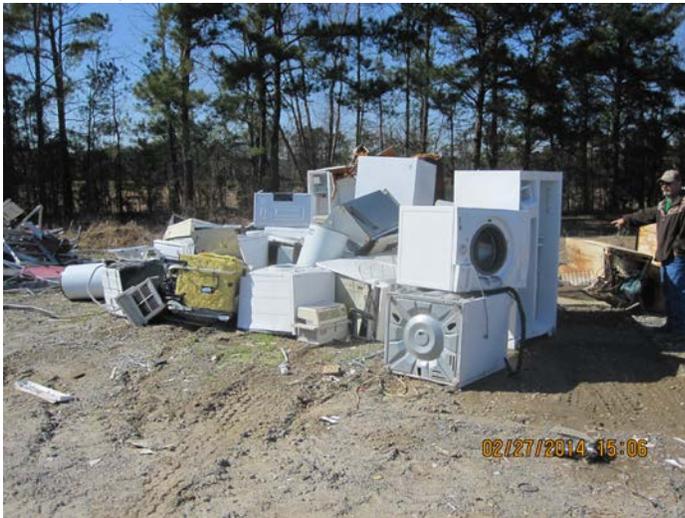
White goods need to be stacked more neatly. Jones indicated few Freon containing appliances are received.

12. White goods containing Freon must be kept separate from the non Freon containing white goods. ACR of Greenville is removing the Freon. The county hauls the white goods to Atlantic Scrap in Smithfield.
