SITE VISIT REPORT

Project: Dunn Erwin Landfill CAP Projects

Job No.: 3002B

Location: Dunn-Erwin Landfill, Dunn, NC

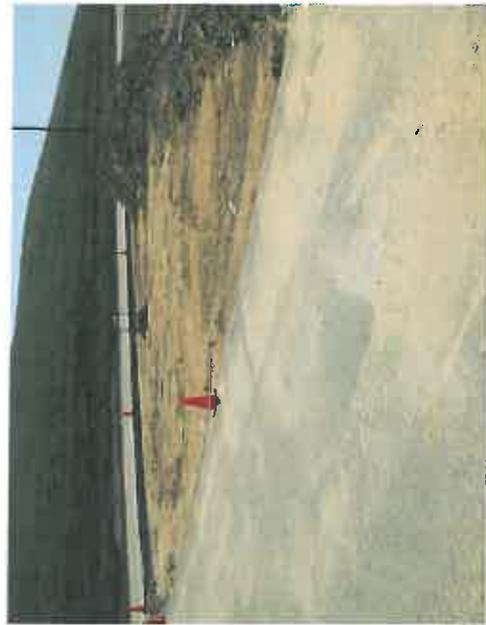
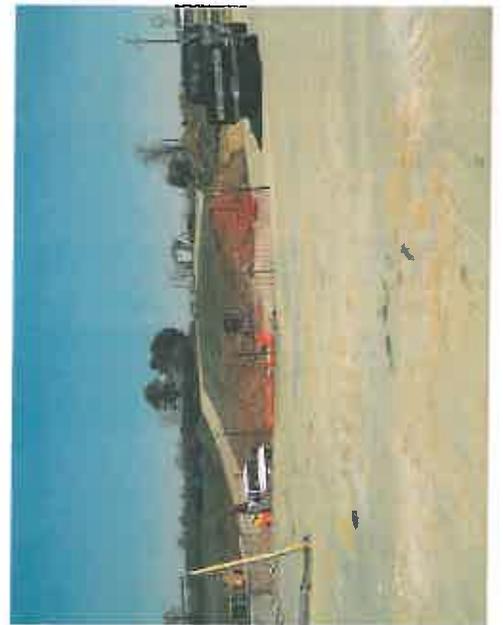
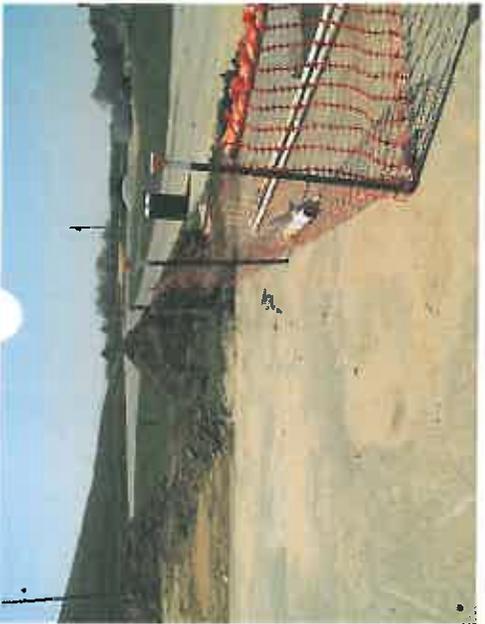
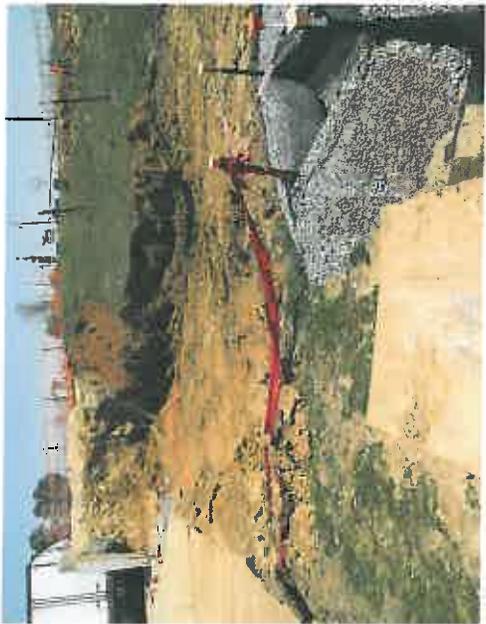
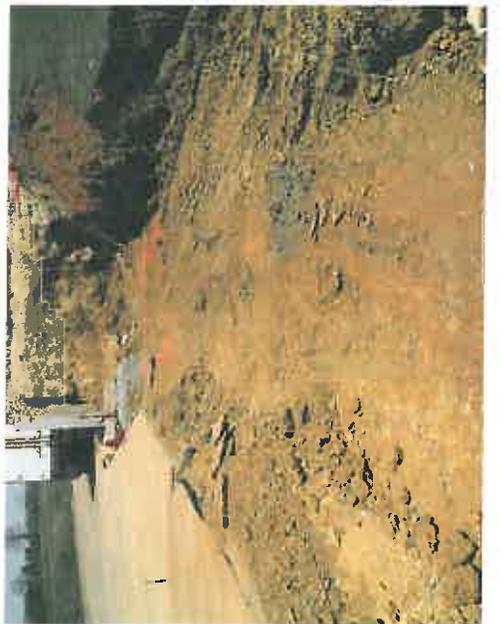
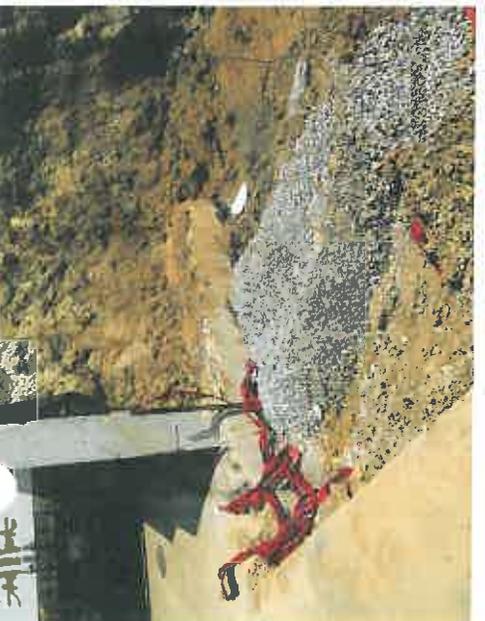
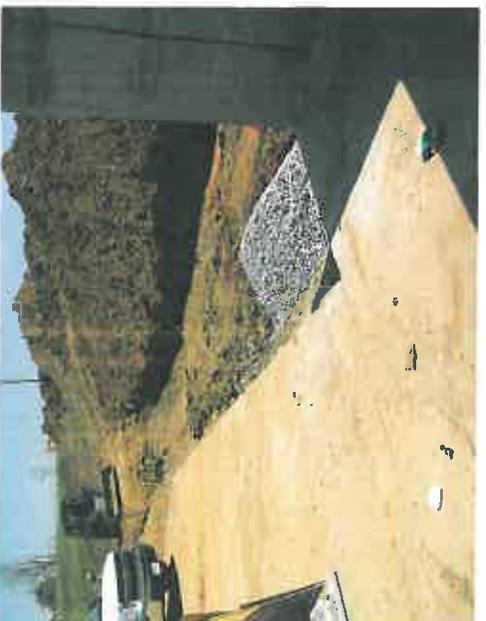
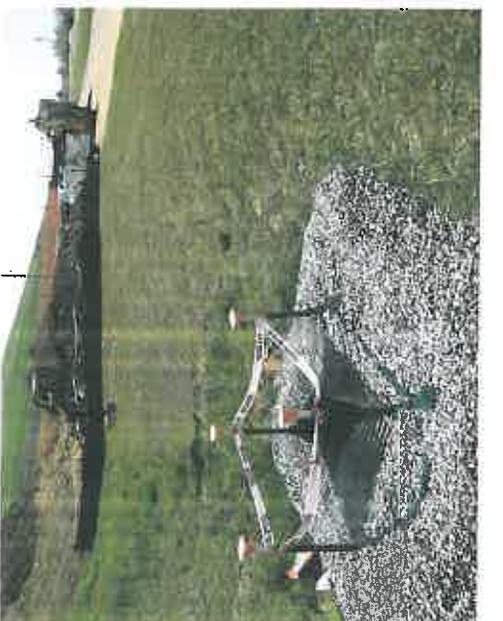
Met with Greg of WECC. We discussed the footing excavation area which has been a saturated area. Some parts of the footing have dried out while the areas closes to the existing concrete remain soft. Greg stated that ECS has dug some sample holes and found solid virgin material approximately 1.5 feet deep. Therefore an area approximatley 15'x20'x1.5' may have to be removed in that area. Greg was waiting to hear back recommendations from ECS.

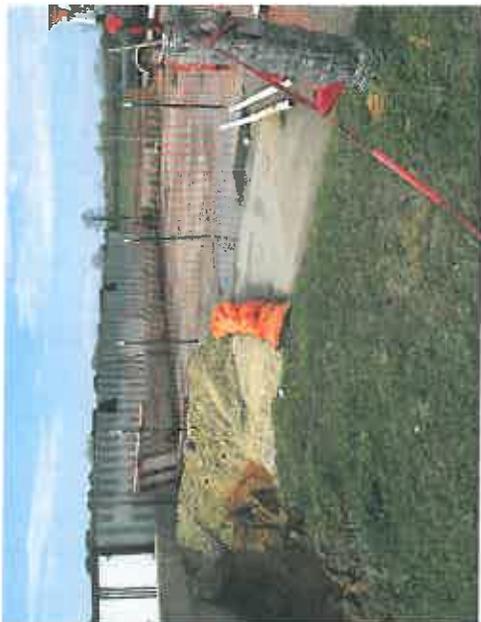
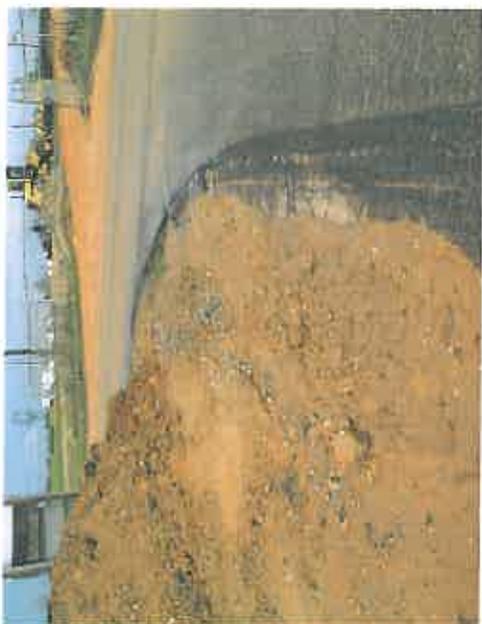
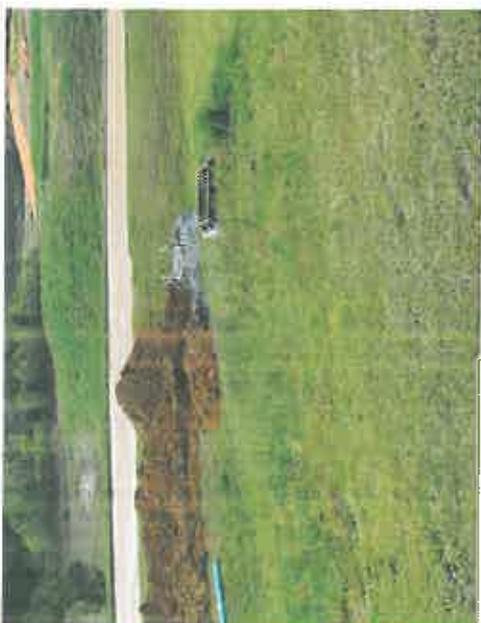
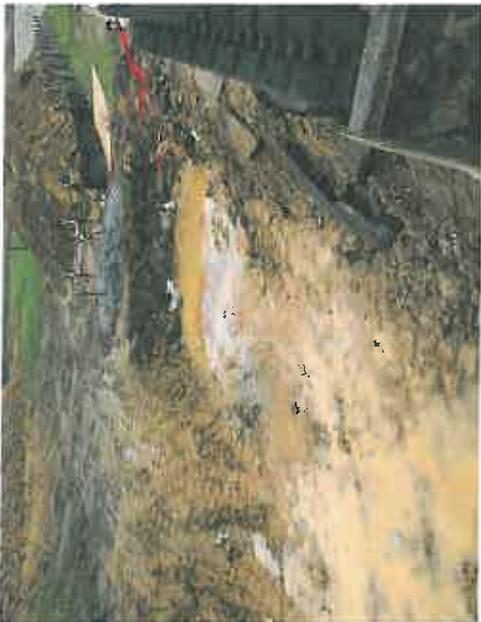
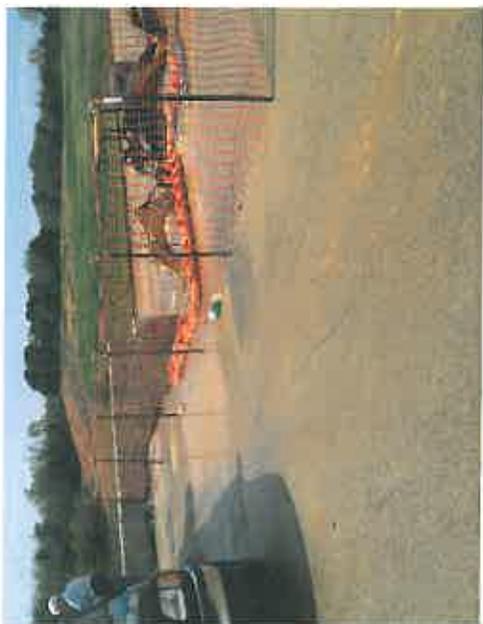
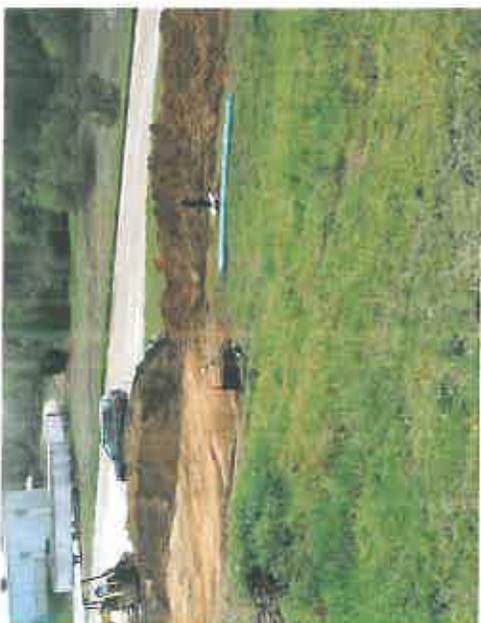
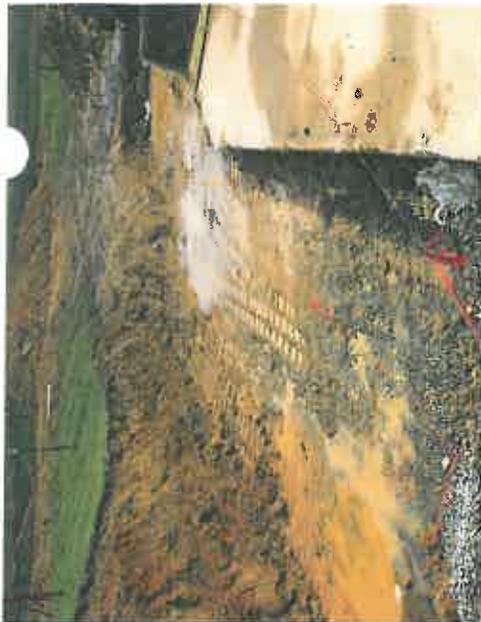
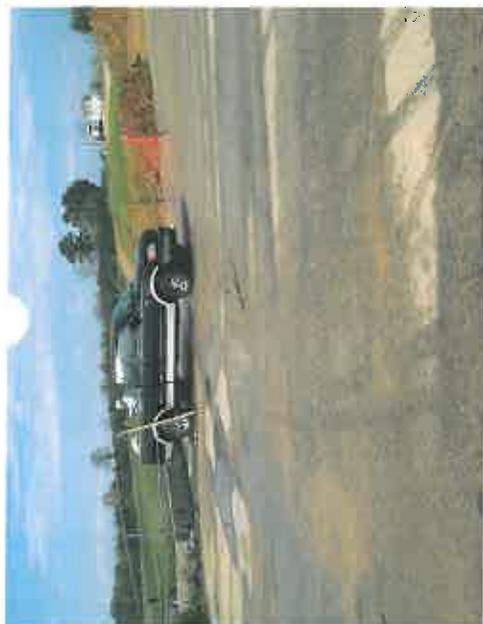
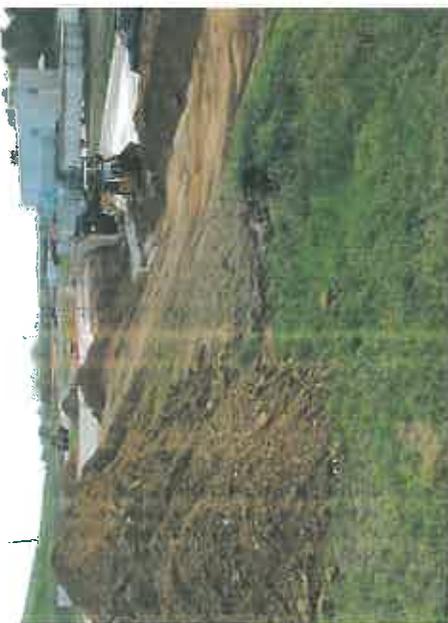
IF the standing water has caused problems with subsoil it may need repair - check Monday before starting work.

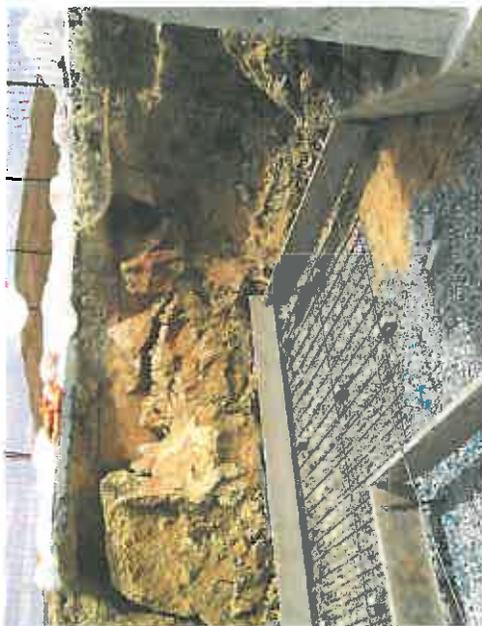
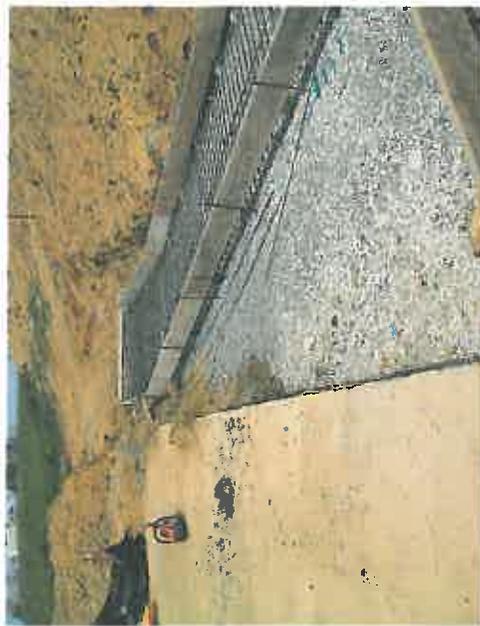
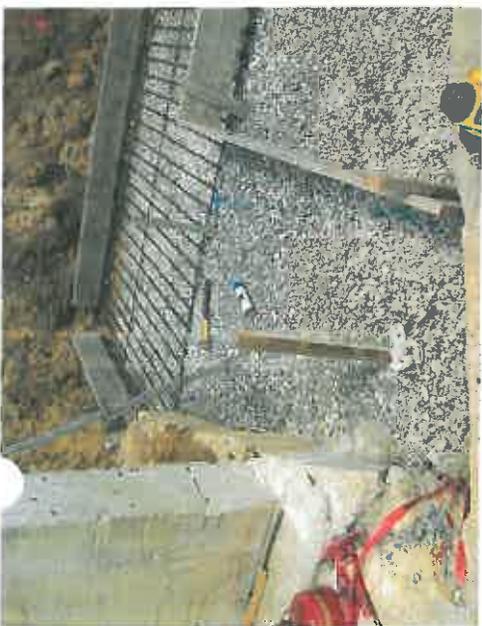
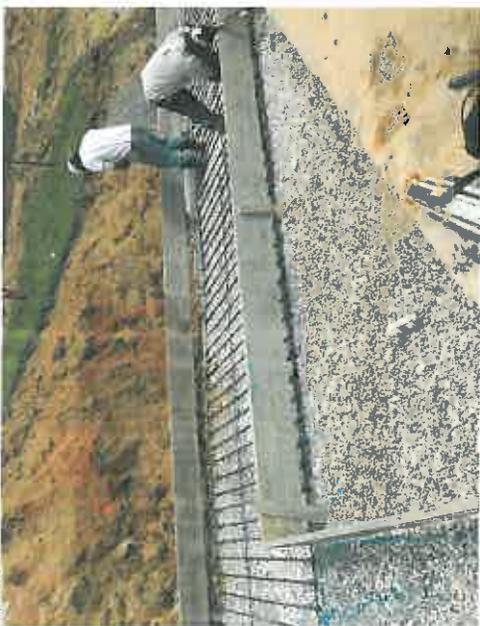
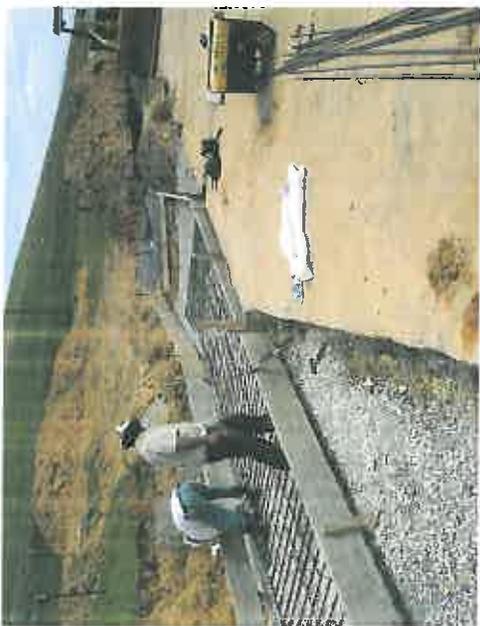
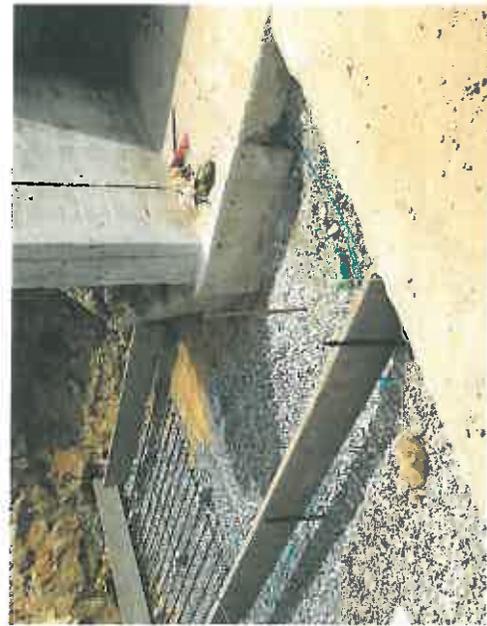
4-22-2013

Summary of Activities and Test Results: Sunny + Windy Temp. in 60's
 Met w/ Greg @ site steel being installed. said he planned to pour concrete on Wednesday. Discussed soil wall starting to slide on the north end seems to have been caused by the rain on Friday. Greg said he would keep it checked. see photo's

← Sliding Wall

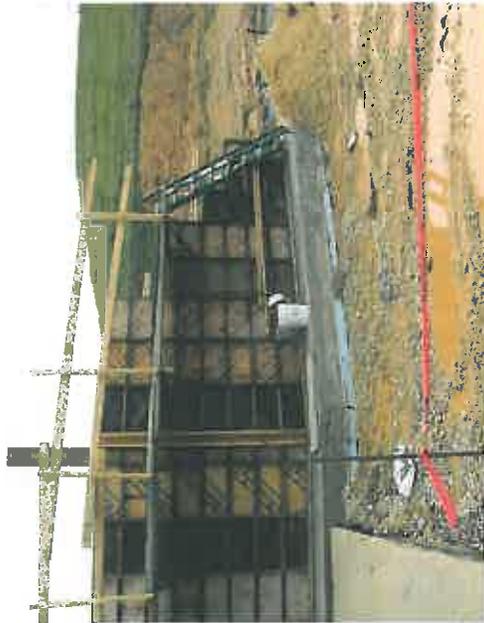
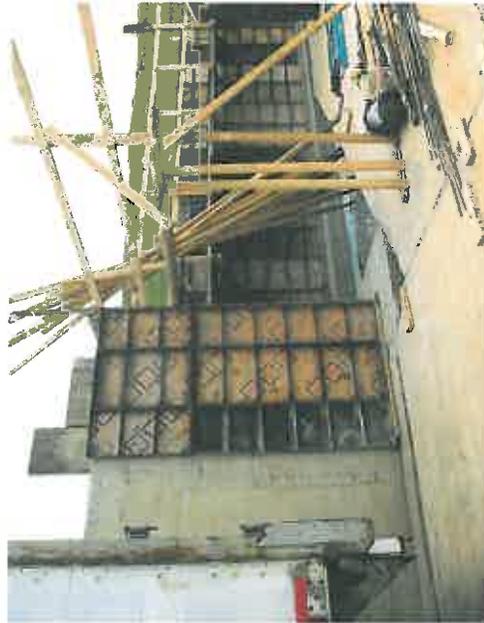
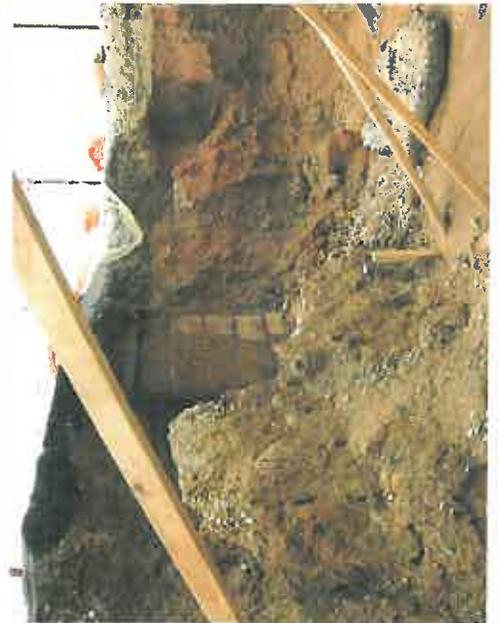
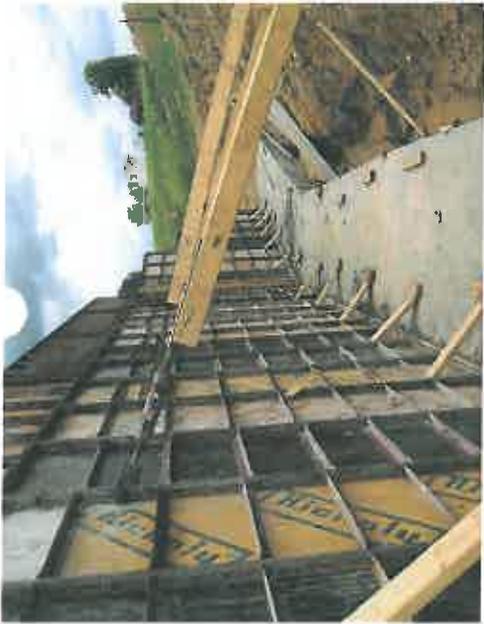
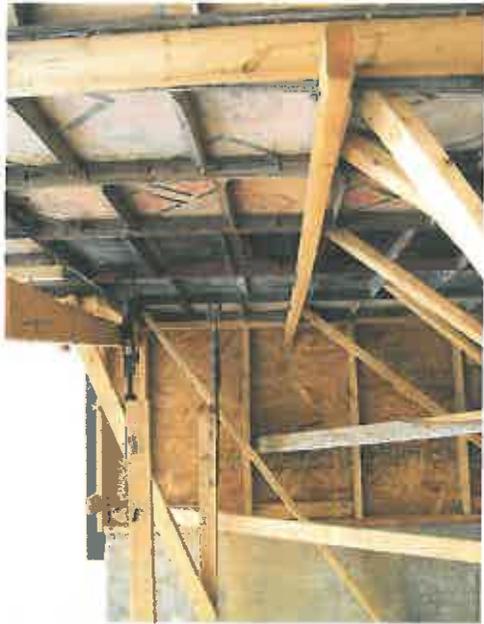
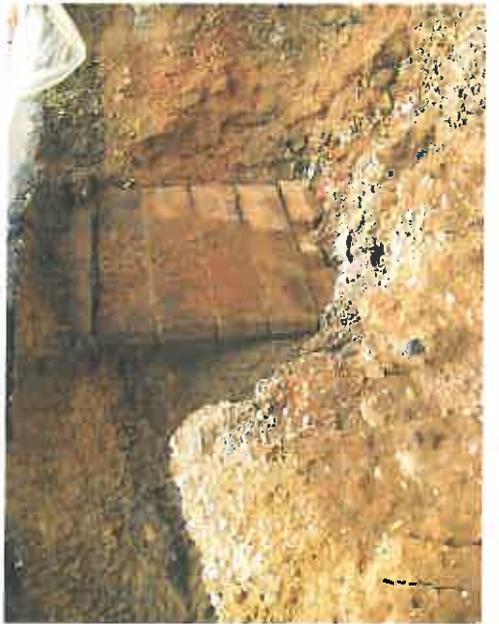
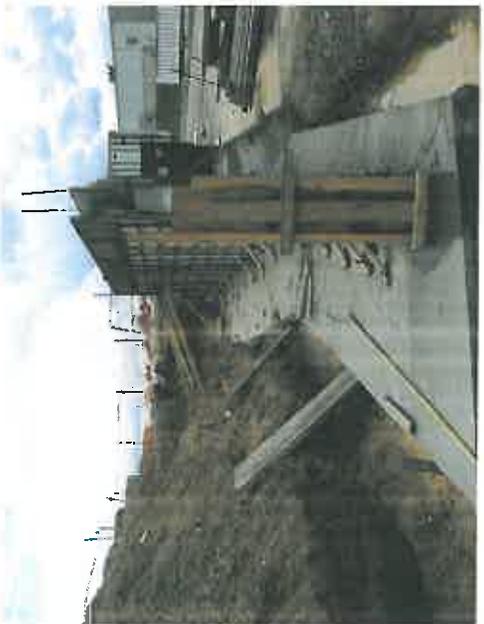
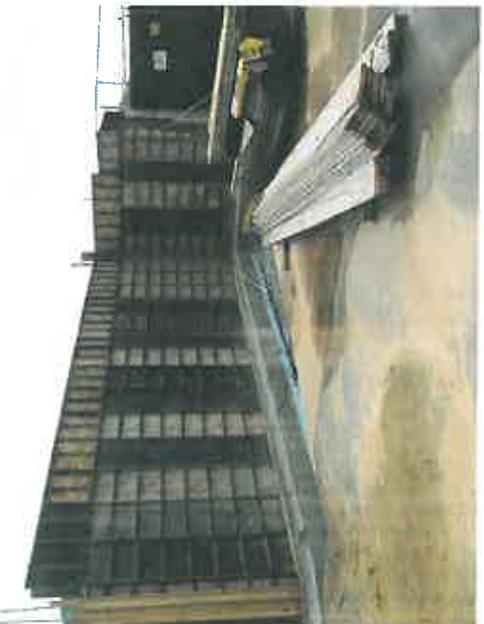
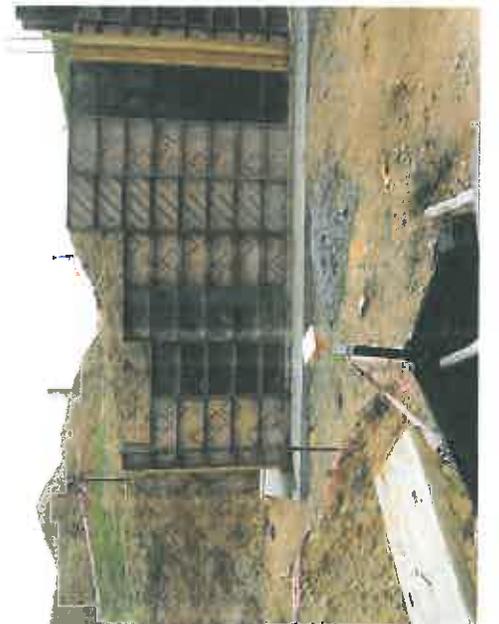
DELF CAP Project

Summary of Activities and Test Results: Rain approx. 2" today, No one working mid morning. Some storm water damage on the soil bank behind the concrete walls, catch basin wall exposed. Pressure on the HDPE pipe holding at 7 PSI. See Photos, Discussed w/ Tyrus.

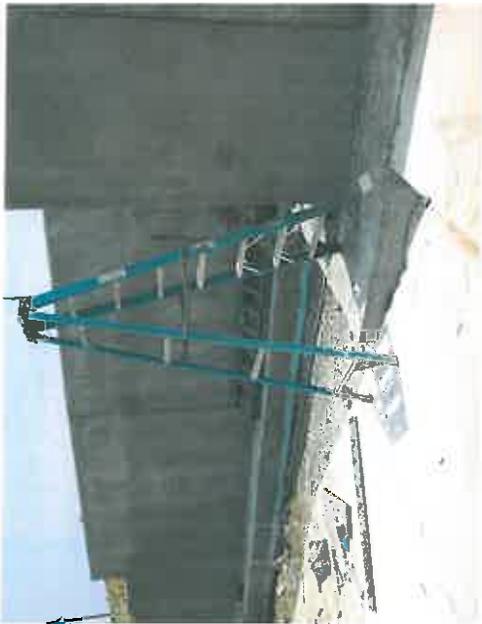
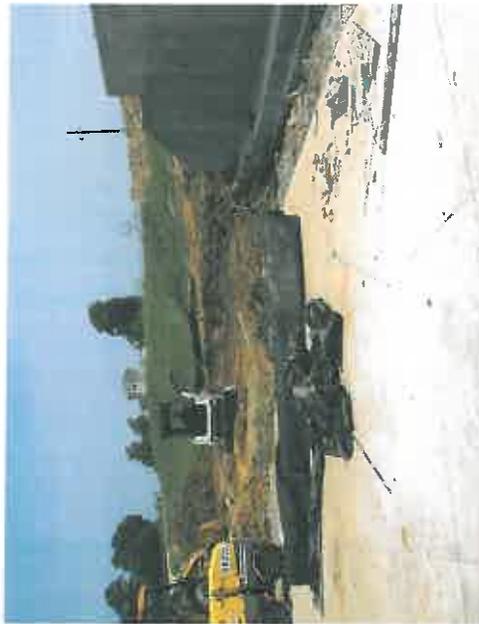
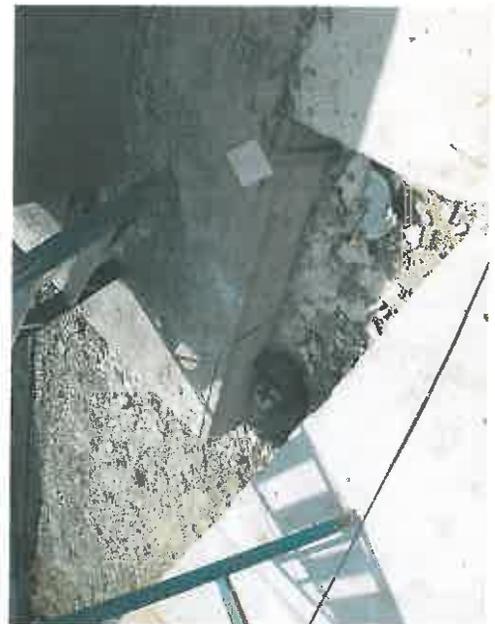
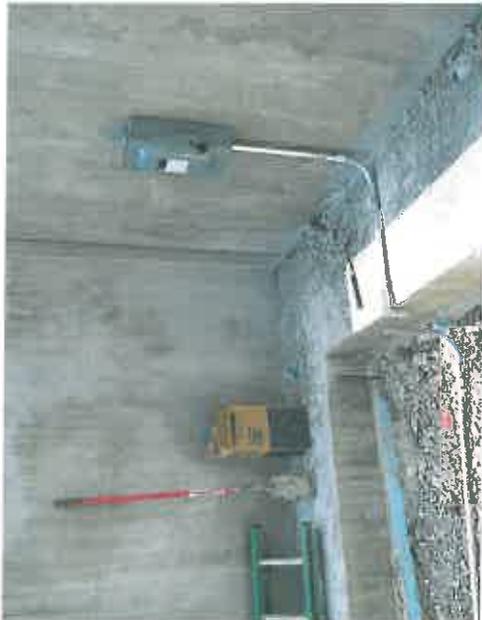
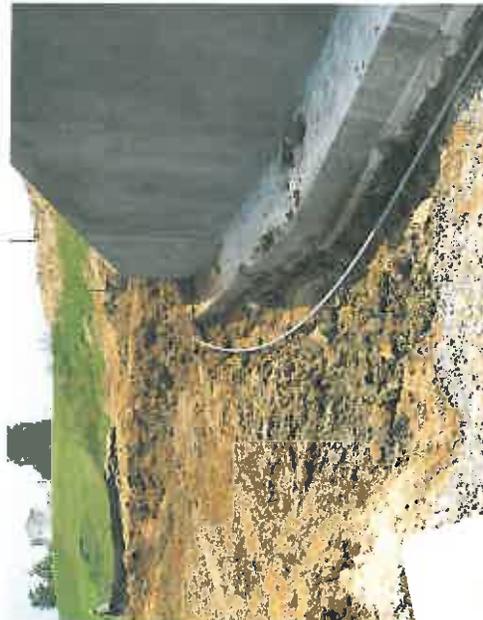
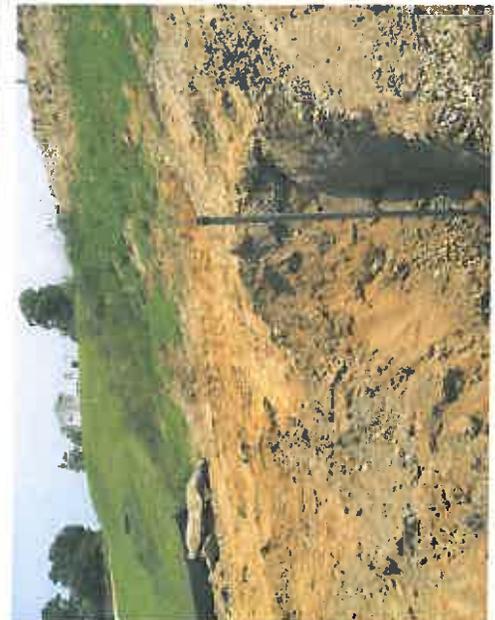
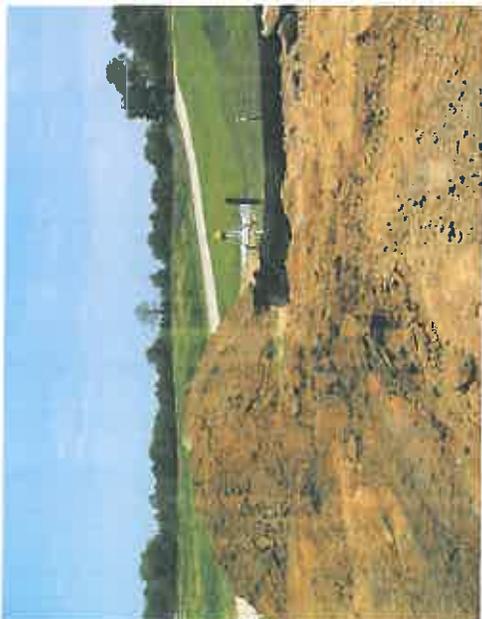
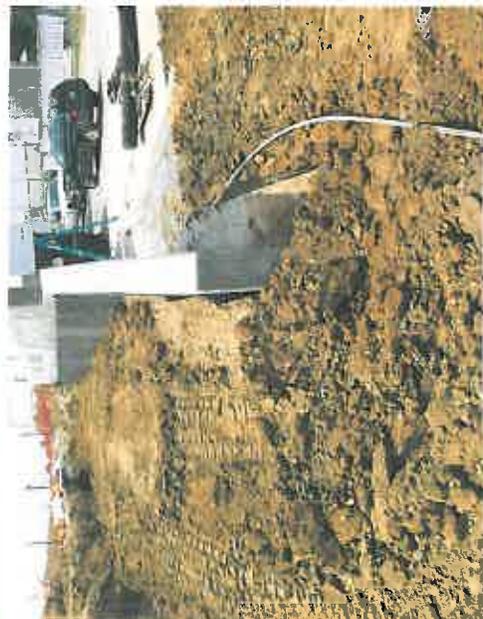
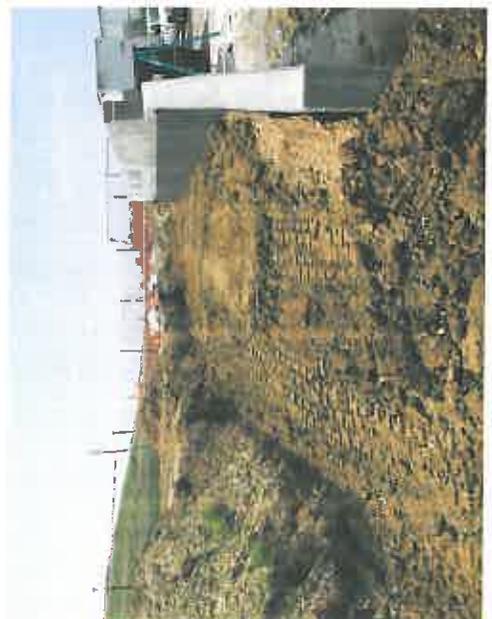
DELF CAP Project

Summary of Activities and Test Results: Mtg. w/ Ralph on site, excavating in prep. for slab pour, discussed grading behind wall, observed patch paving at transfer sta., checked HDPE force main location on Turlington rd. at creek crossing. See Photos, Discussed w/ Tyrus.

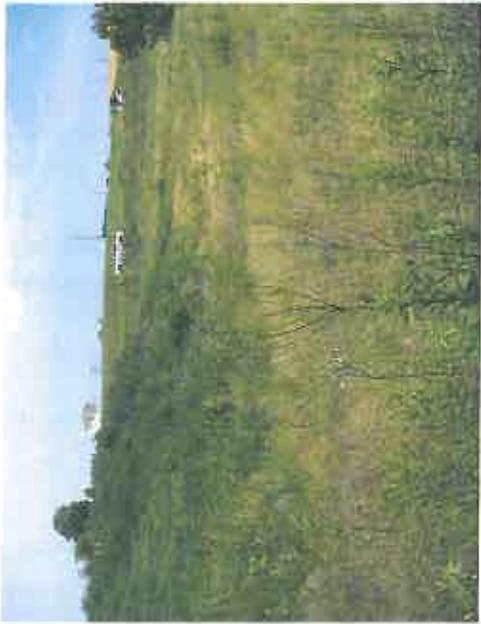
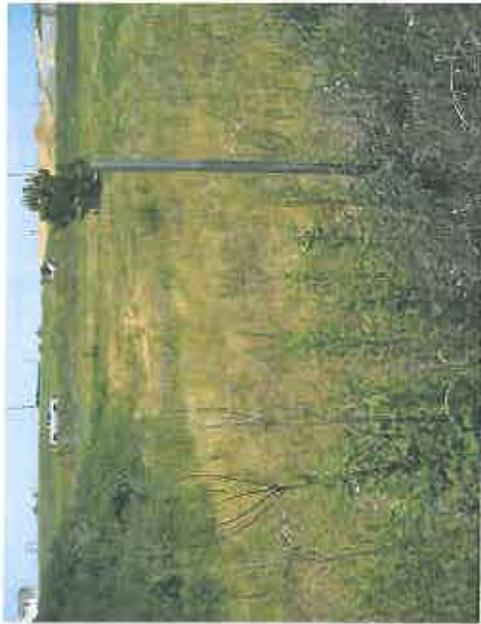
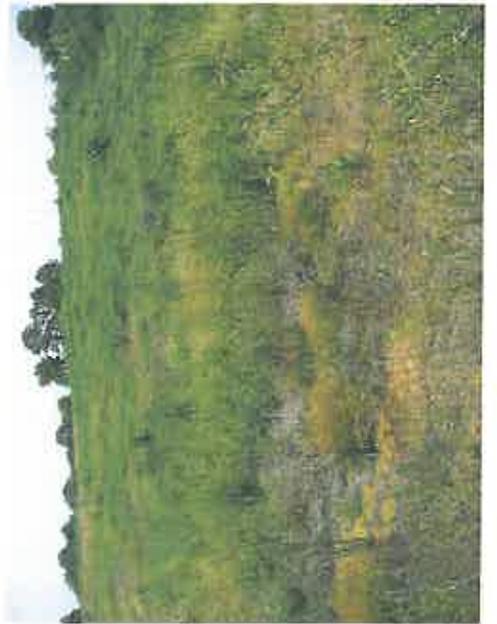
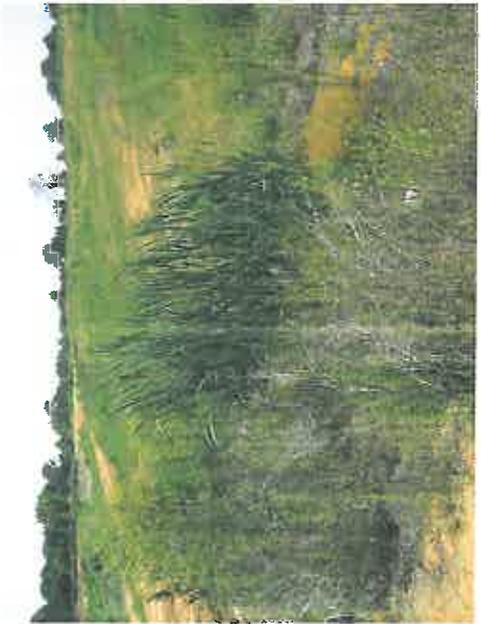
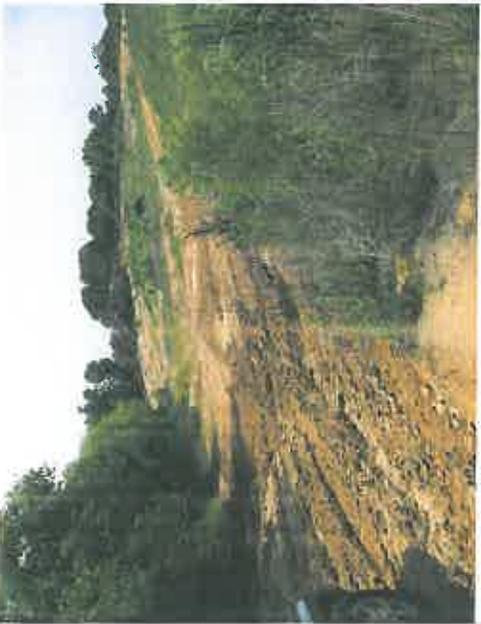
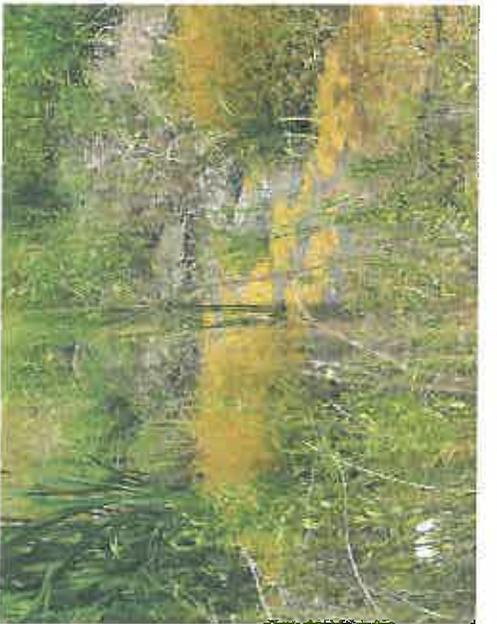
DELF CAP Project, Popout at LCID

Summary of Activities and Test Results: Investigated LCID popouts, found four [4] major and evidence of several past minor popouts, see sketch and photos. Discussed w/ Tyrus.
