SITE VISIT REPORT

Project: Dunn Erwin Landfill CAP Projects

Job No.: 3002B

Location: Dunn-Erwin Landfill, Dunn, NC

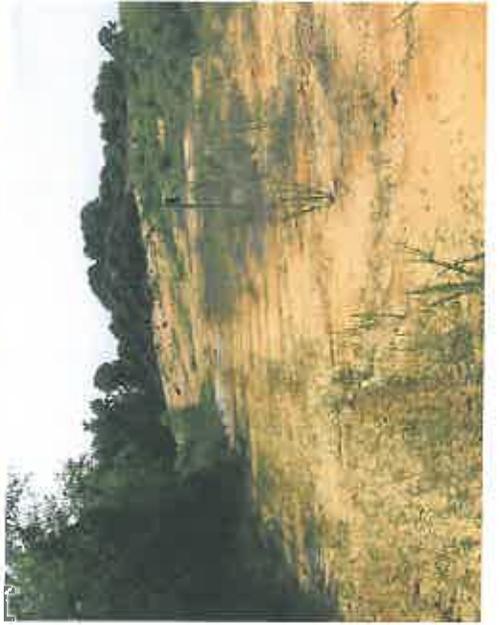
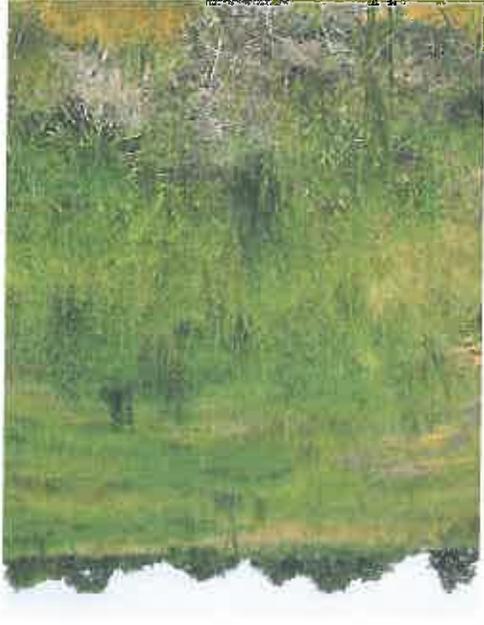
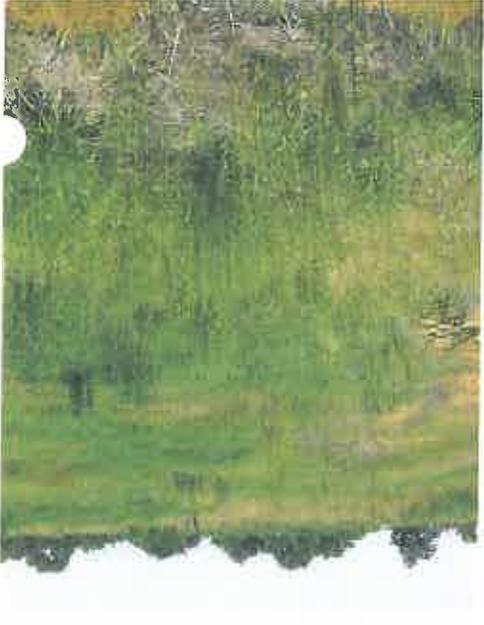
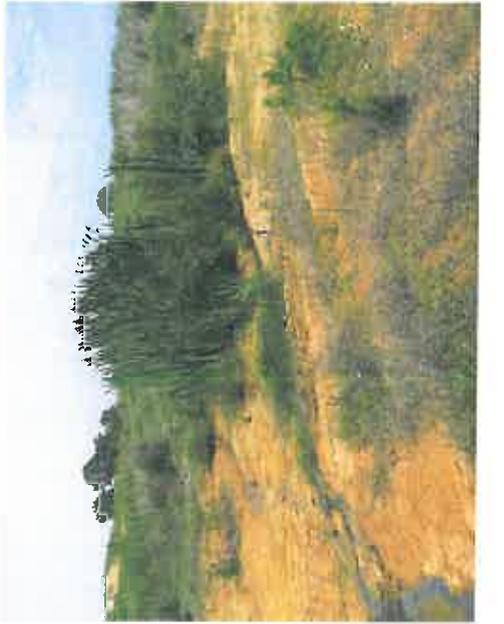
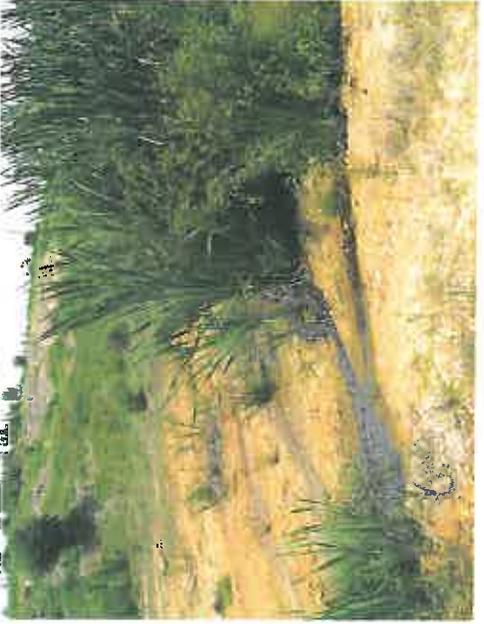
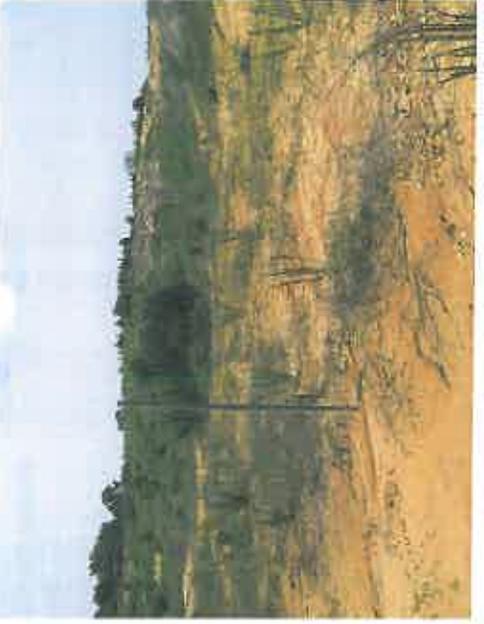
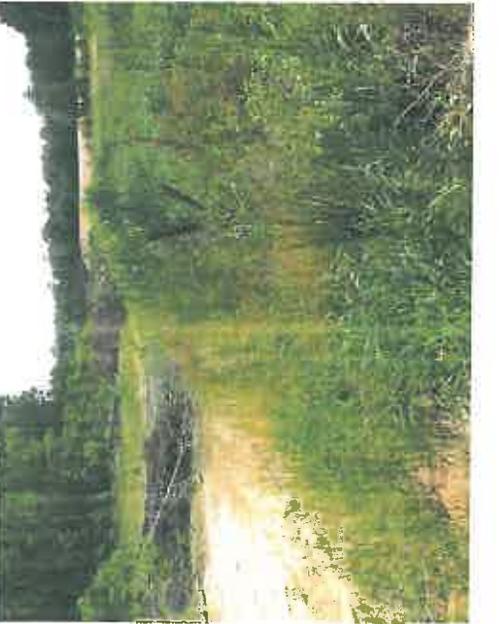
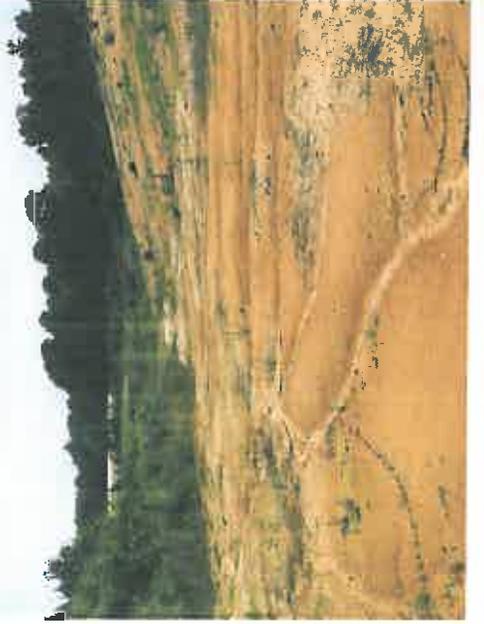
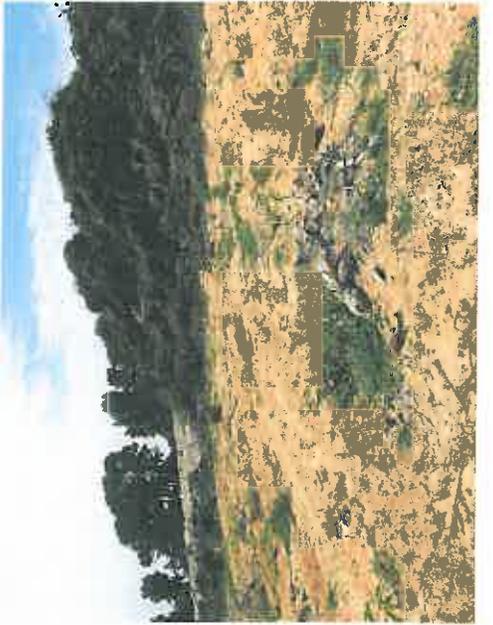
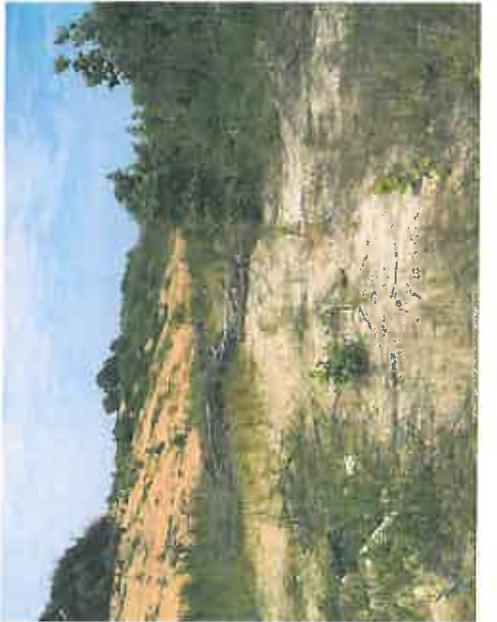
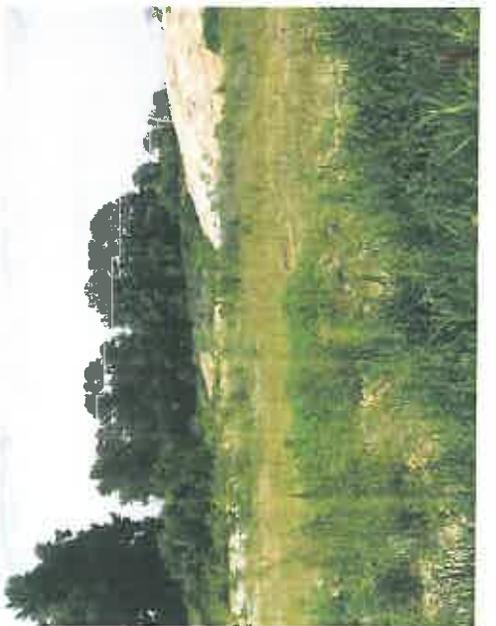
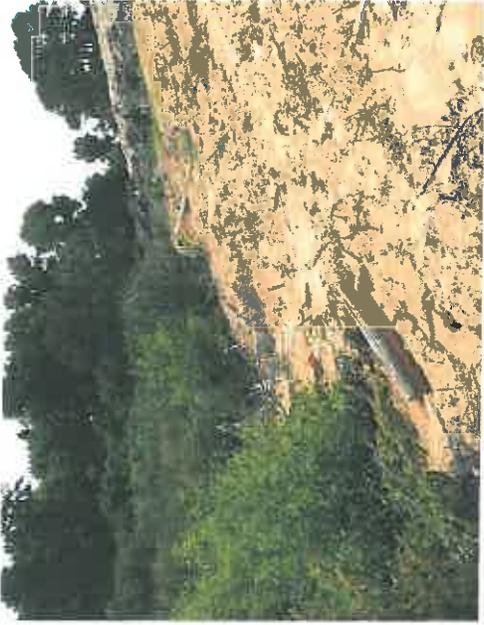
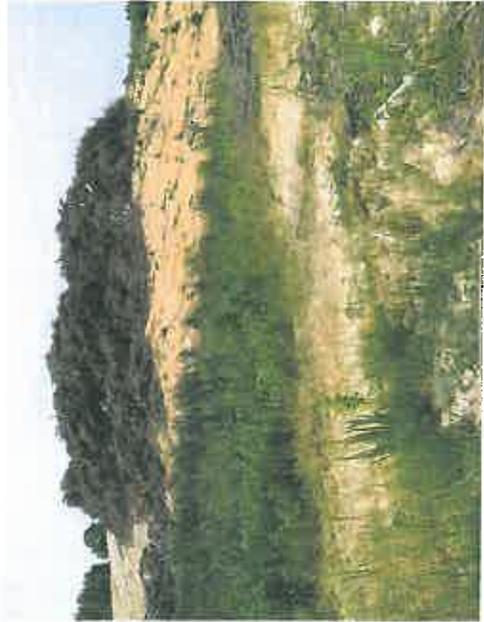
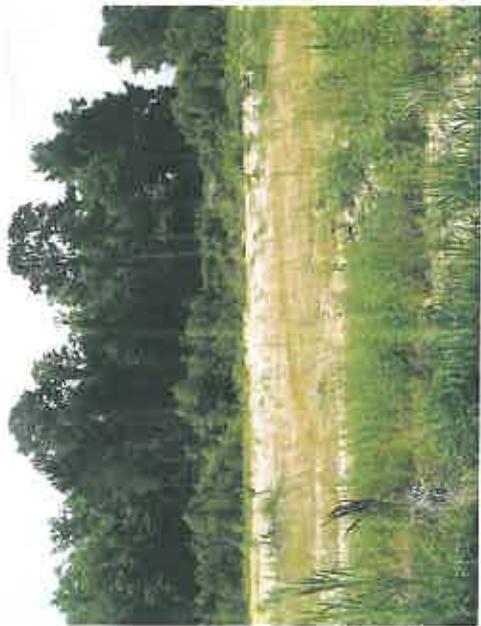
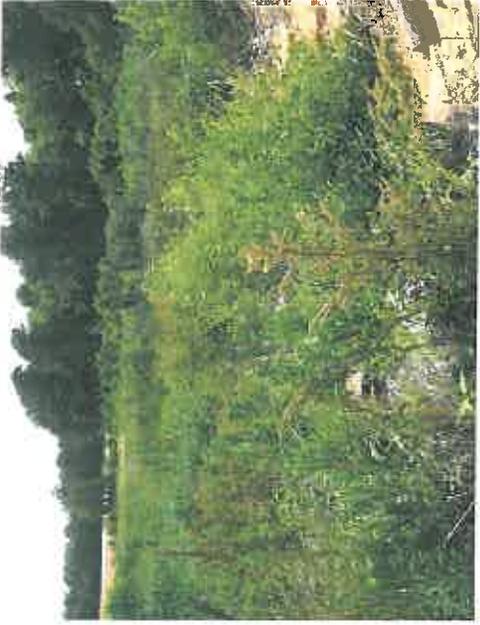
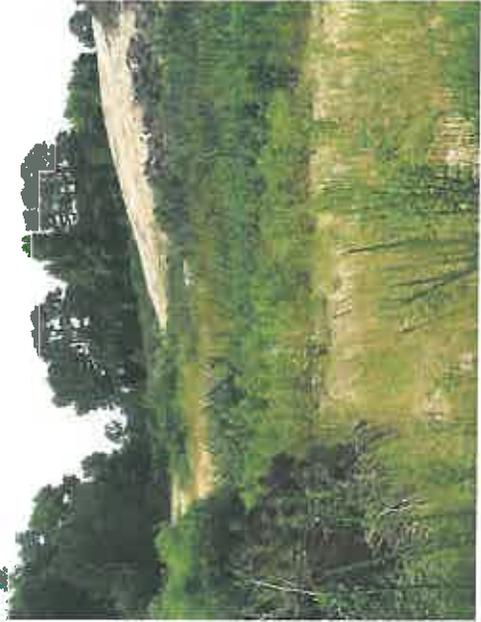
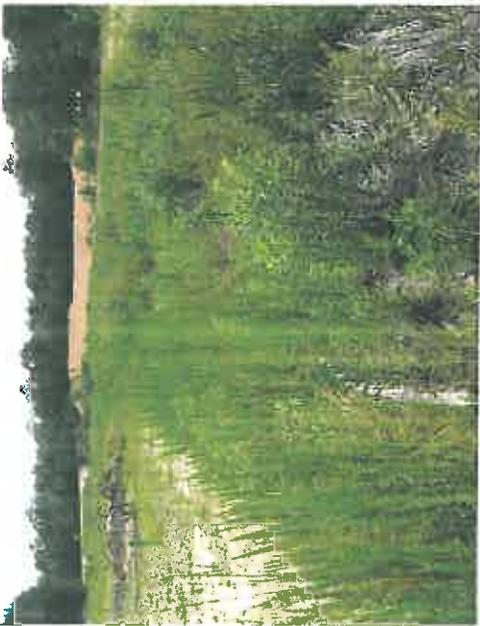
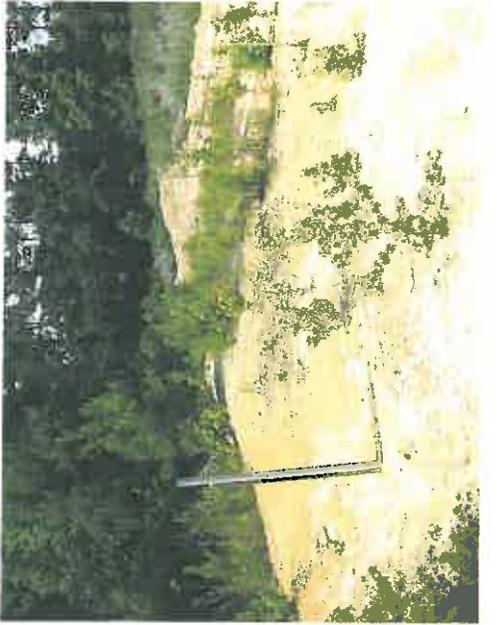
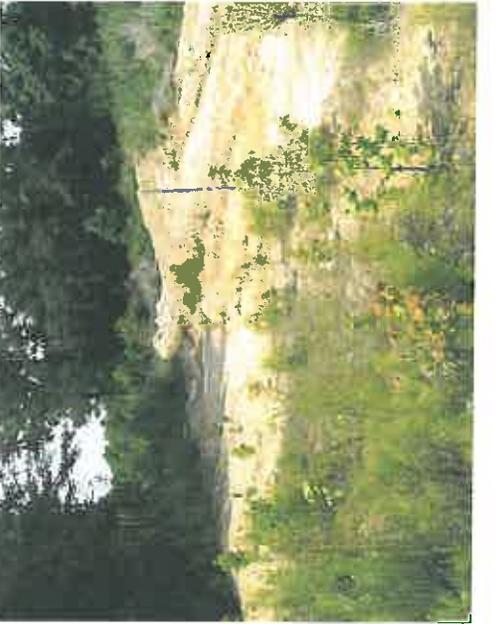
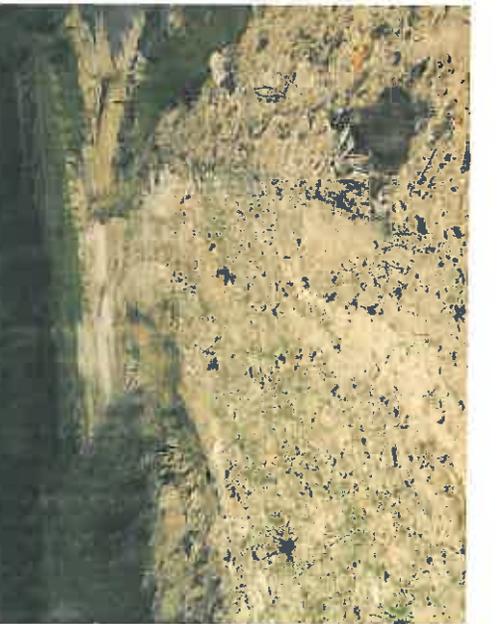
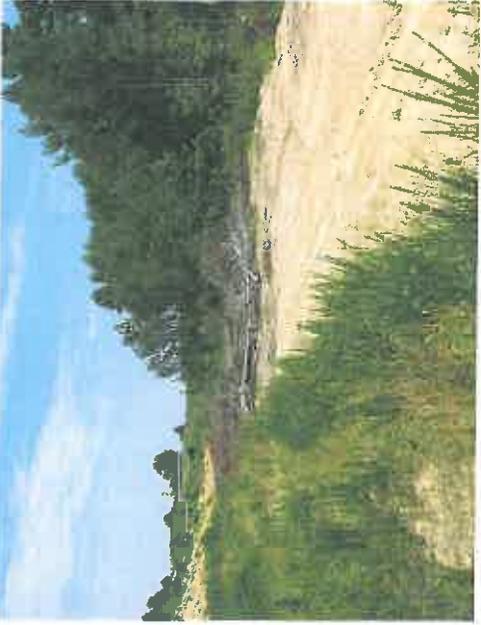
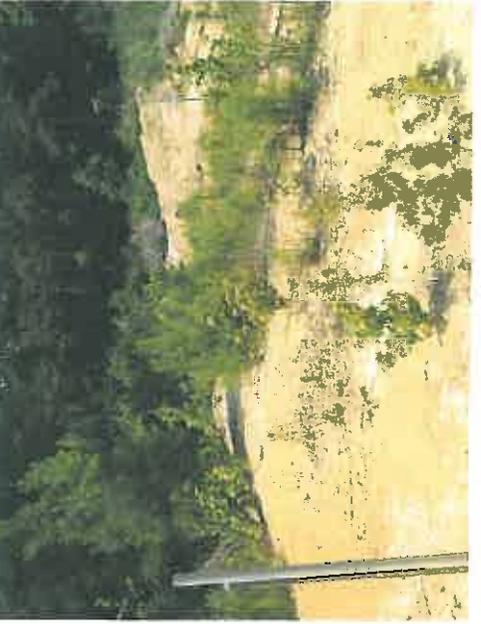
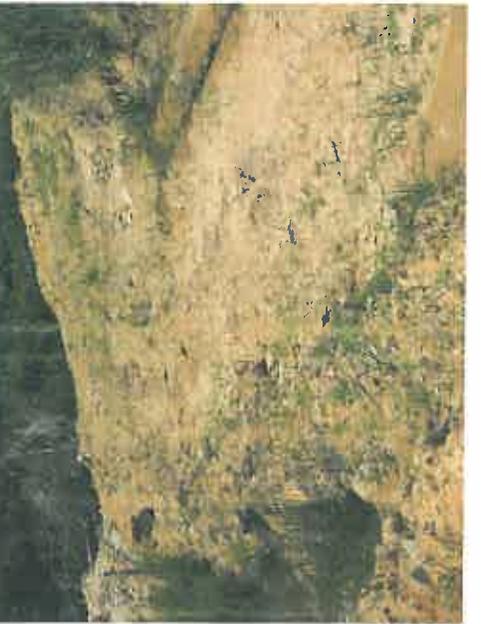
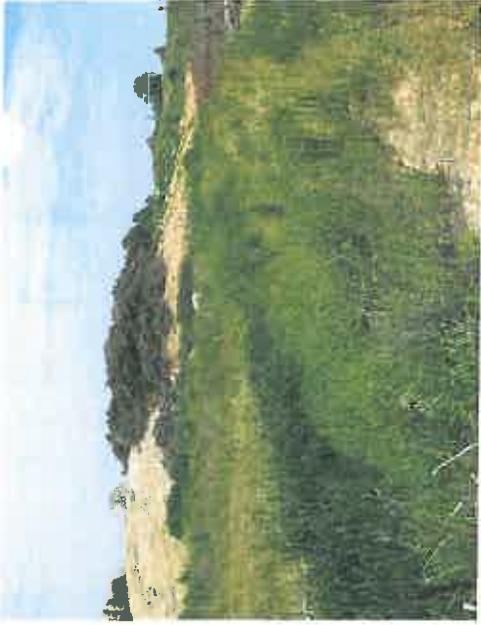
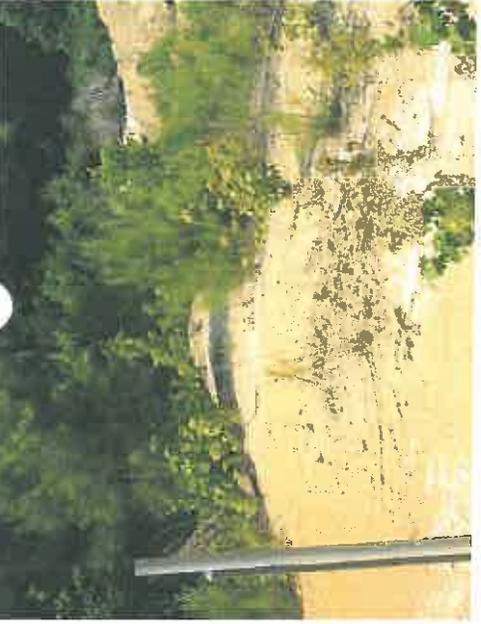
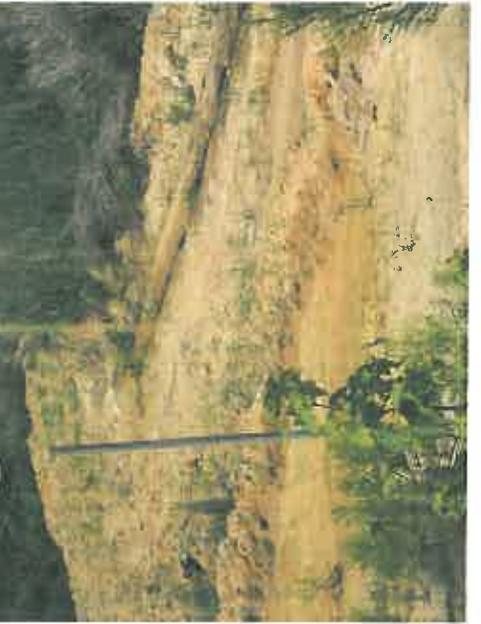
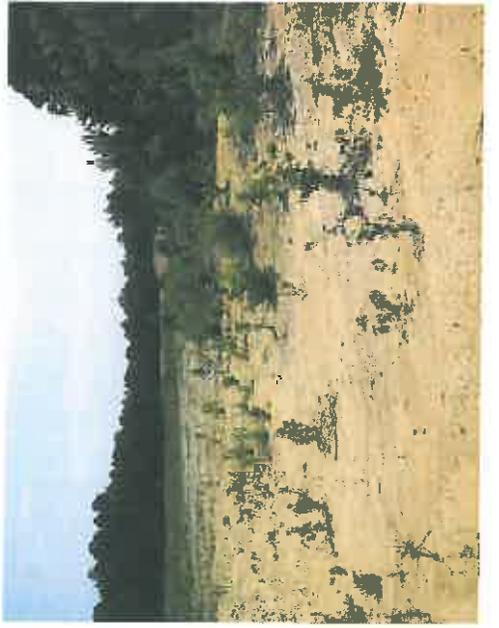
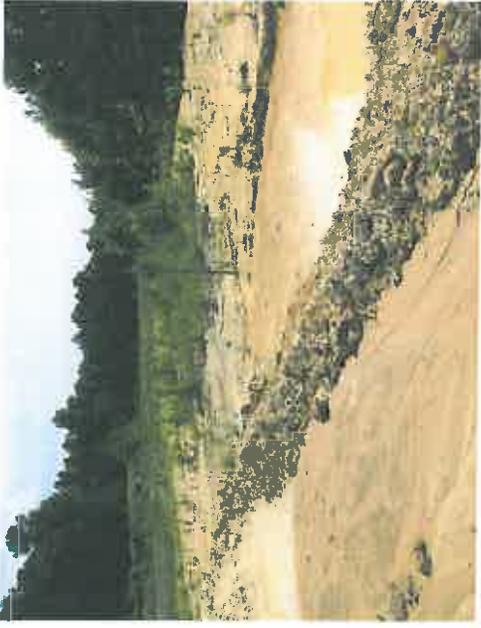
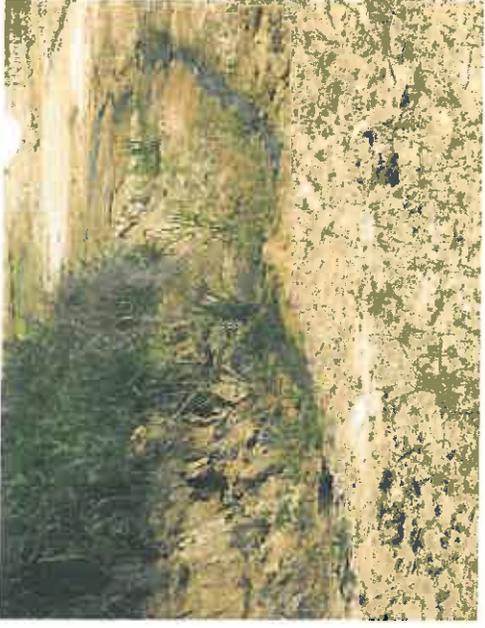
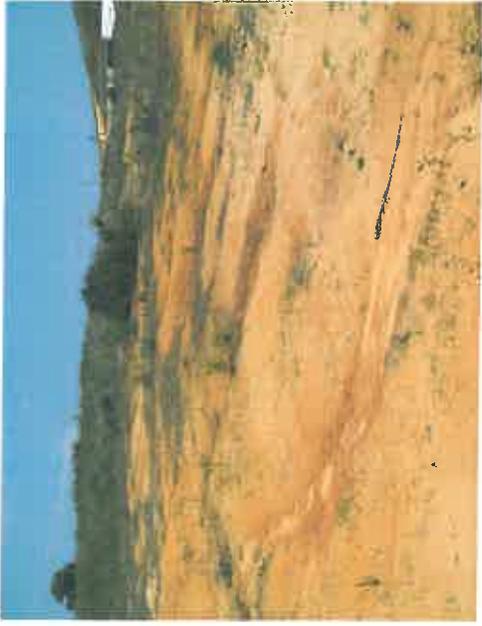
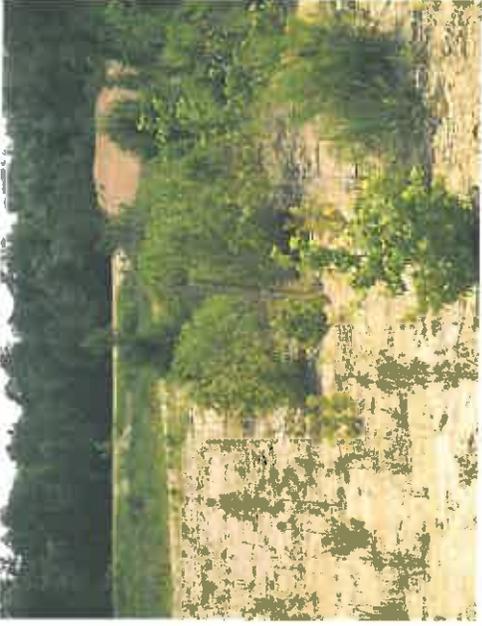
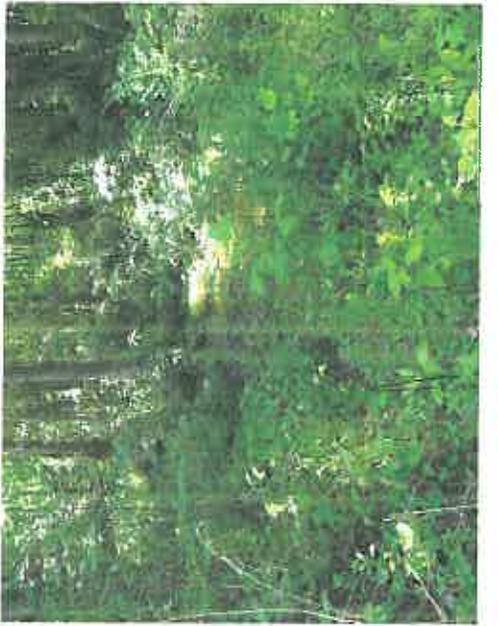
6-5-2013

Summary of Activities and Test Results: Investigated LCID popouts, found four [4] major and evidence of several past minor popouts, see sketch and photos. Discussed w/ Tyrus.

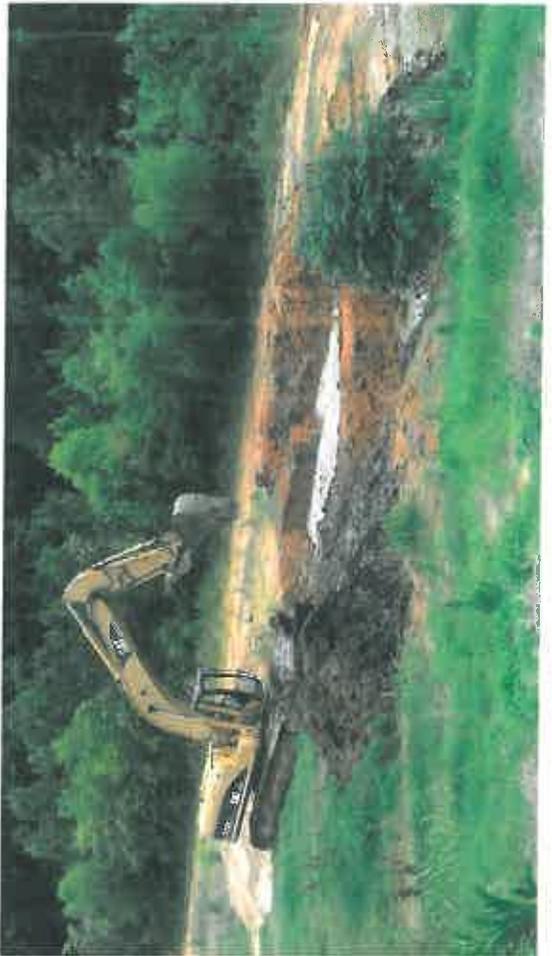
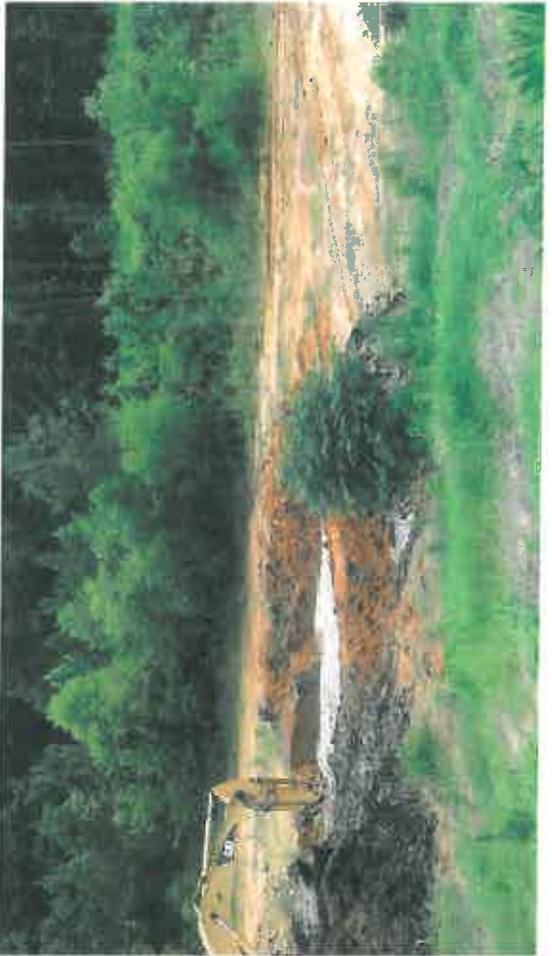
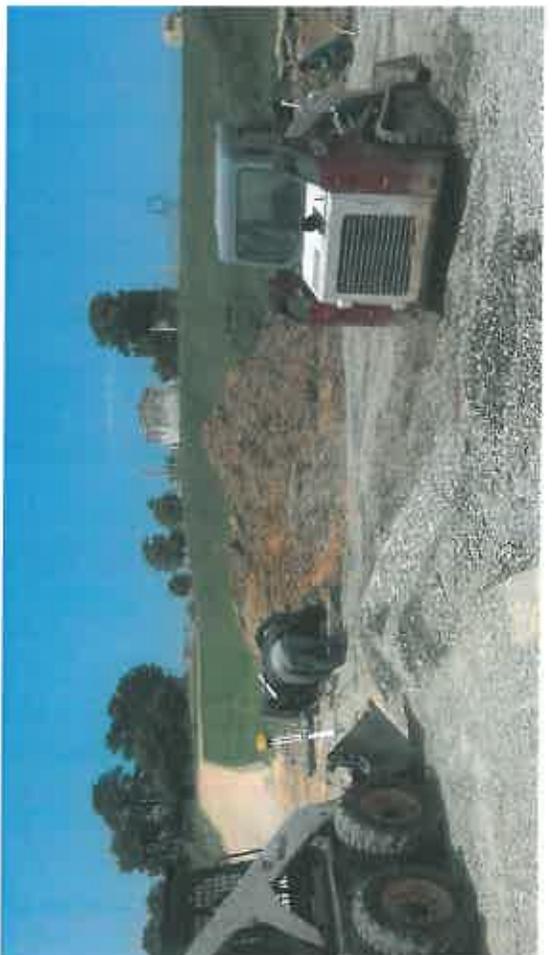
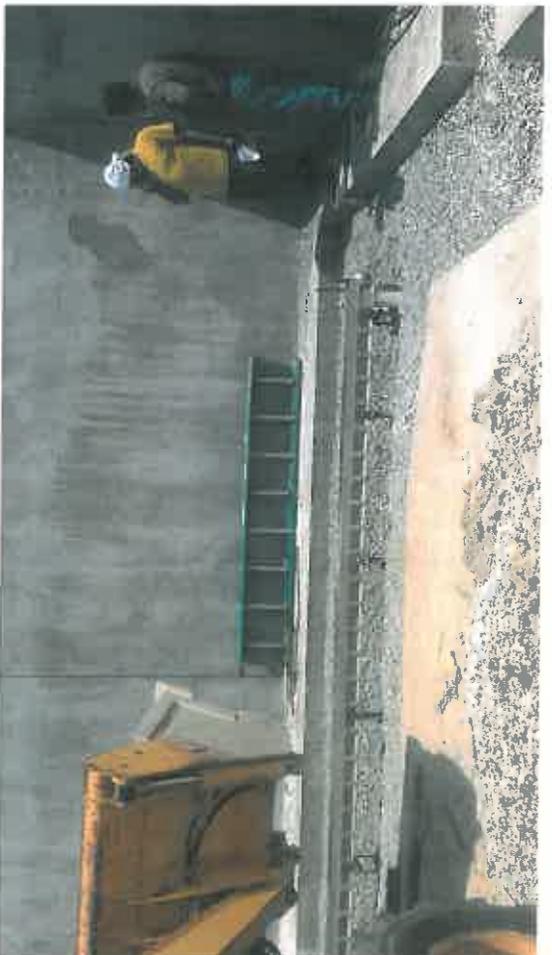
Amanda Bader called and indicated they had issues at the LCID. Upon arrival, found Randy excavating a large hole to attempt to repair a leachate seep. While there, Randy continued to dig and broke "through" to seep. Immediately the flow increased to approx. 20+ gal/min. Robert Herndon from NCDENR SWS arrived. He toured the area and took notes on the overall leachate response since last week (6-7-2013). Amanda and Randy narrated the response and activities. Robert visited the Transfer Station. He indicated to scoop up the soils that came in contact with leachate from tank. Robert visited the rear sump on the C&D/MSW.

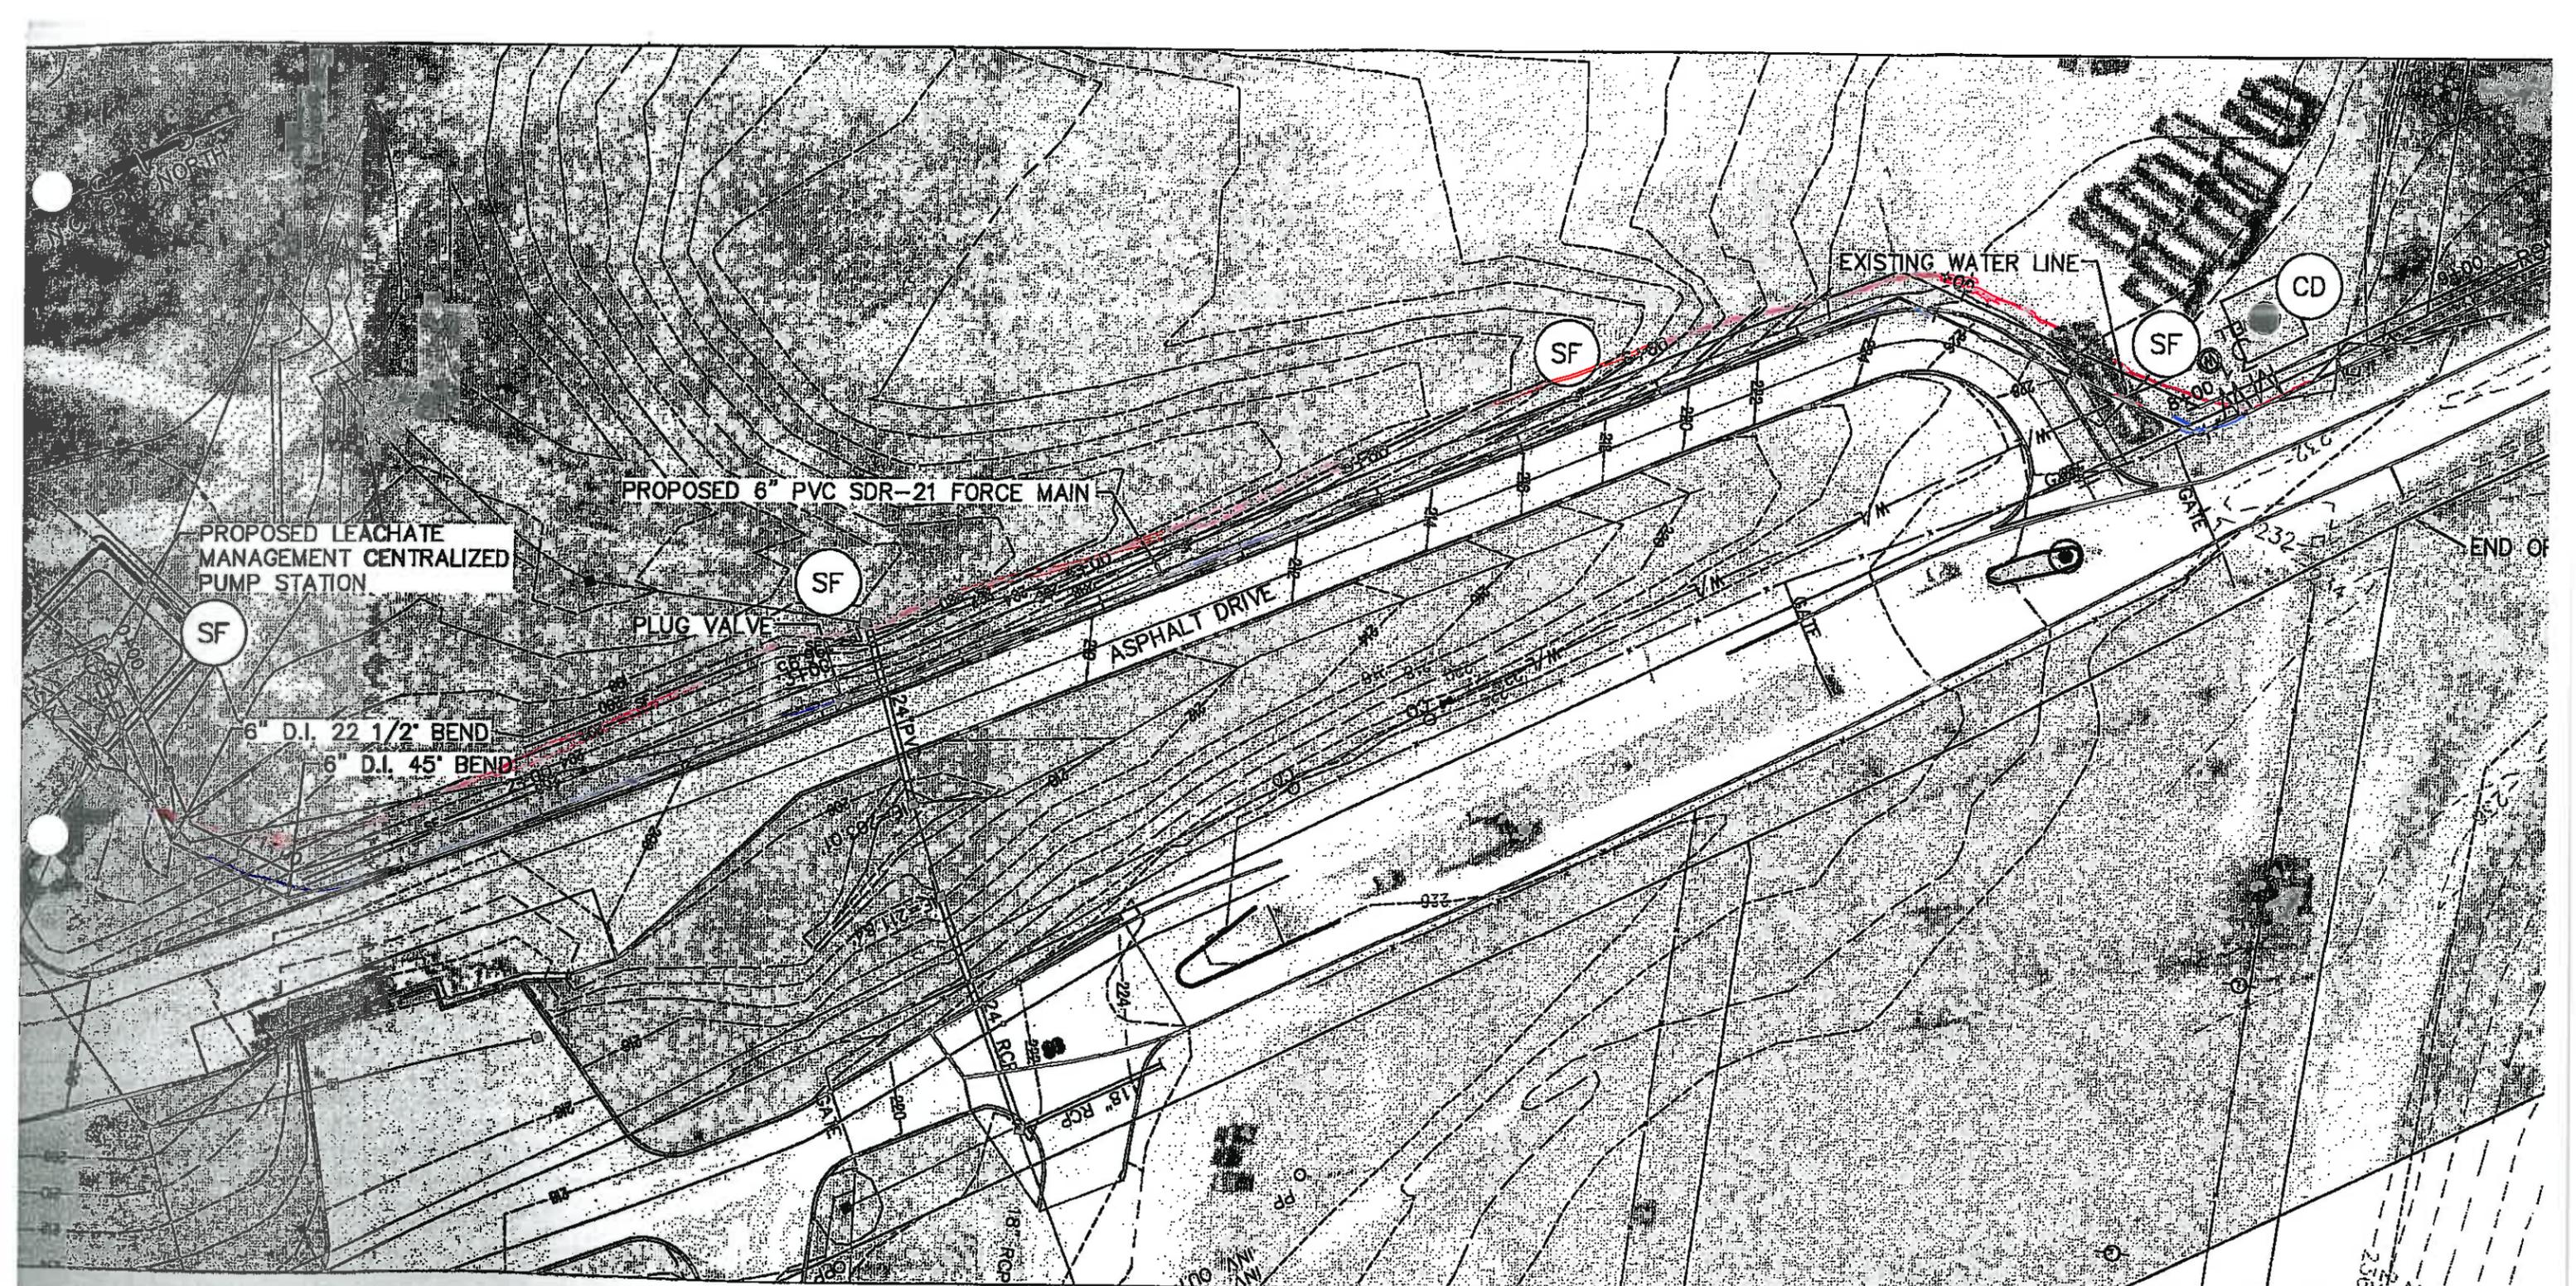
DELF CAPS Project
 Relocation of PVC FM
 Mtg. w/ Randy 6-20-13

PLAN
 SCALE: 1" = 50'
 0 50 100

Arrived onsite at approx 2:30 pm. Met with Dennis Turlington to discuss force main route along Daniels Road and at intersection with Turlington. Walked route inside Landfill property. Discussed revising location from back of curb to behind fence at LCID. Dennis indicated a test pit had been dug at the wet well and wet/soft soils were encountered. Also, a storm pipe had been damaged.

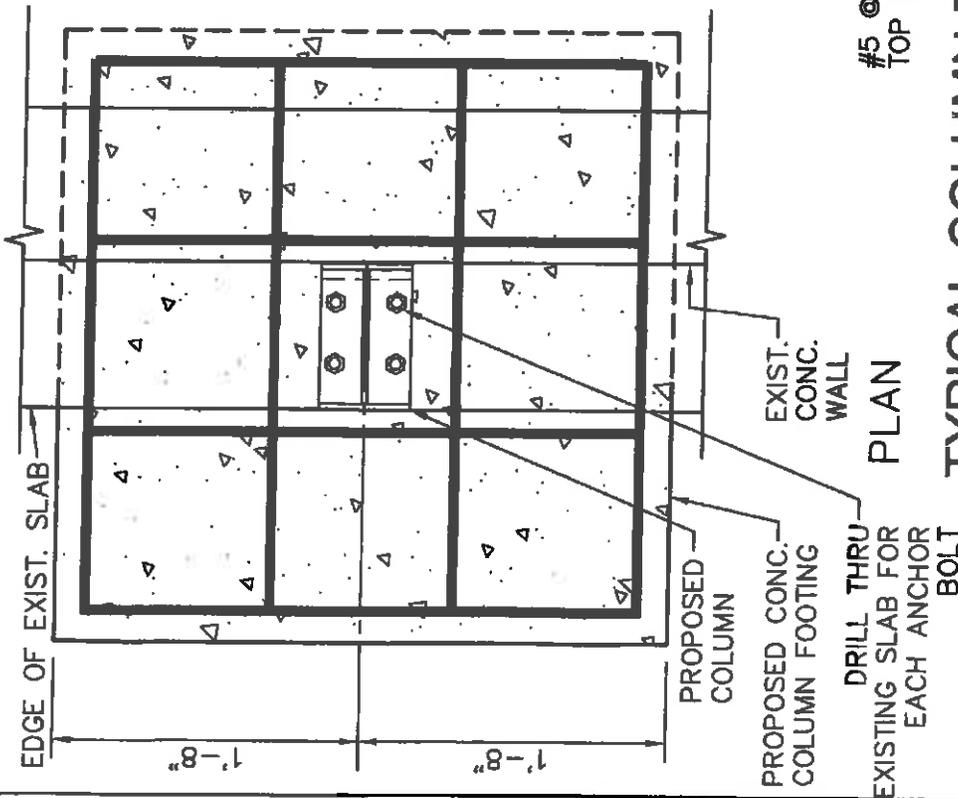
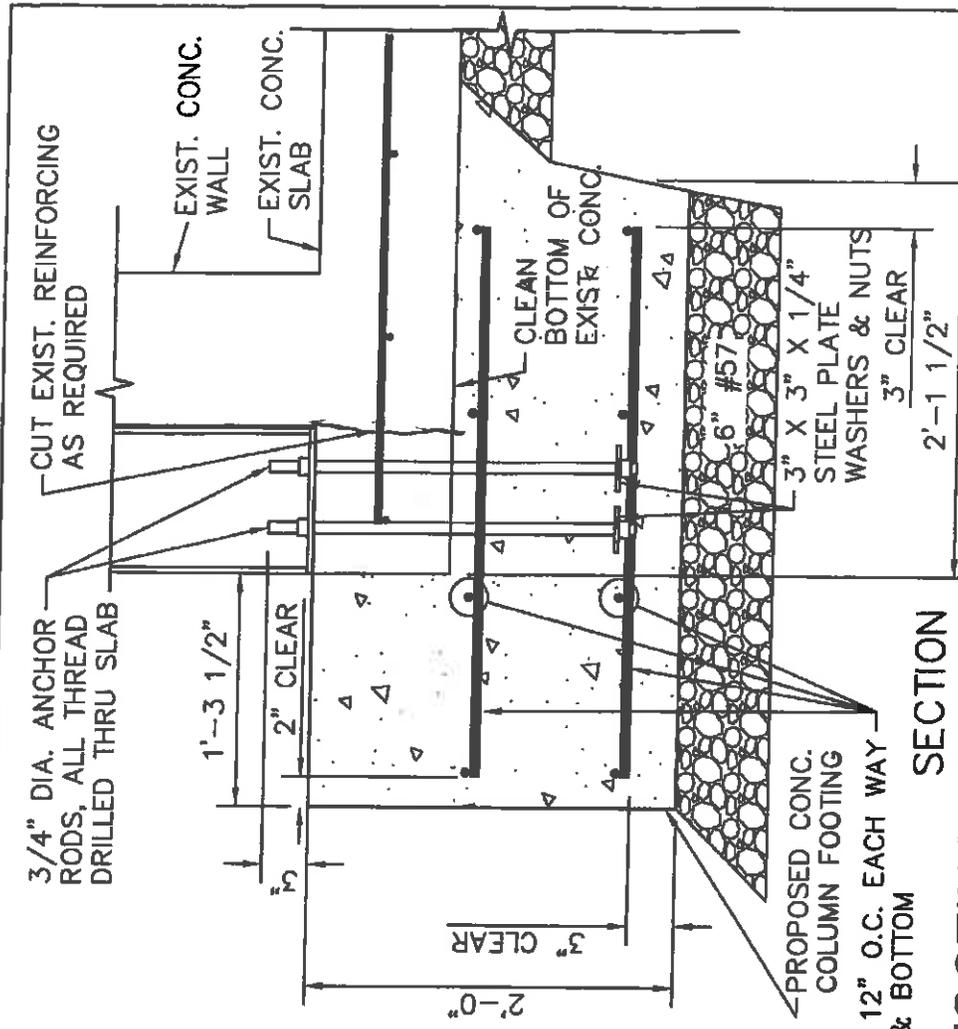
TYPICAL COLUMN FOOTING DETAIL

PLAN

SECTION
