SITE VISIT REPORT

Project: Dunn Erwin Landfill CAP Projects

Job No.: 3002B

Location: Dunn-Erwin Landfill, Dunn, NC

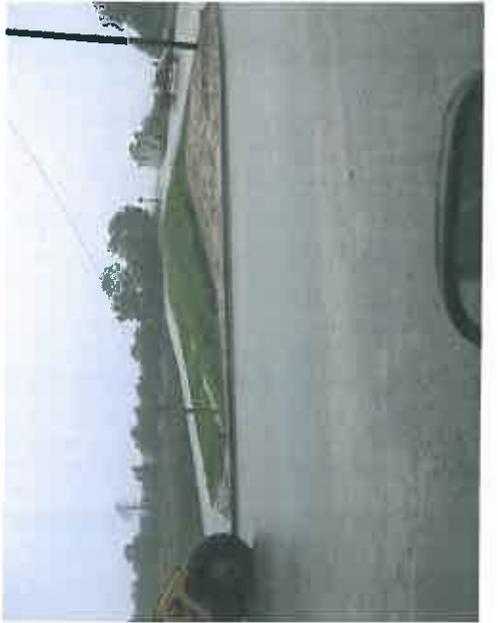
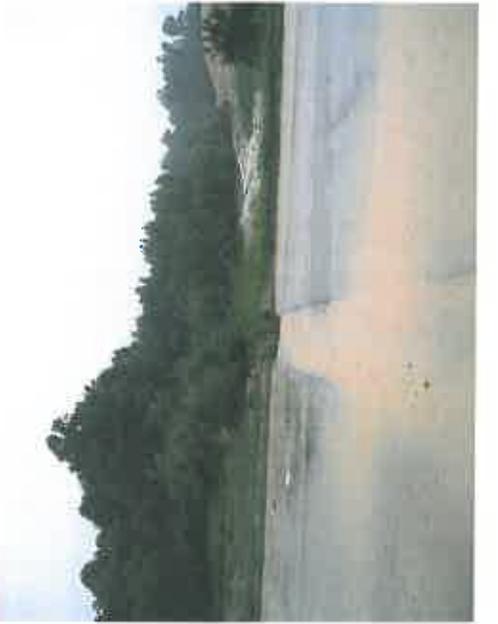
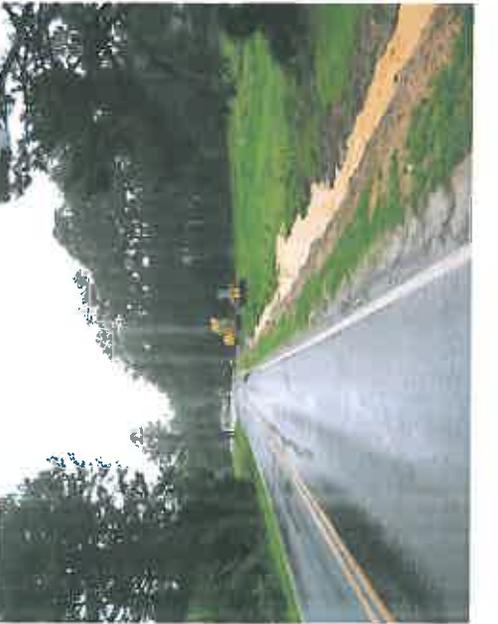
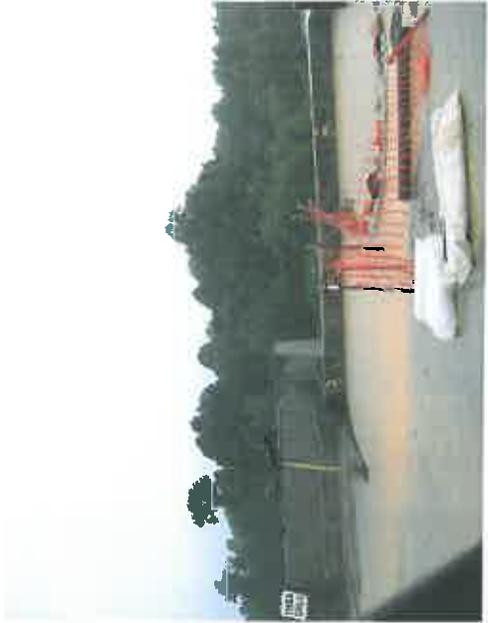
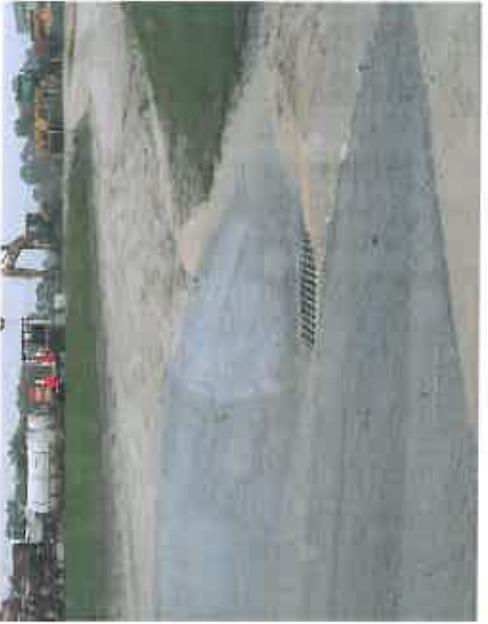
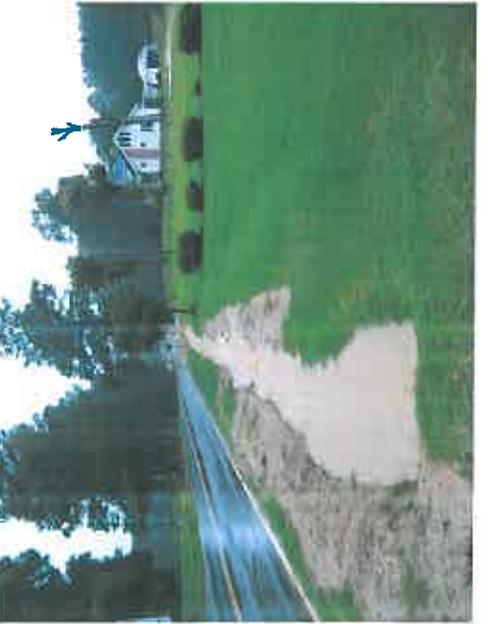
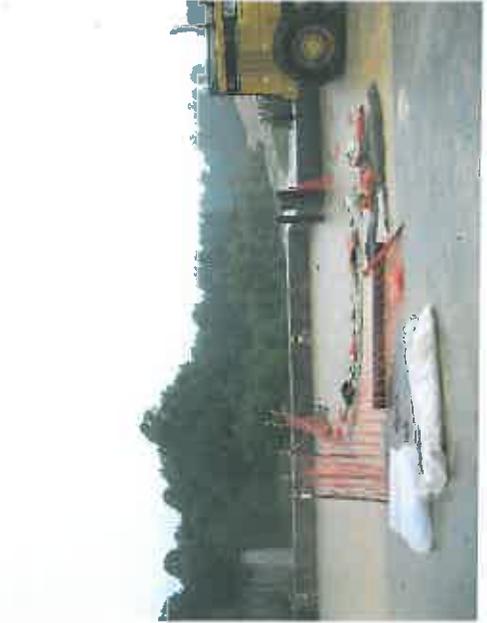
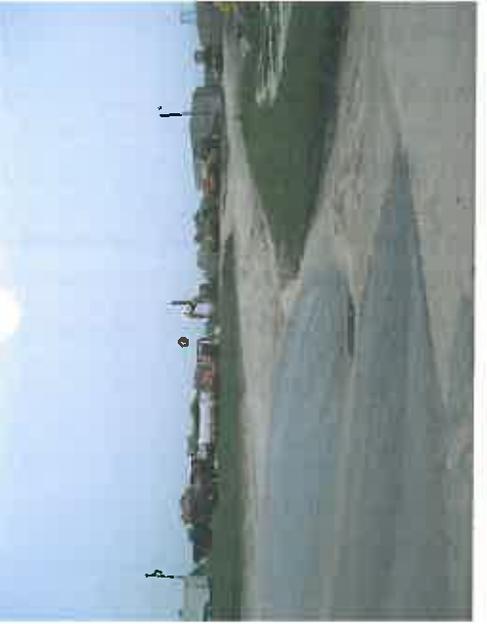
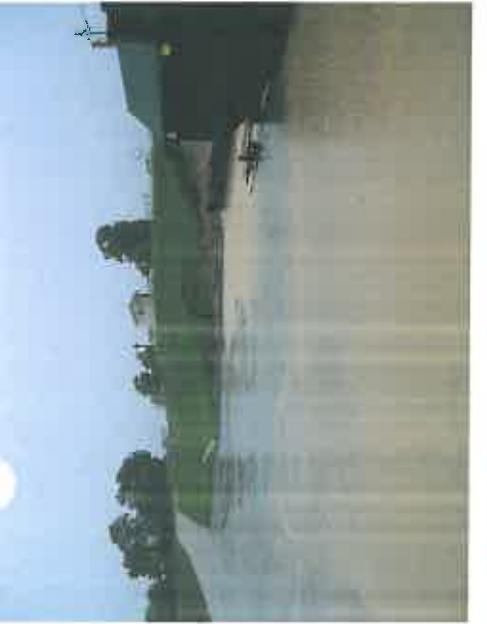
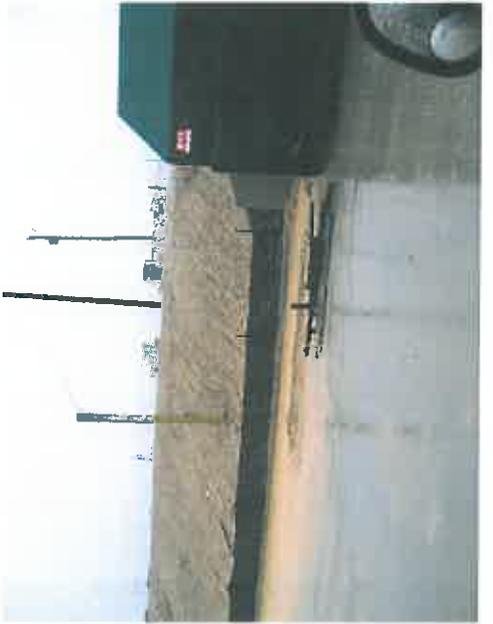
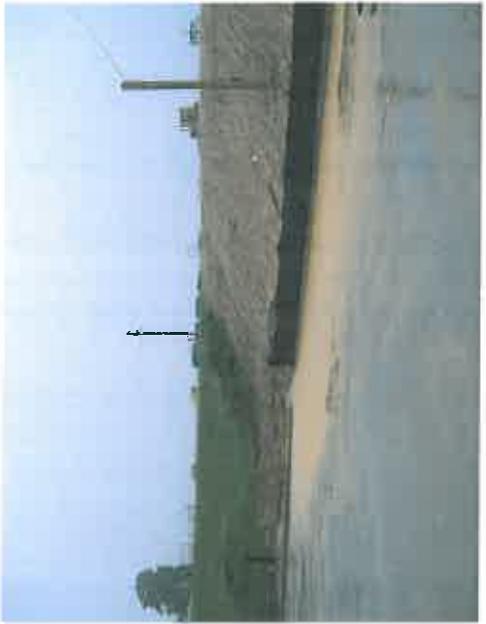
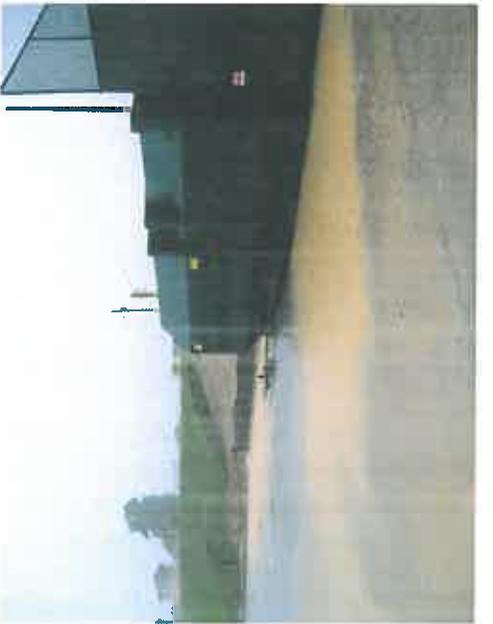
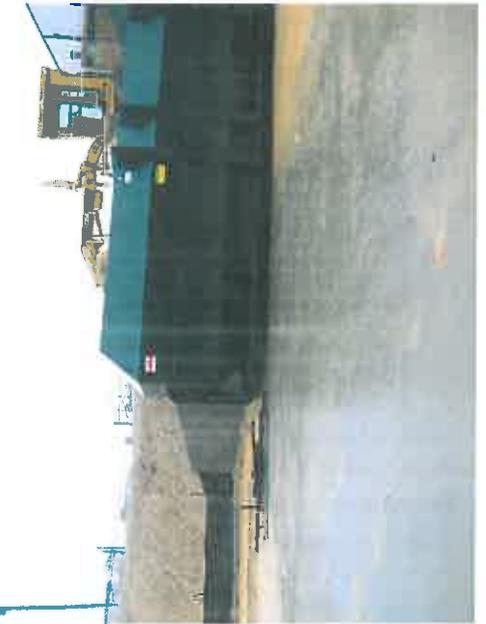
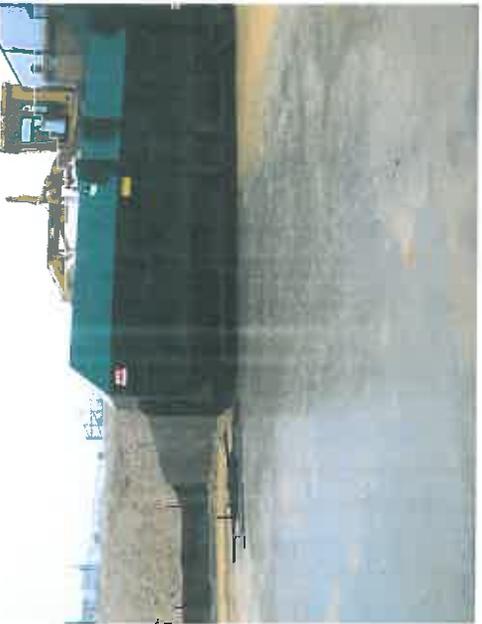
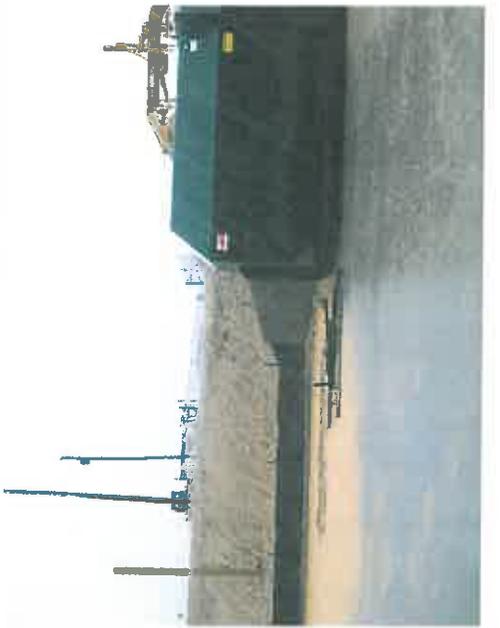
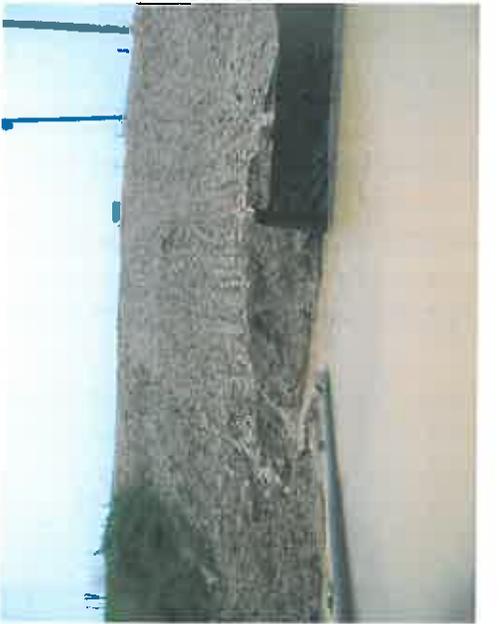
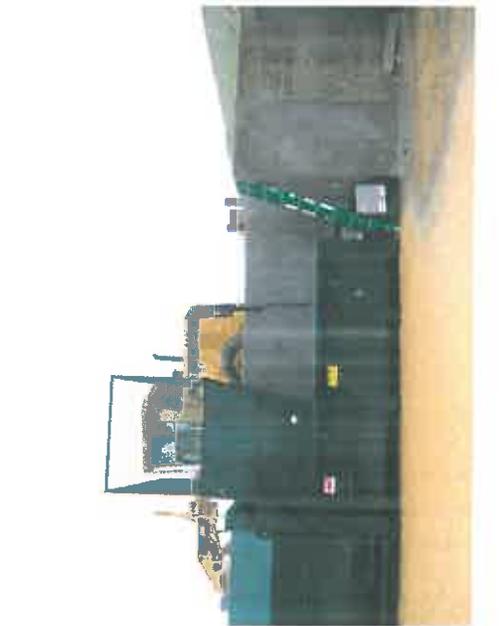
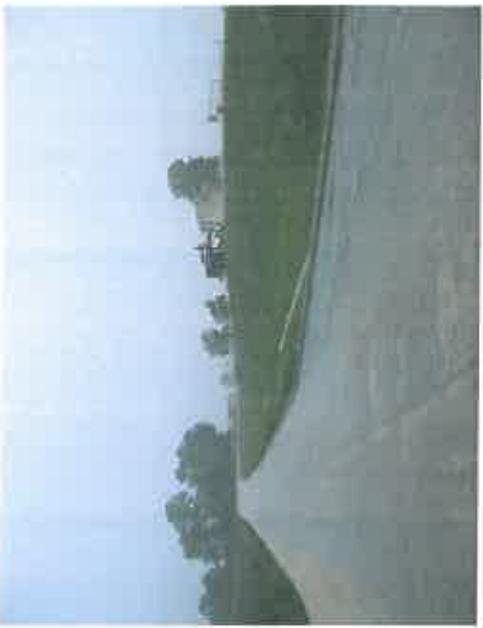
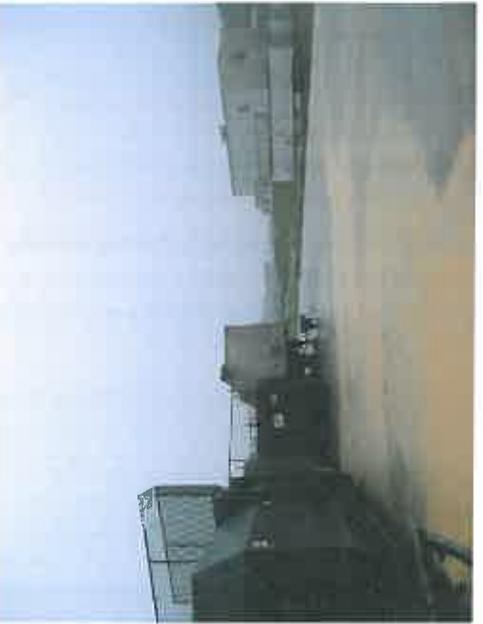
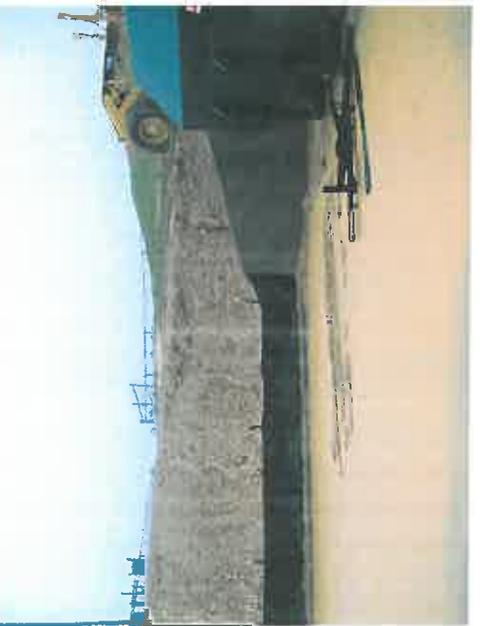
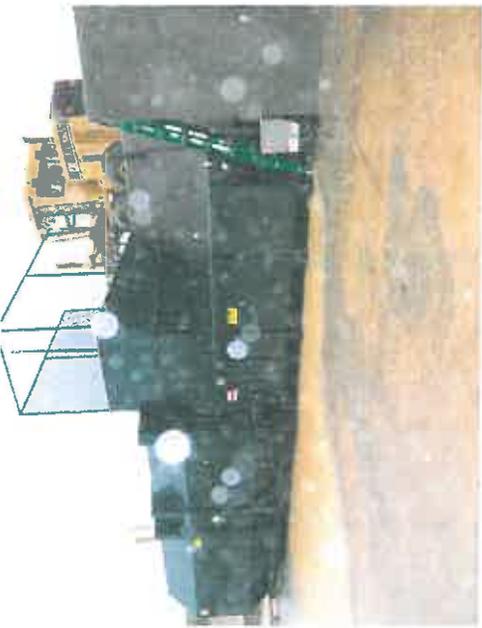
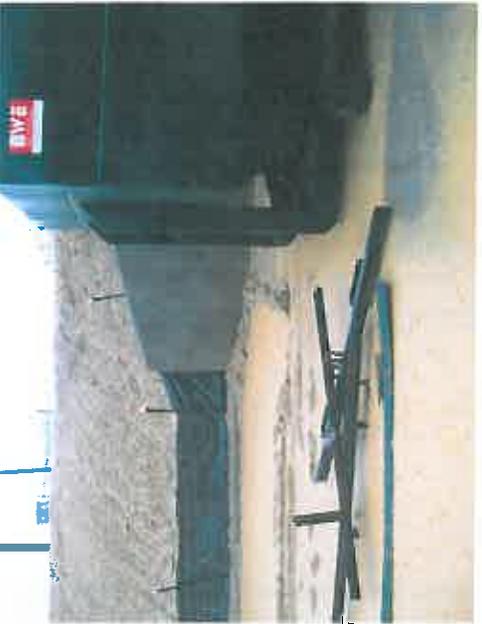
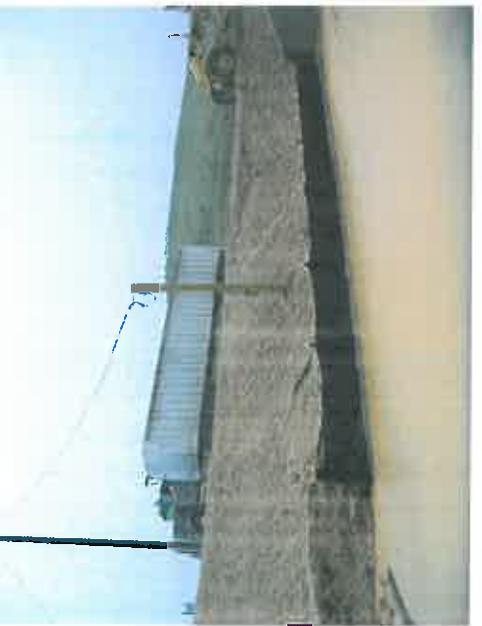
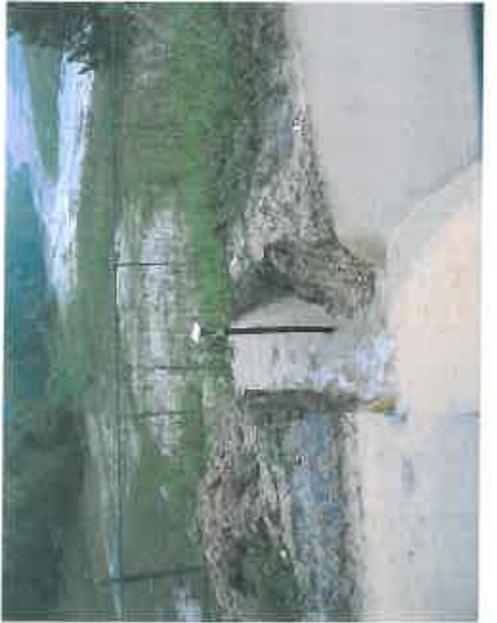
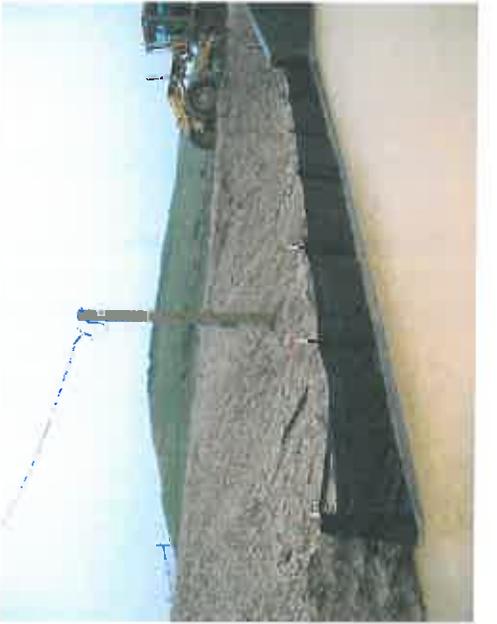
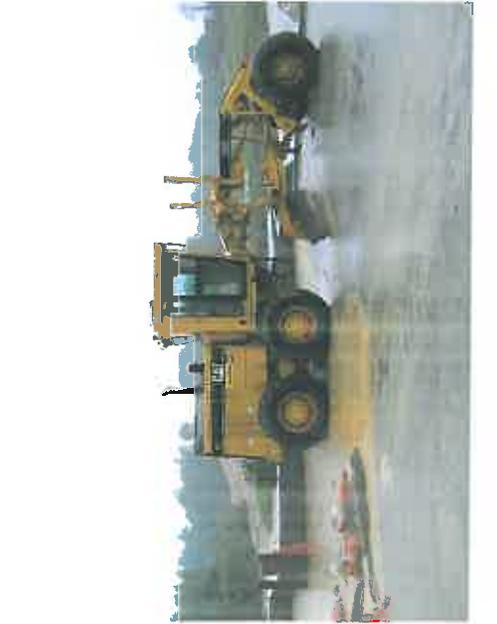
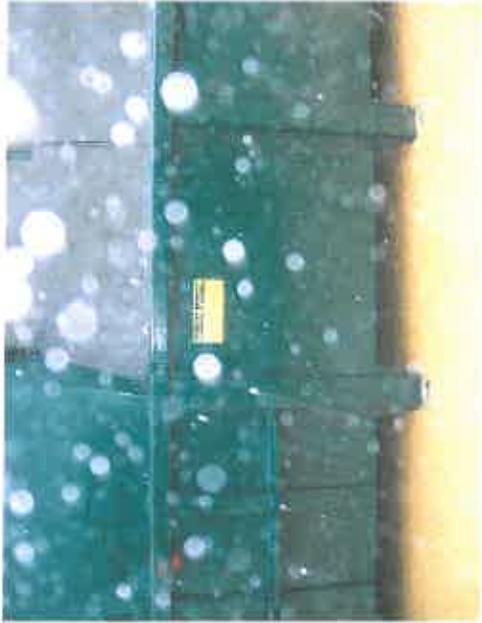
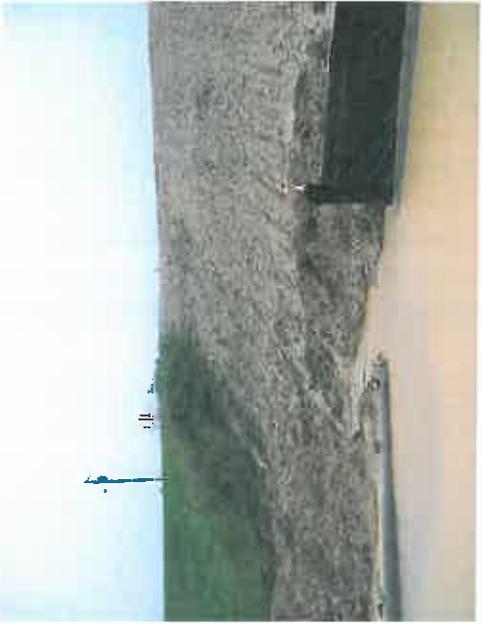
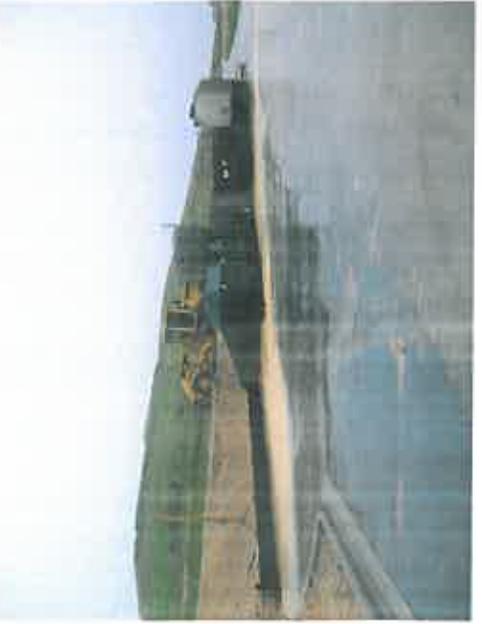
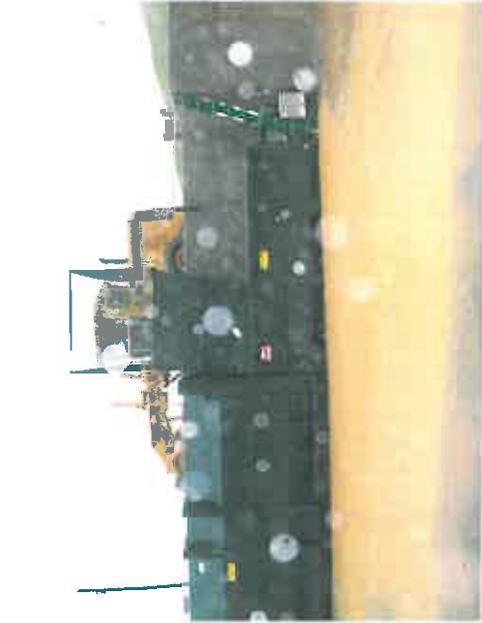
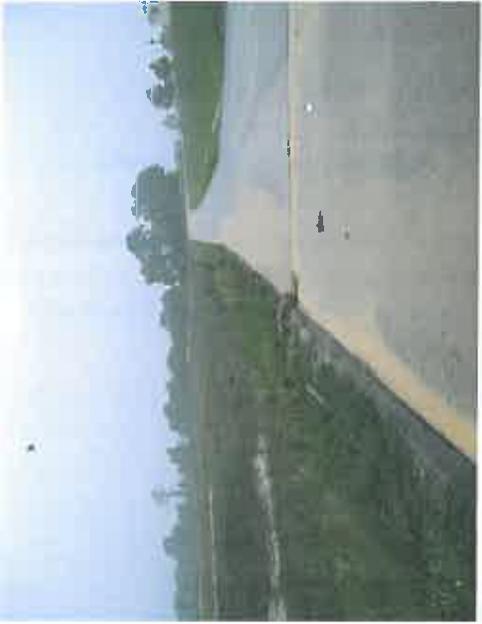
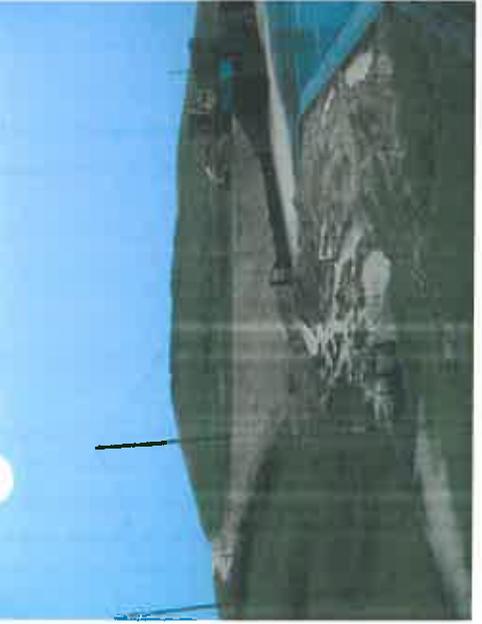
Site visit to check for any rain damage. No one working at site. See photos, Discussed w/ Tyrus
