SITE VISIT REPORT

Project: Dunn Erwin Landfill CAP Projects

Job No.: 3002B

Location: Dunn-Erwin Landfill, Dunn, NC

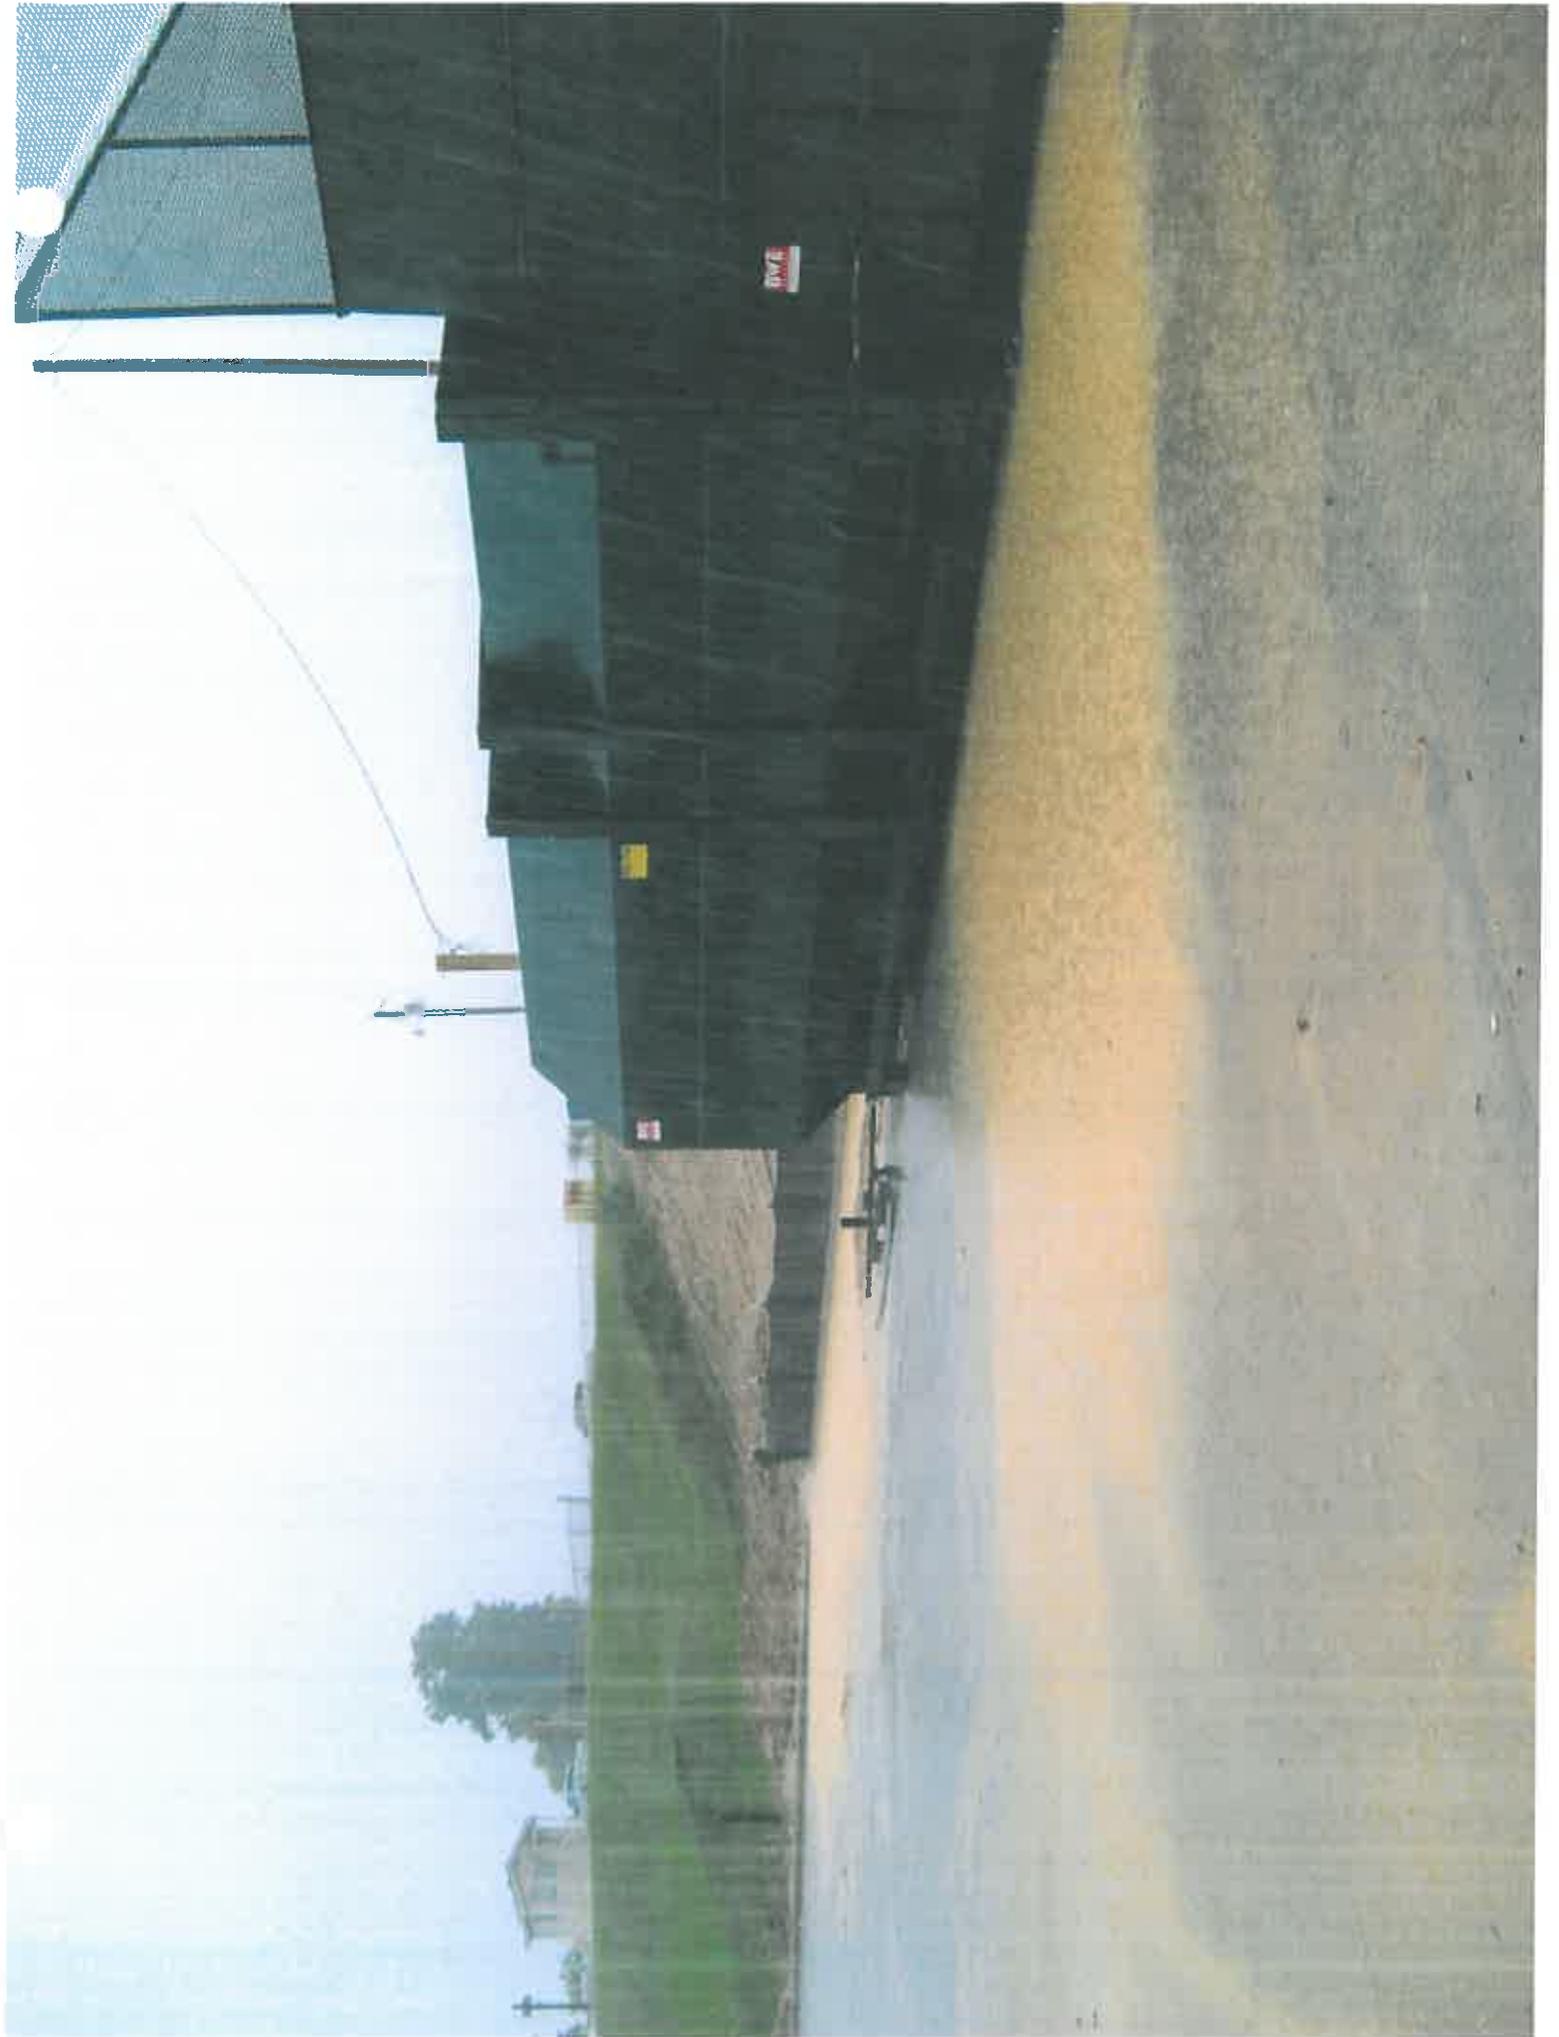
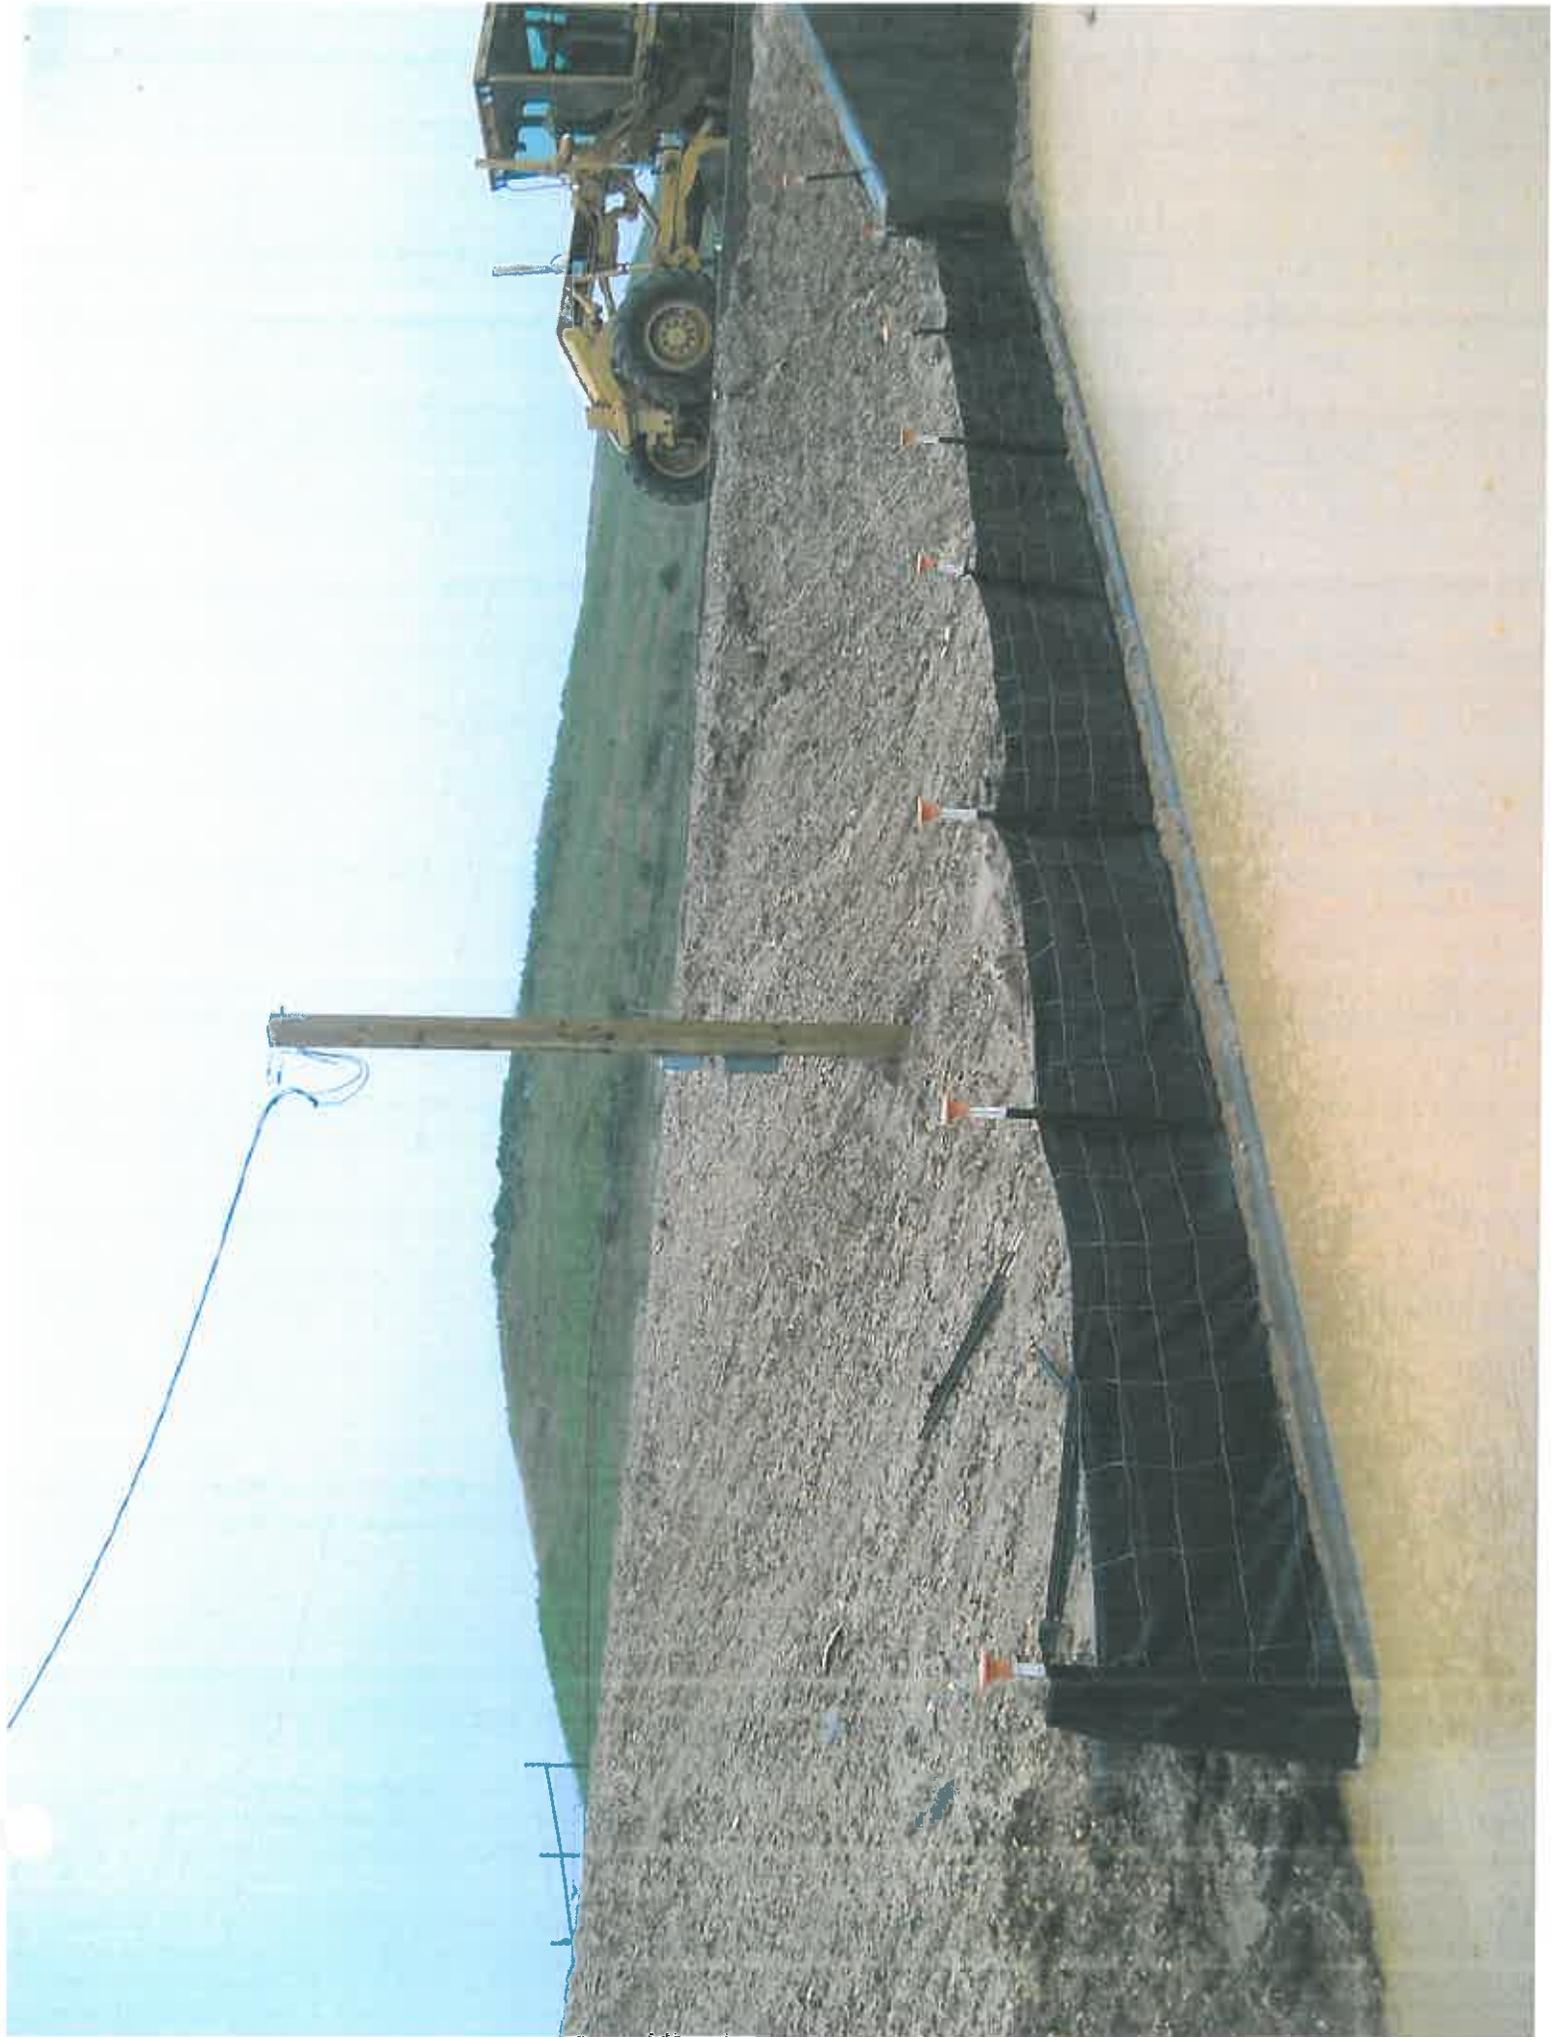
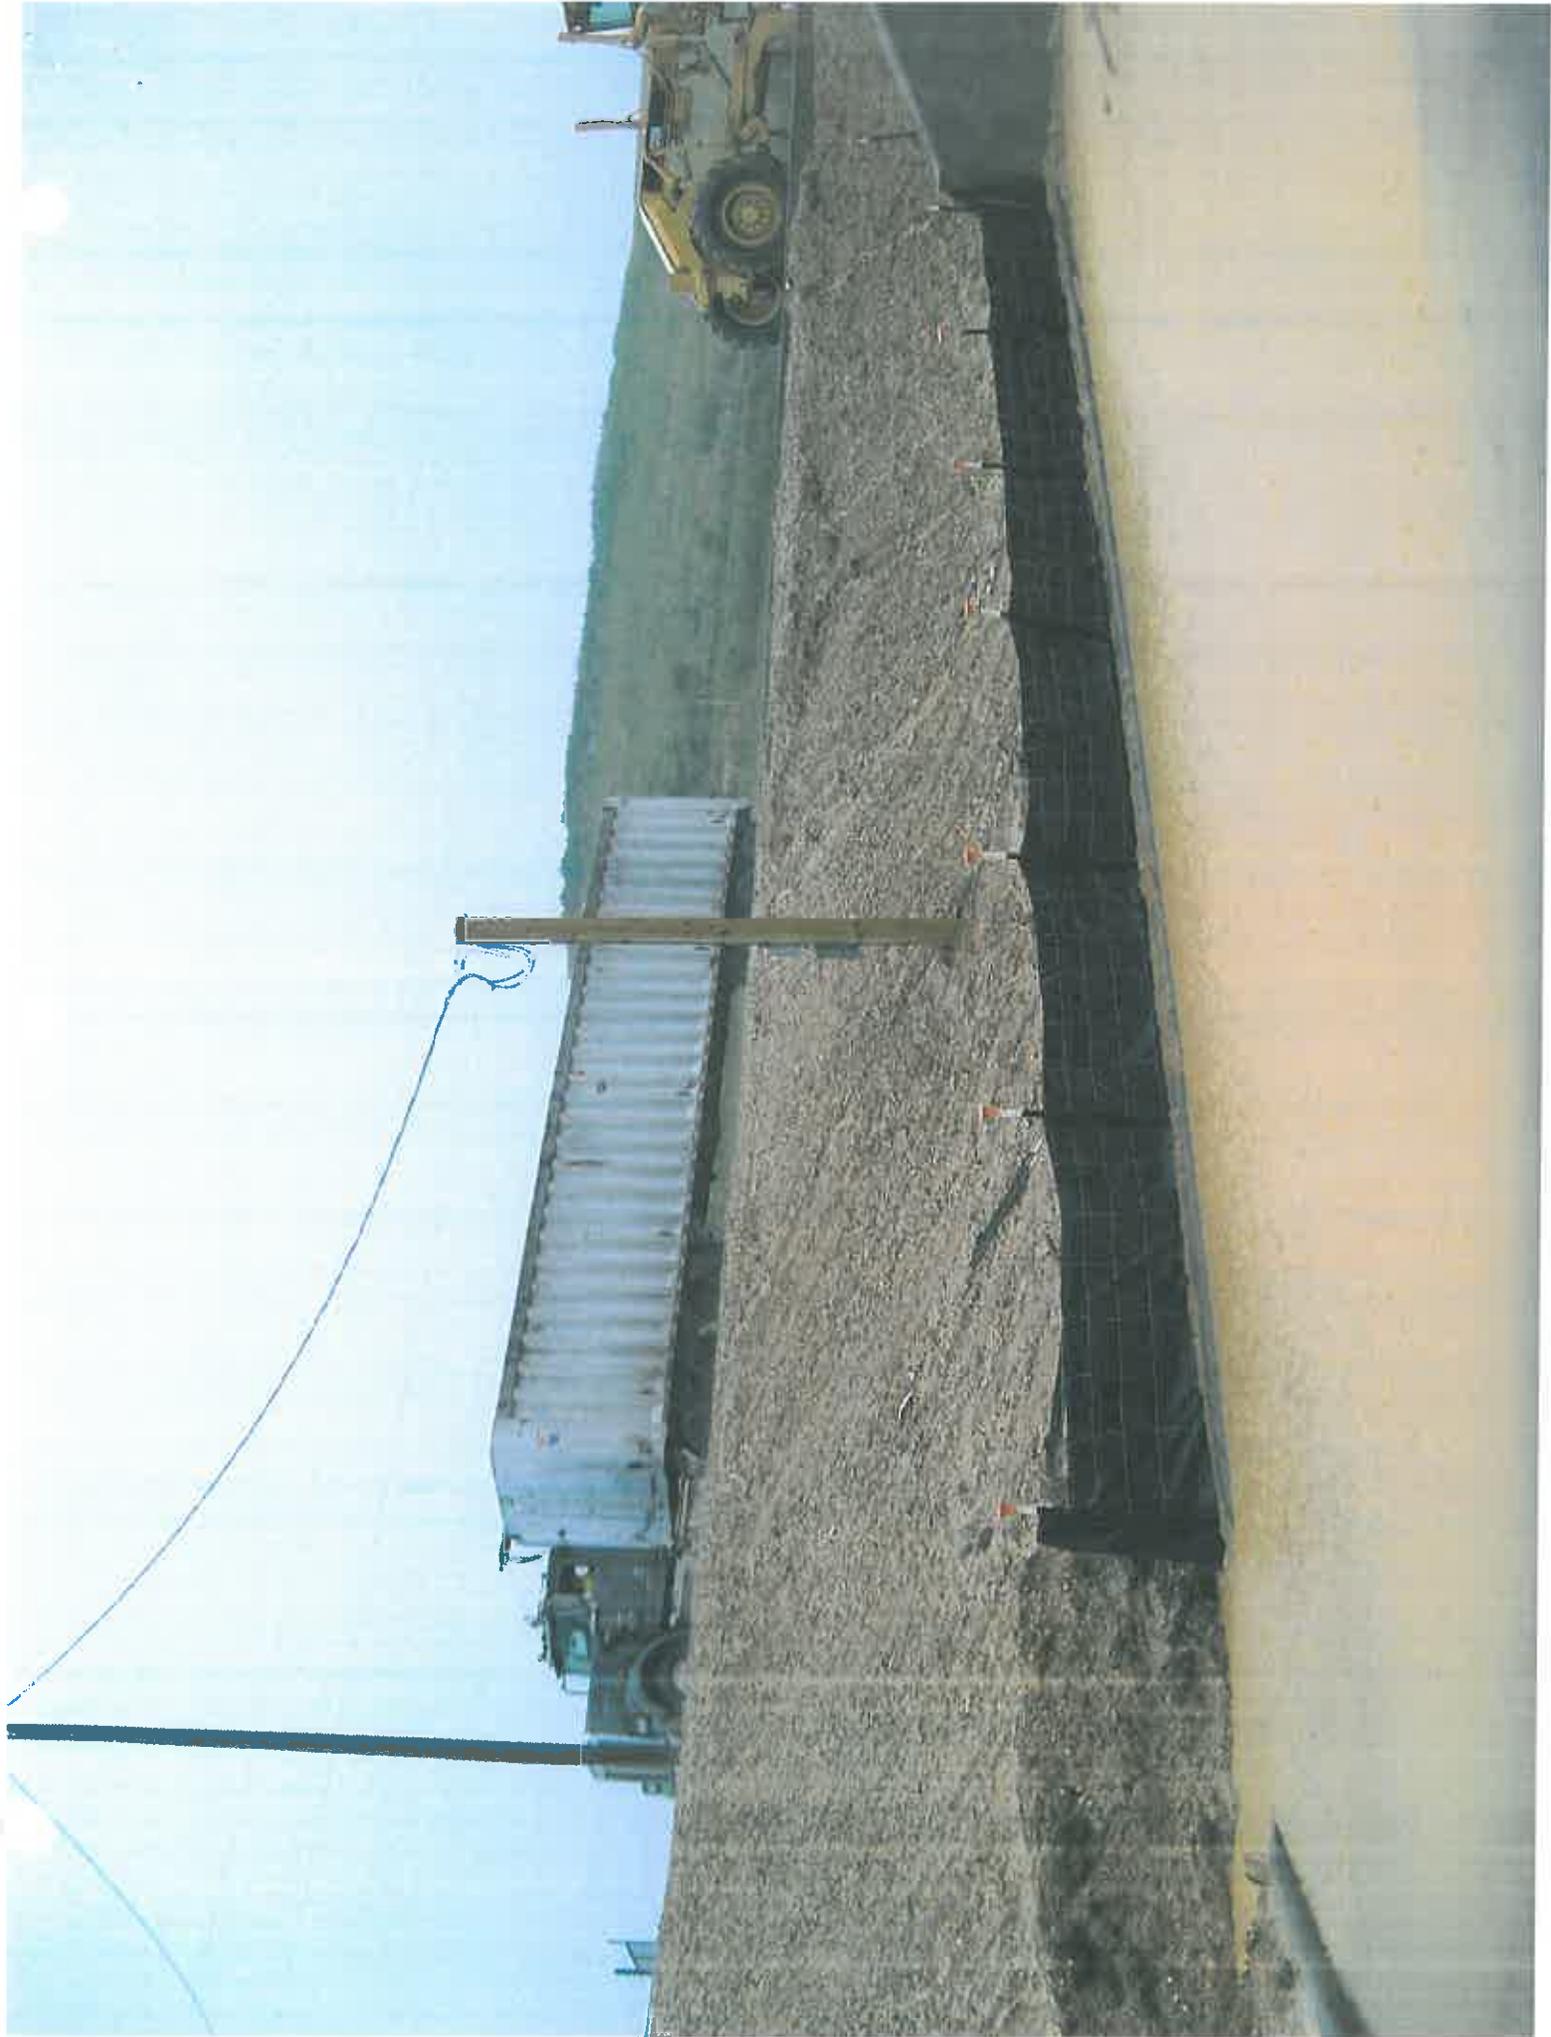
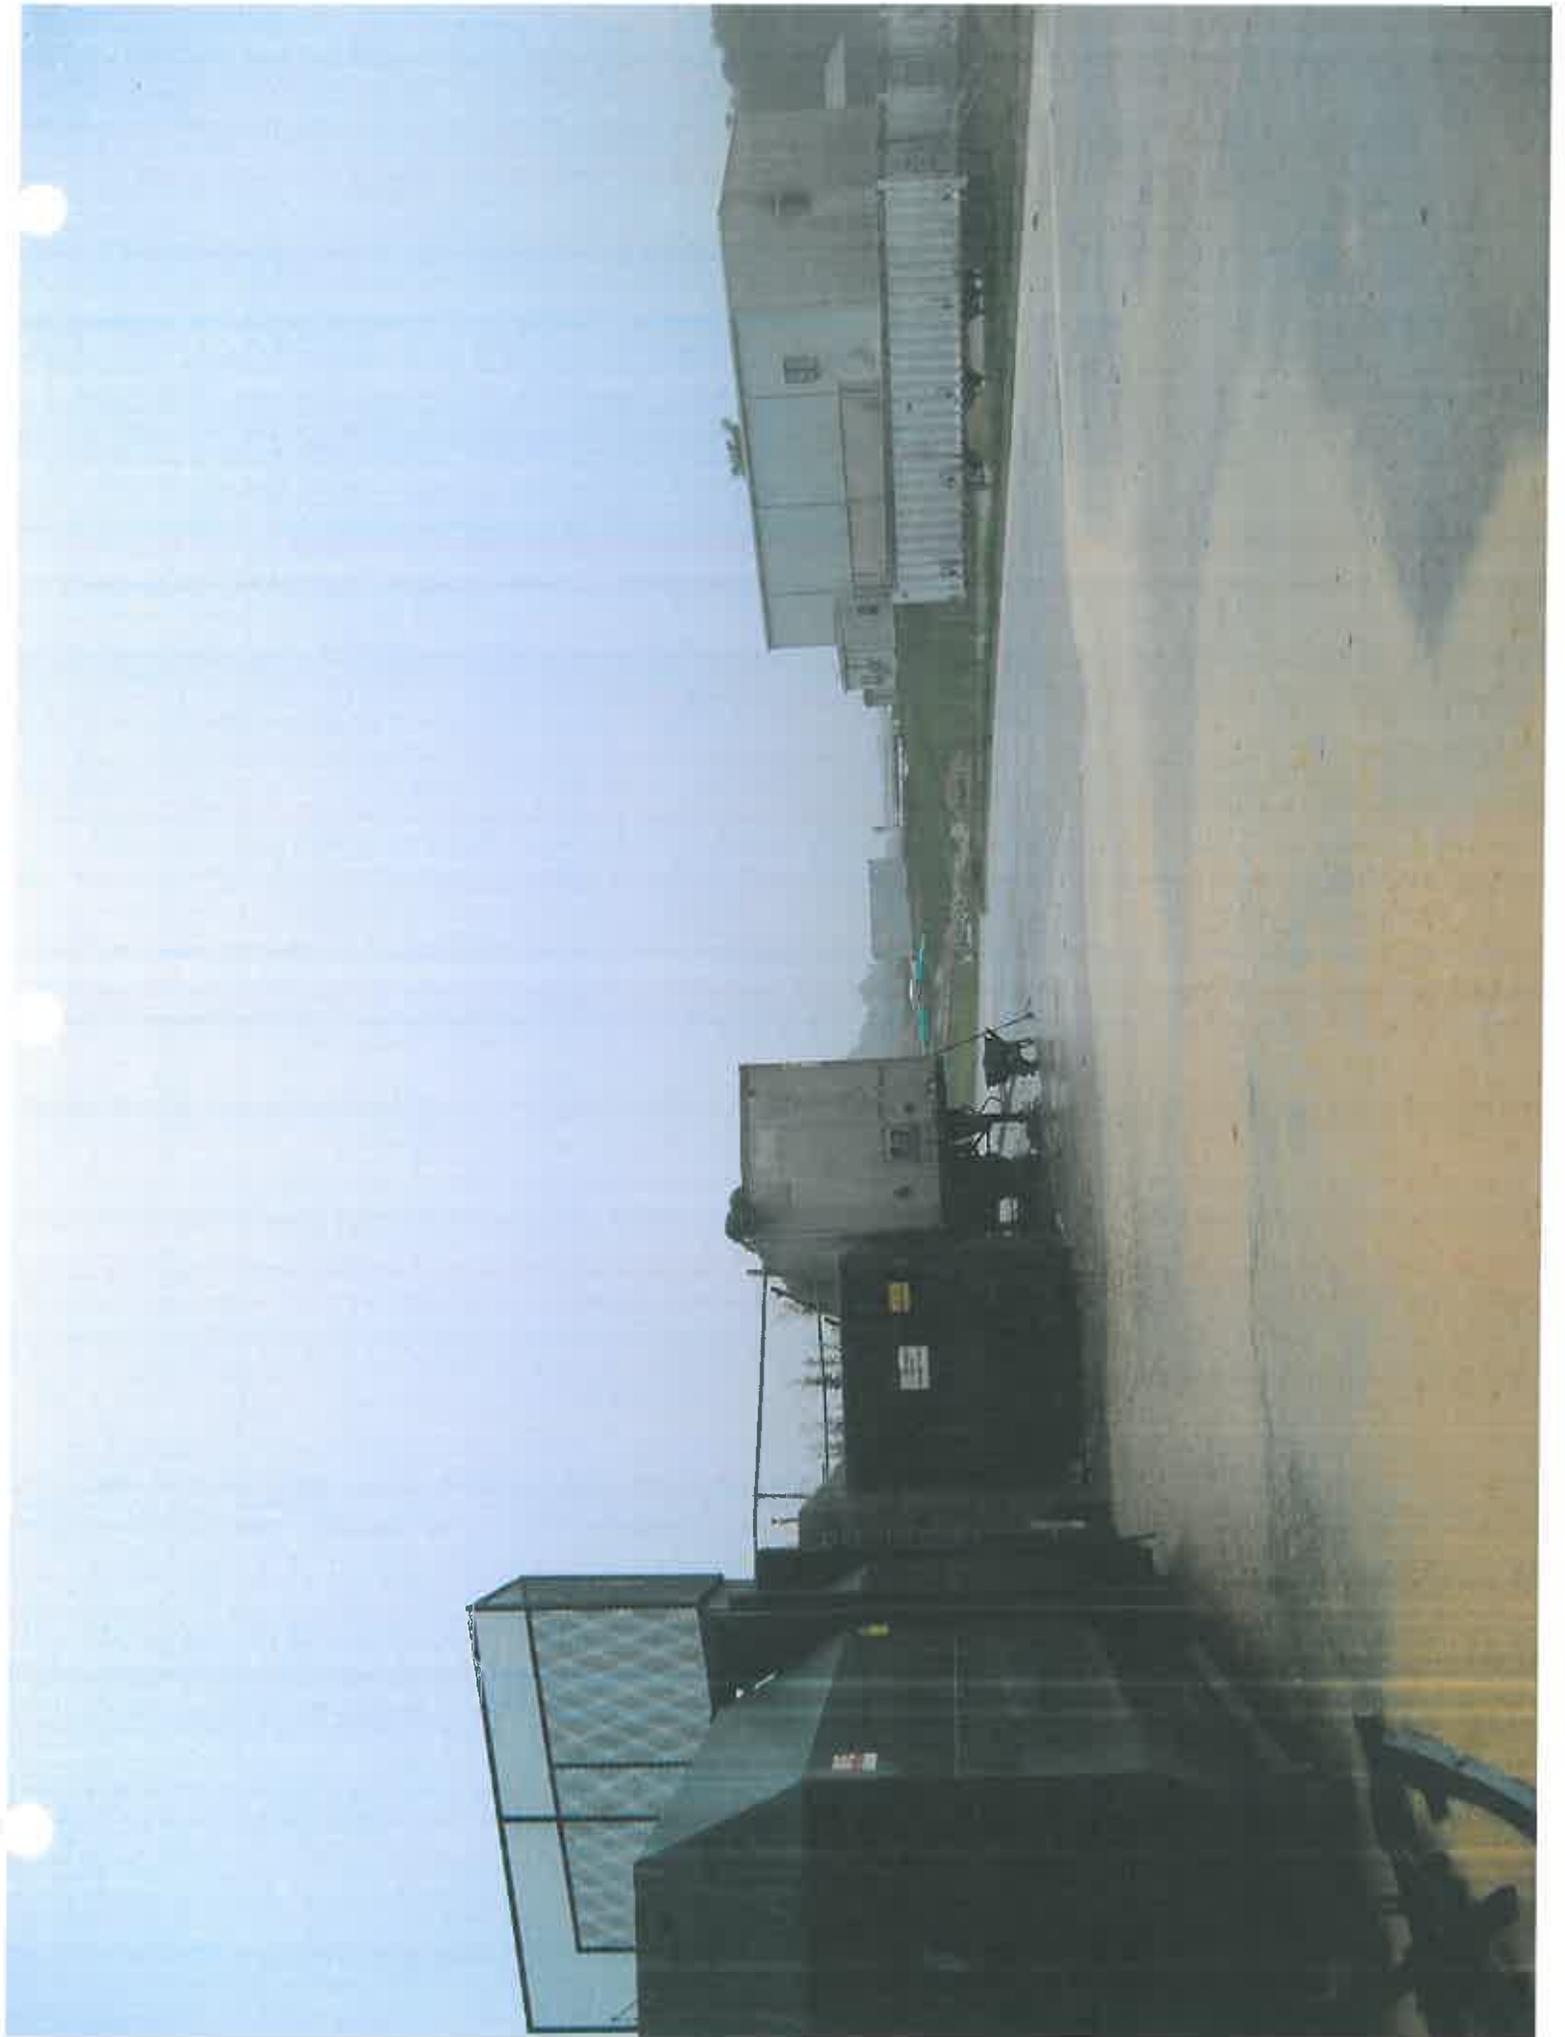
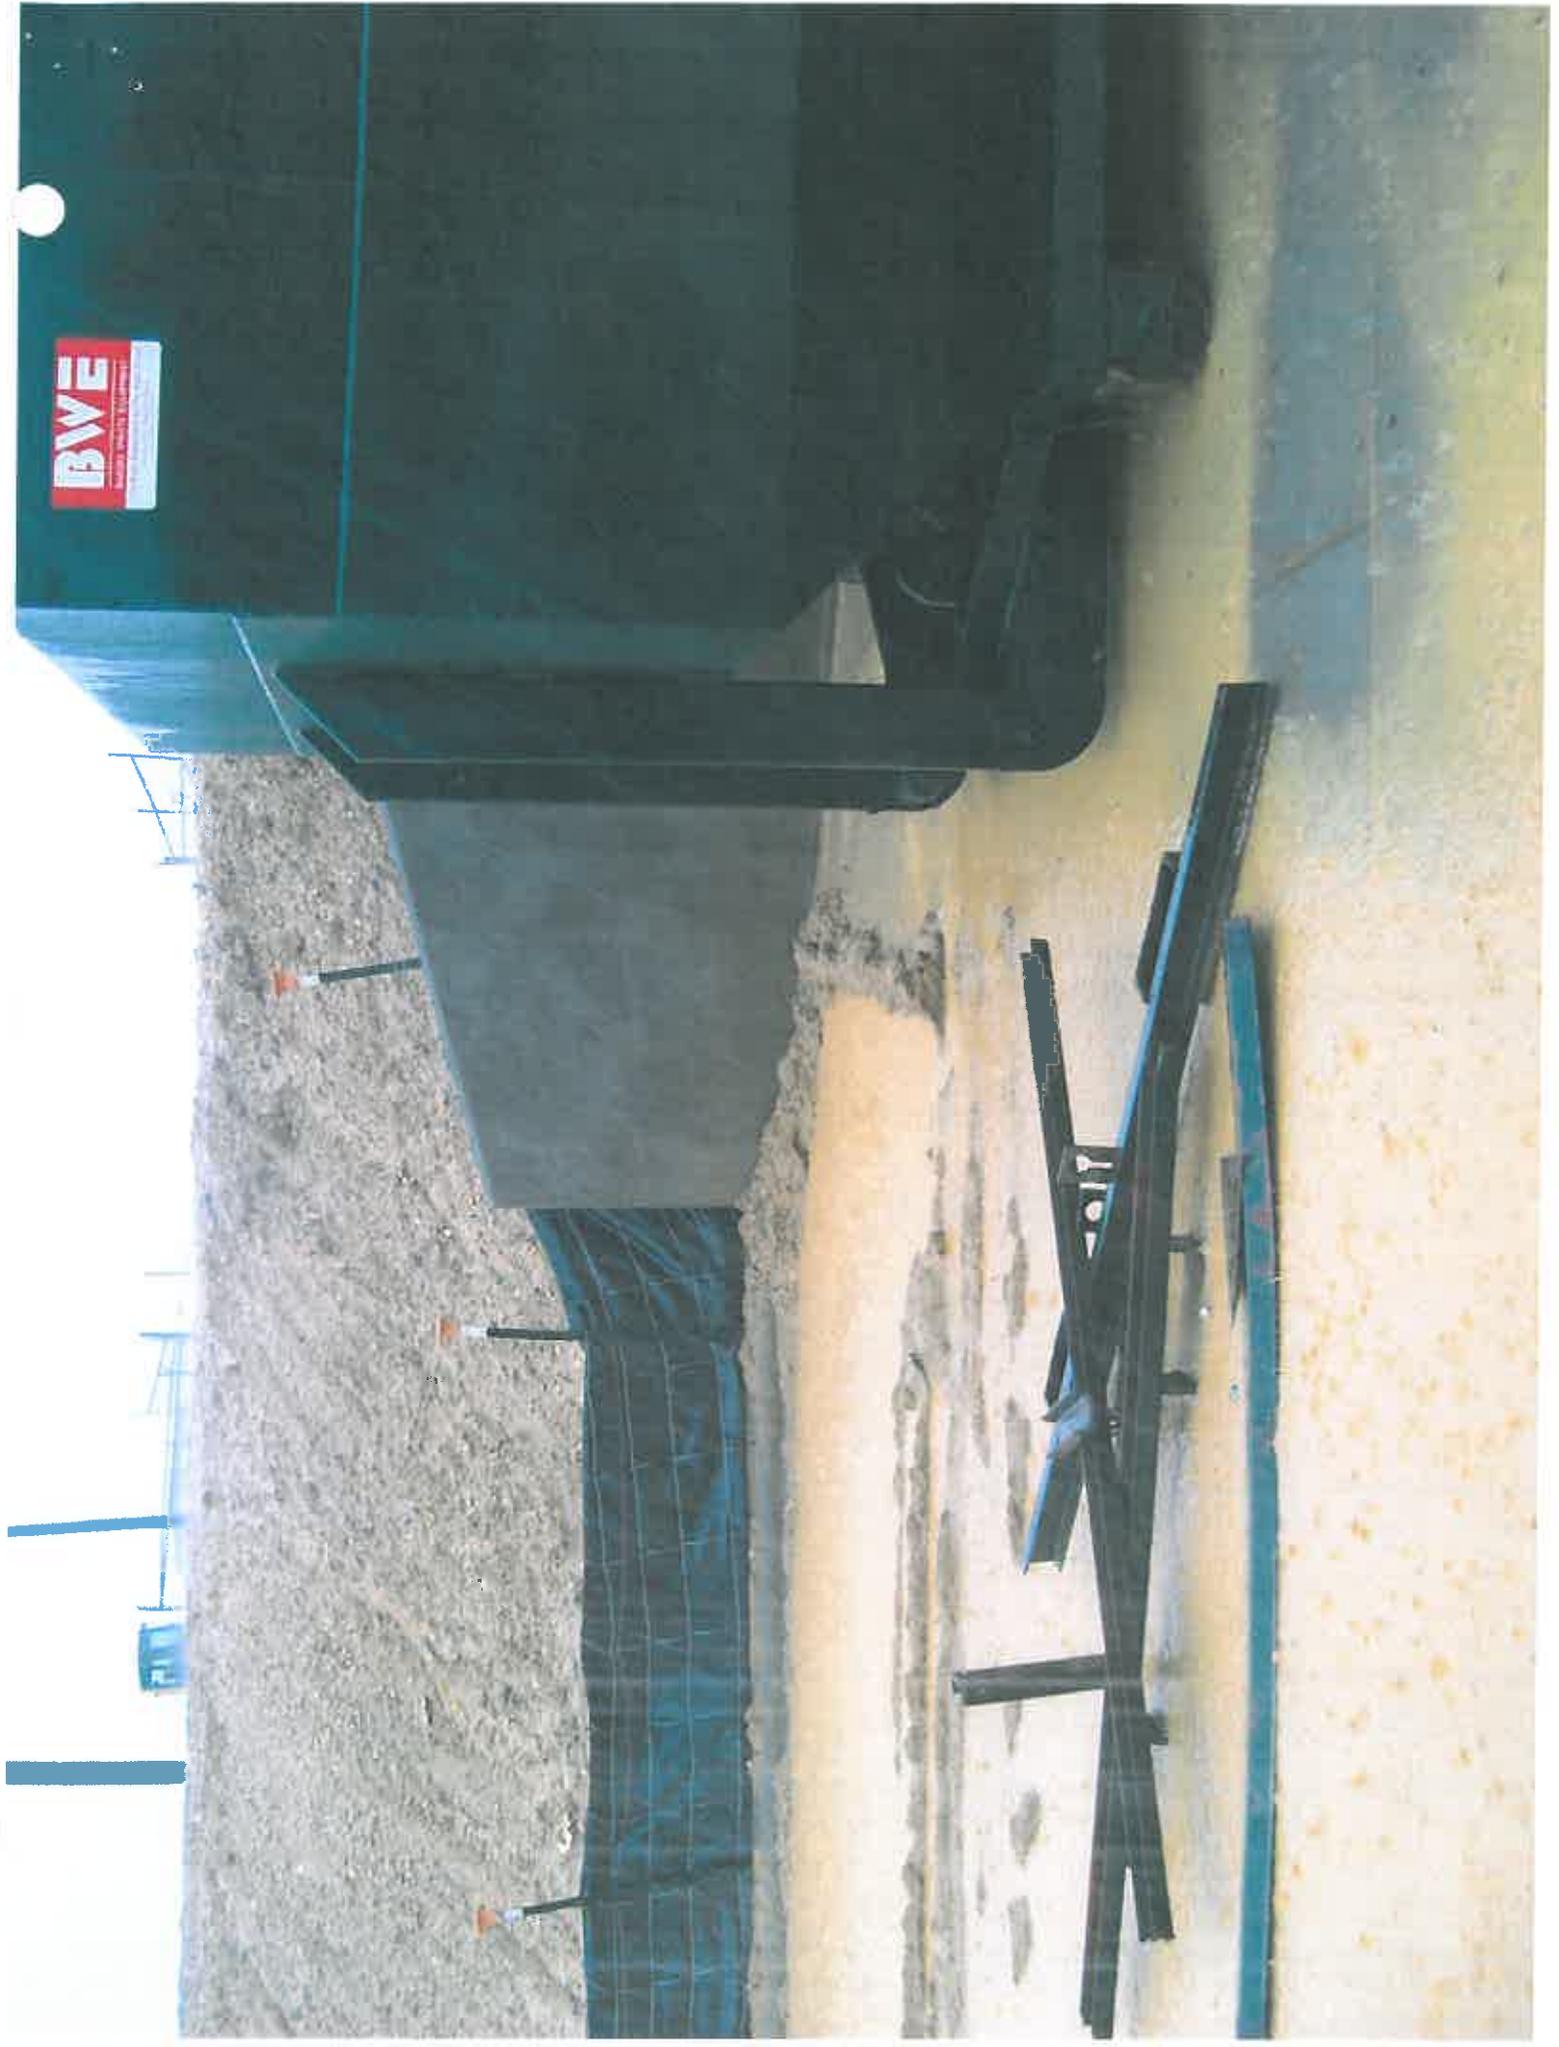
Site visit to check for any rain damage. No one working at site. See photos, Discussed w/ Tyrus

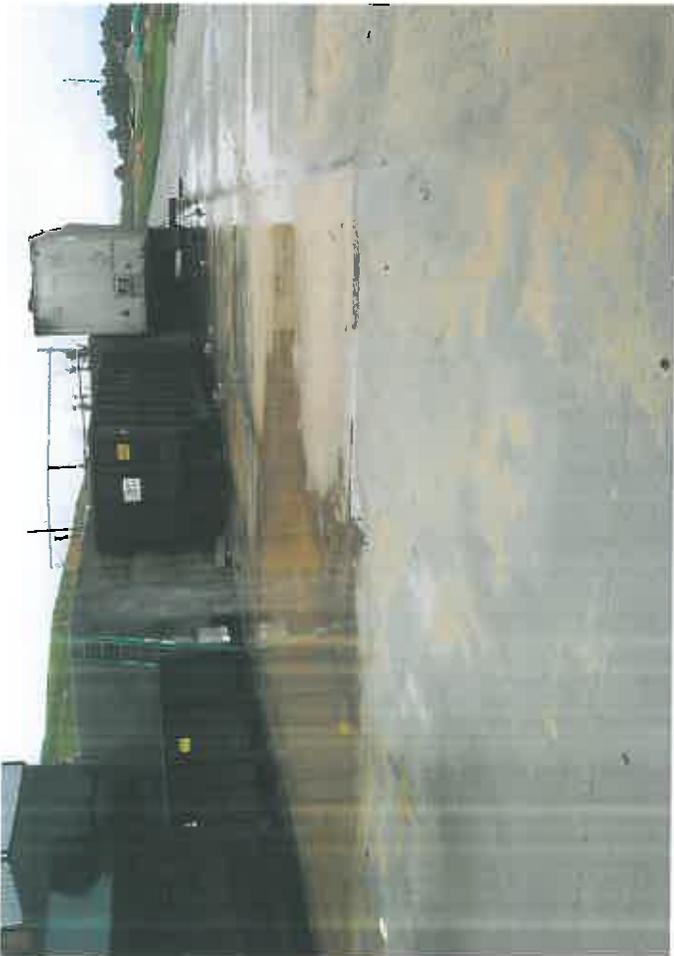
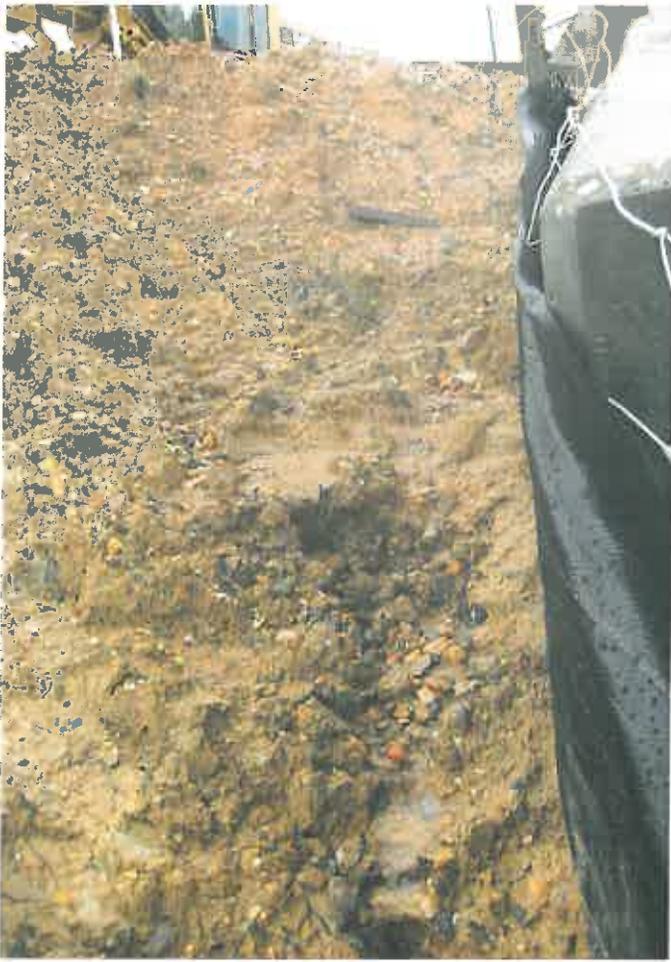
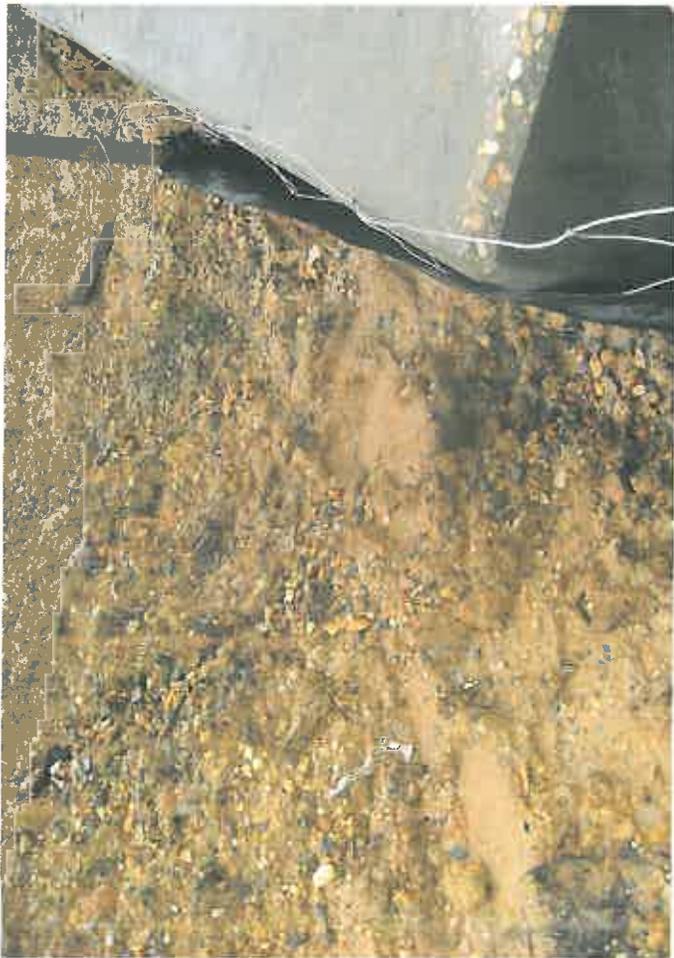
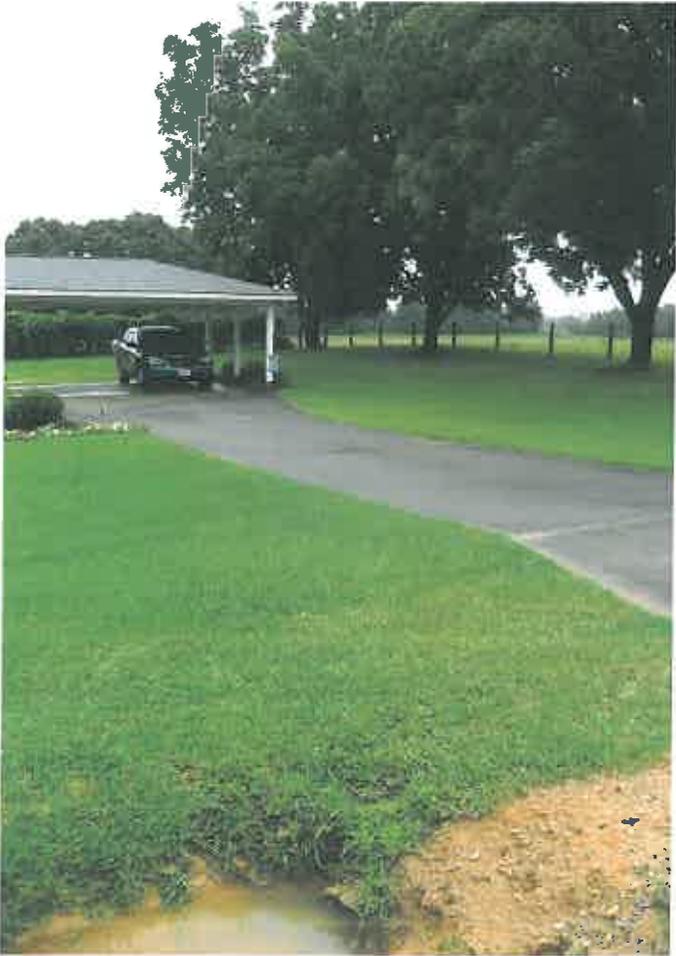
DELF CAP Project

Site visit to check for any rain damage. No one working at site. See photos, Discussed w/ Tyrus

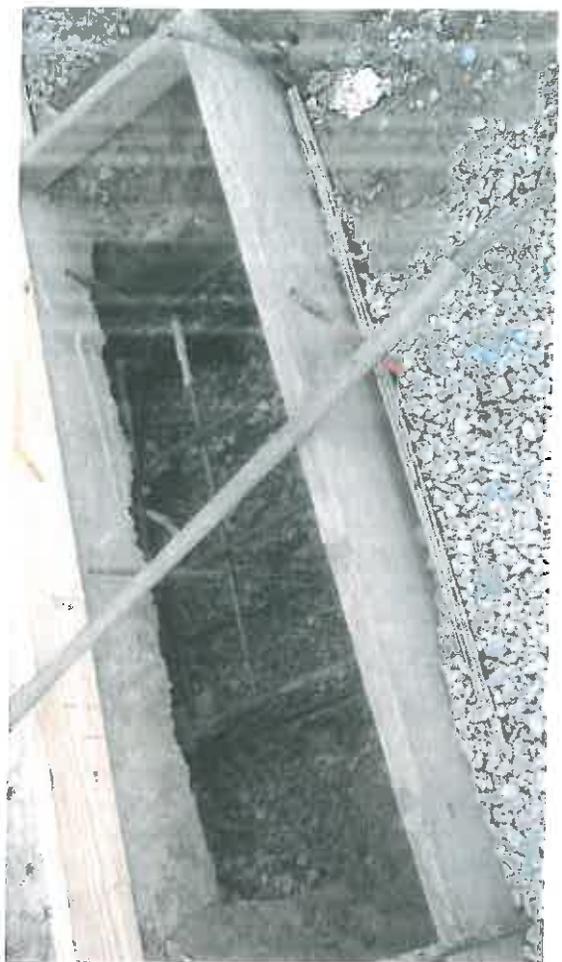
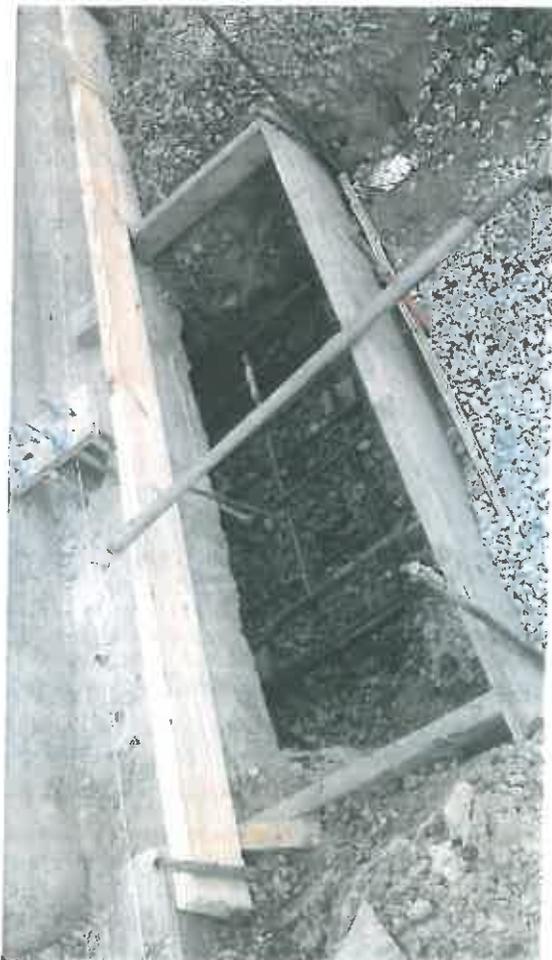
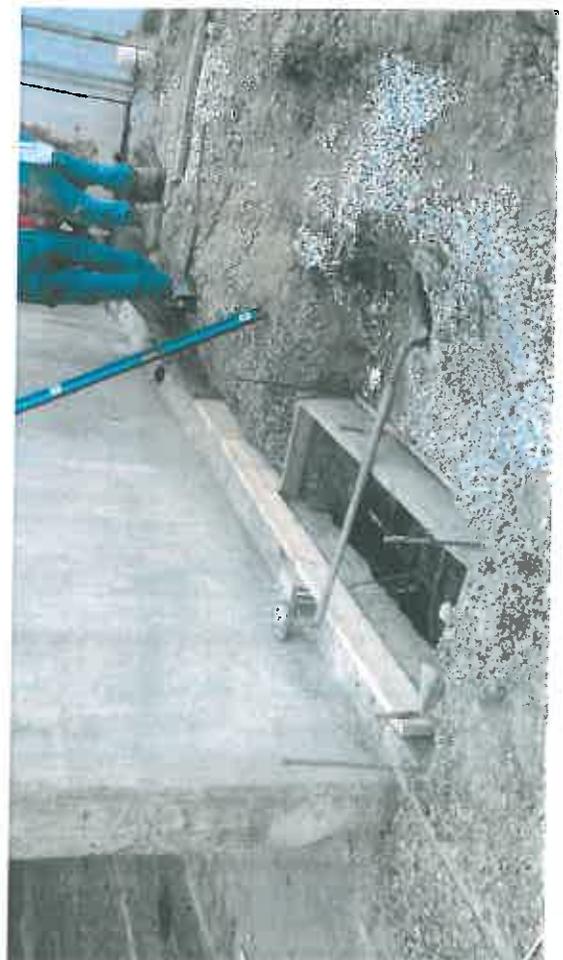
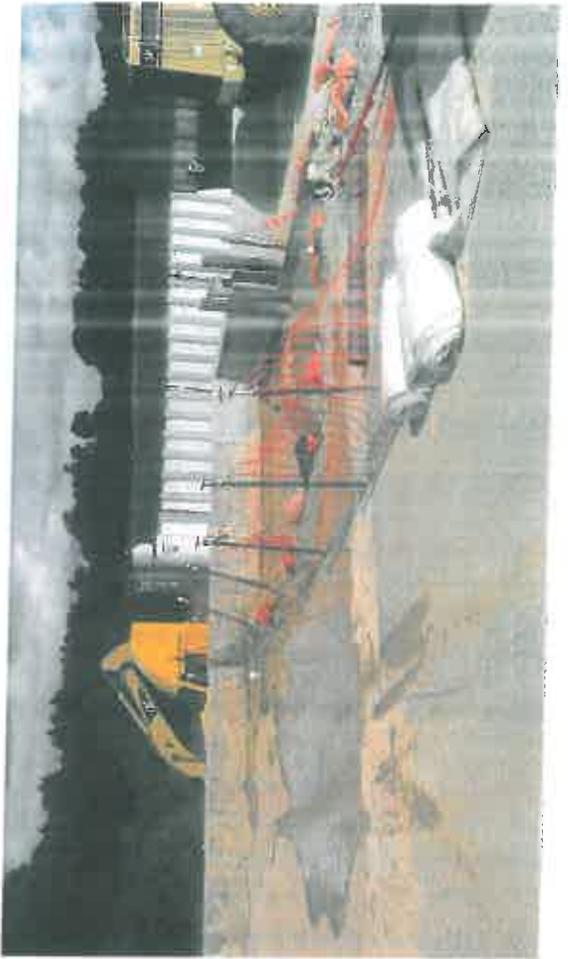
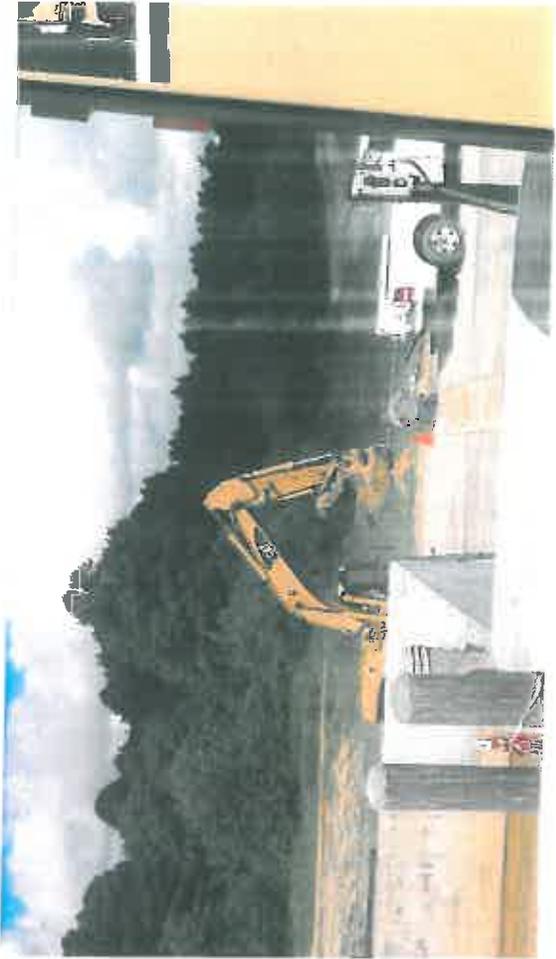
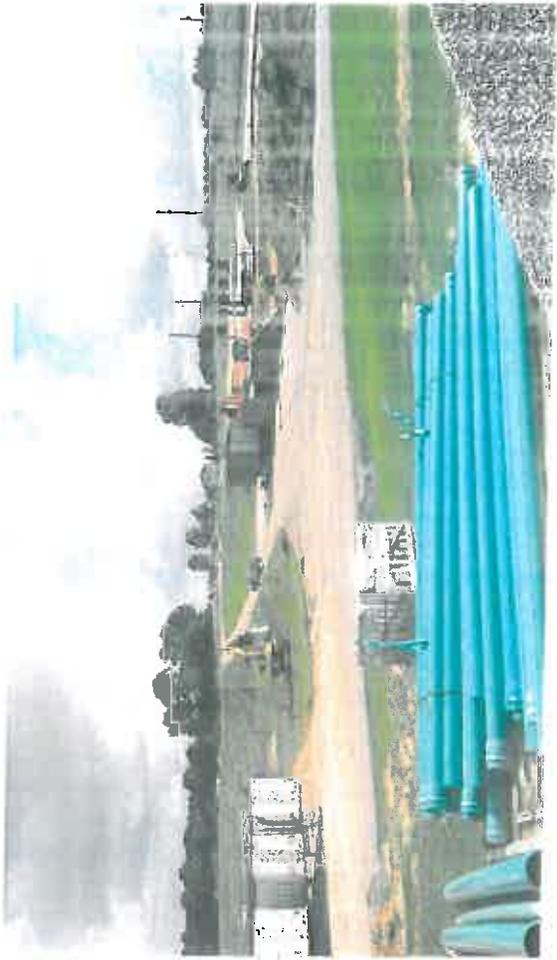
Arrived at 8:30 am. Met with Randy Smith and Ralph Barile at the convenience center. Discussed the upper north end. There is a hole in the existing asphalt that was cut to allow new work to be completed. Currently, this area has not been repaired and is staying full of water. Plans call for area to be asphalt. Ralph indicated the soonest asphalt would be available from his paver is over a month out. Randy indicated the public is voicing complaint with the standing water and mud from this. Randy inquired when concrete could be placed and Ralph indicated as soon as next week. We estimated the cost to be approximately \$1,500 to switch from asphalt to concrete. Measured size of the area is 19'x16' (304 sf or 33.8 sy). Randy stated to proceed on with the change and get this area patched. Randy indicated he would inform Amanda Bader of this decision. In addition, the missing curb section along the entry drive from the scales will be patched at this same time. Randy stated he did not see the need for amount of rebar being placed in the new concrete. He indicated he thought the concrete pavement should be 4 inches thick instead of the prescribed 6 inch section. I stated this was designed to meet the need and intended use.
