SITE VISIT REPORT

Project: Dunn Erwin Landfill CAP Projects

Job No.: 3002B

Location: Dunn-Erwin Landfill, Dunn, NC

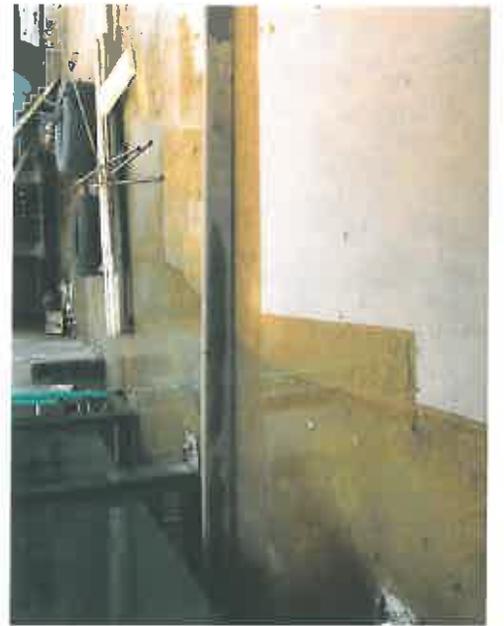
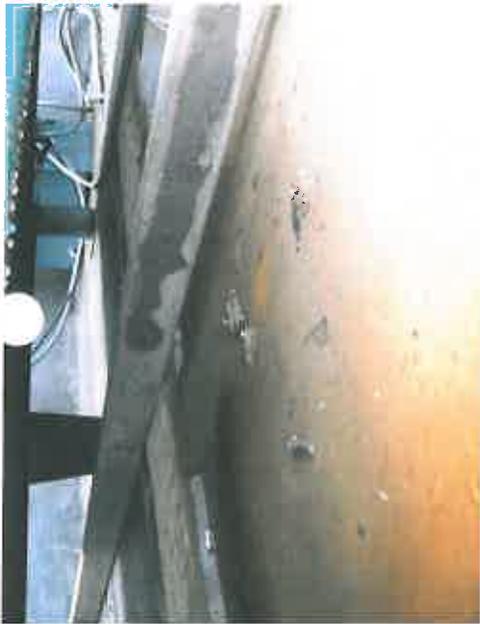
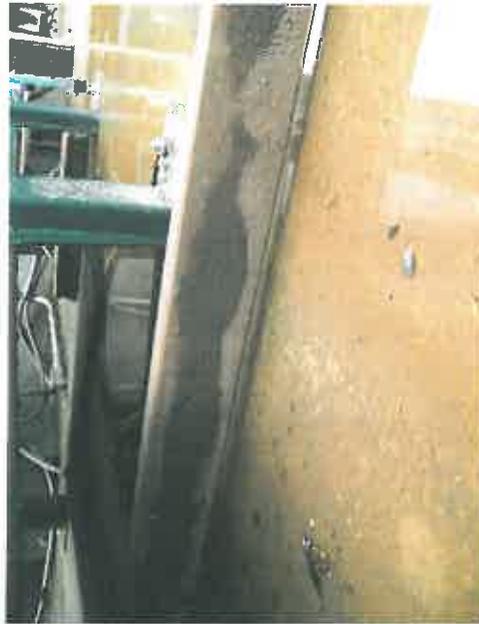
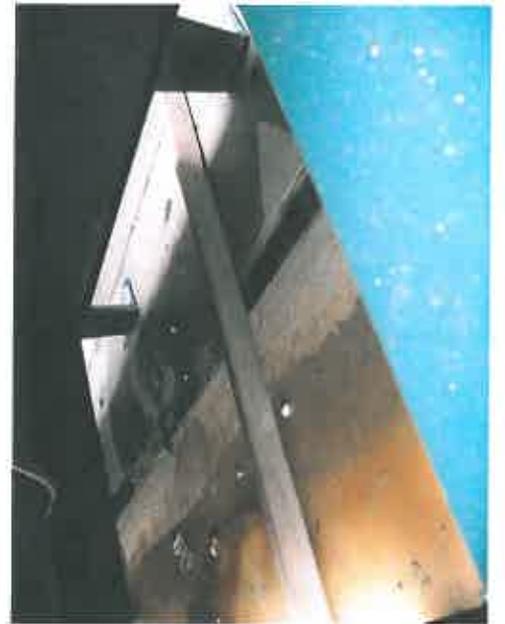
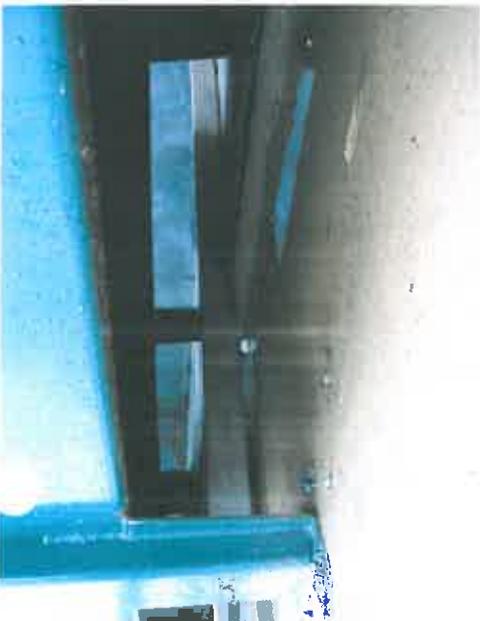
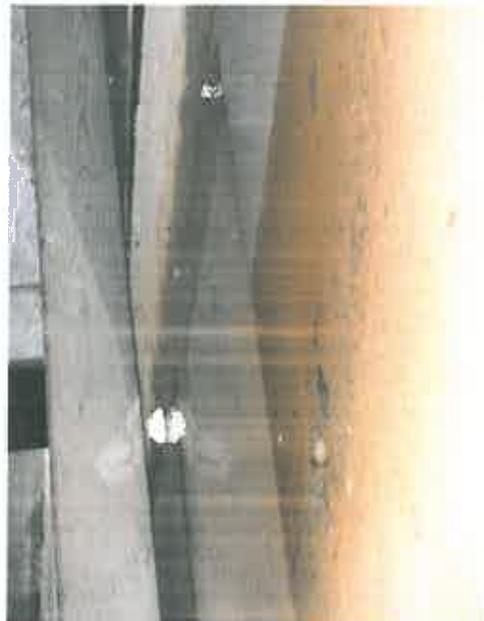
DELF CAP Project

Summary of Activities and Test Results: Mtg. w/Greg on site, removing forms along front wall @ Trnsf. Sta. & grading. Met w/ Frank @ compaction sta. Met w/ Dennis Turlington concern silt dam repair & instal. of fabric in ditch line on Turl. Rd.. Checked vacum line assembly near trnsf. Sta.
See photos, Discussed w/ Tyrus

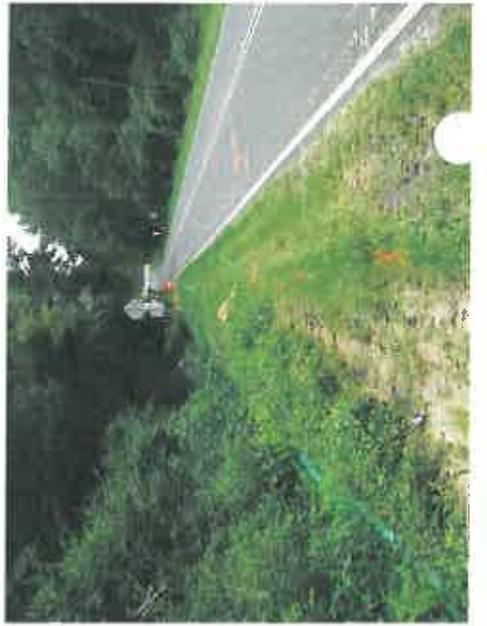
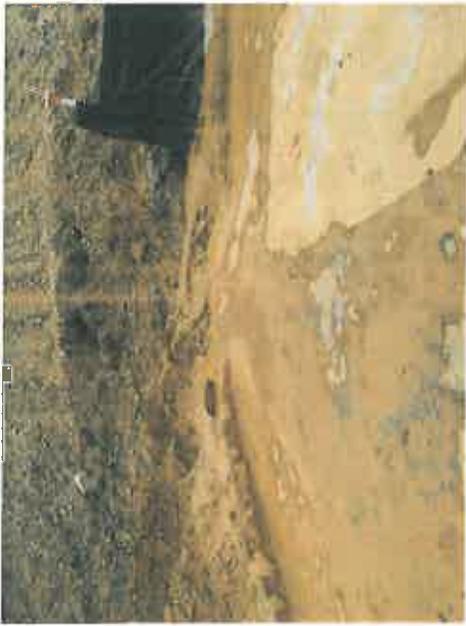
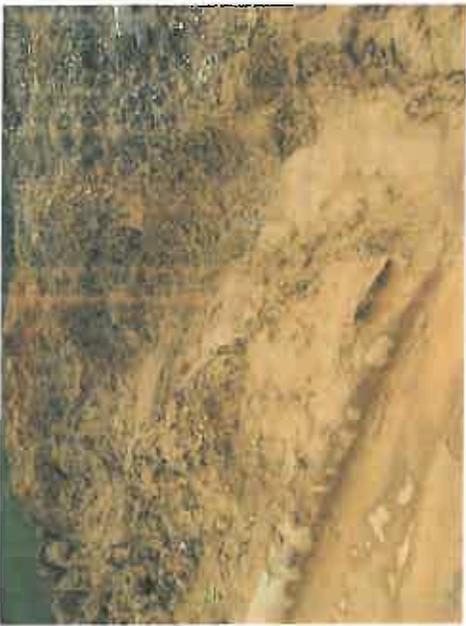
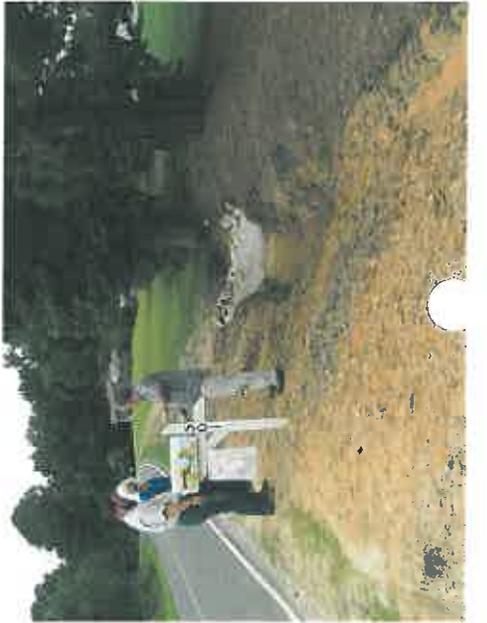
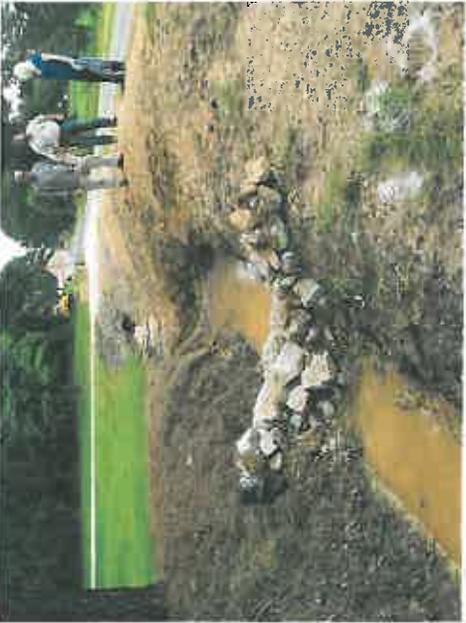
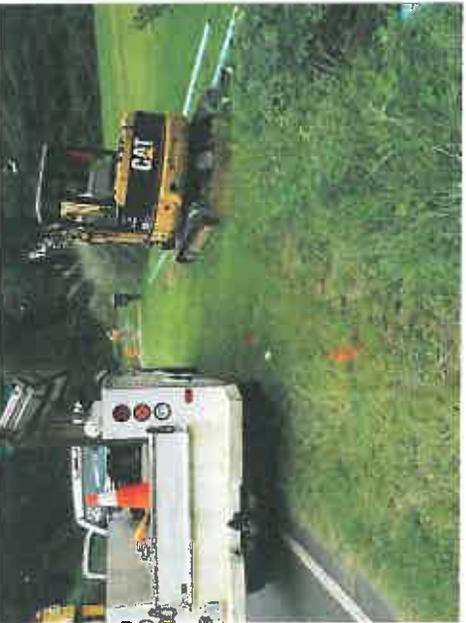
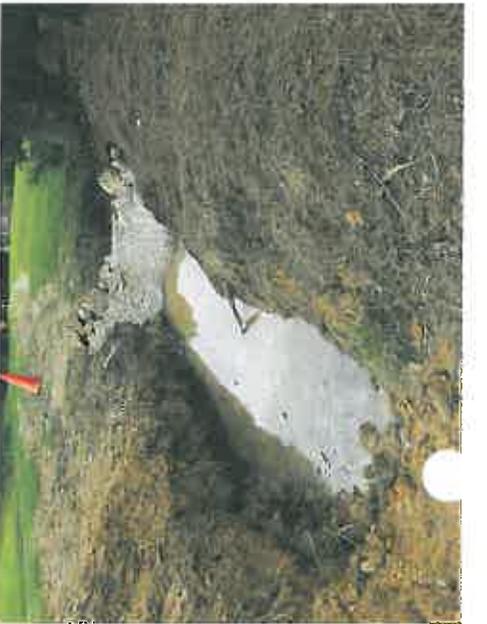
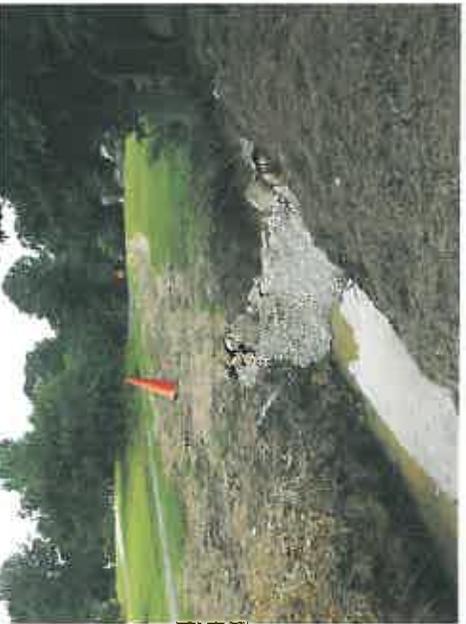
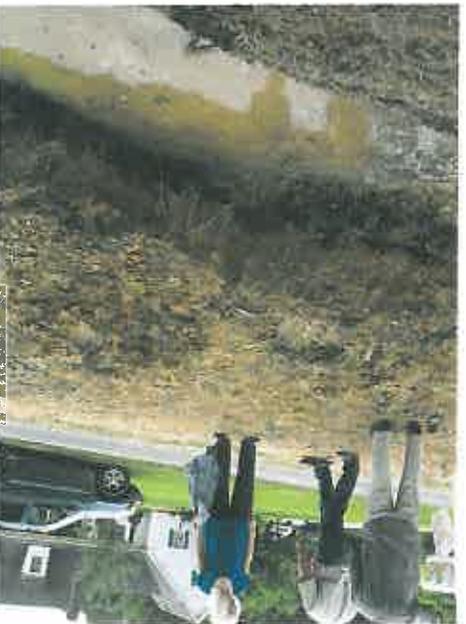
Visited the transfer station to at appoximately 1:15 pm. WECC is currently dismanteling the rear metal panelling to prepare for form of the new 2' thick wall in the truck bay. I discussed the middle perling above the heighth of the proposed wall with Greg and the metal building sub-contractor due to the extensive rust damage. The metal building sub is to find out how they plan to reattach the metal panelling to the new concrete so a decision can be made on if the perling should be replaced. The acid wash of the concrete had been postponed until all concrete surfaces can be acid washed at one time.

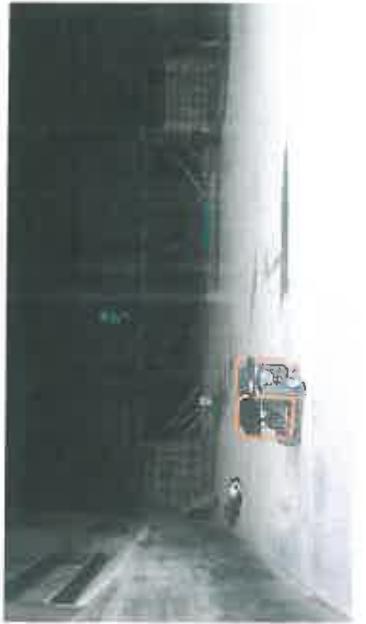
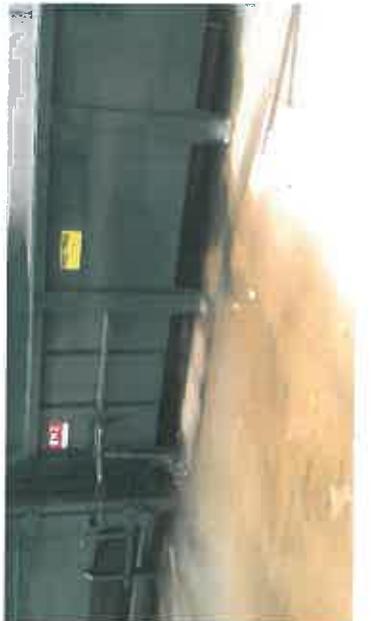
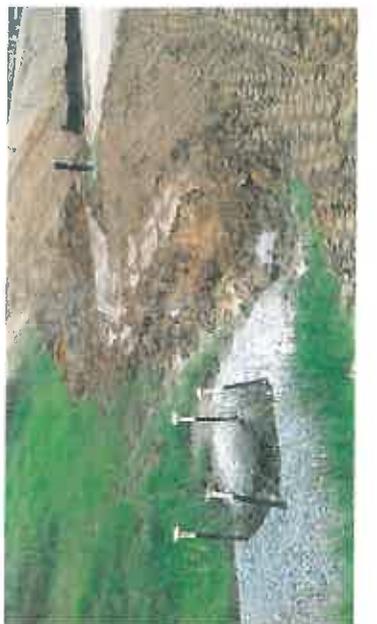
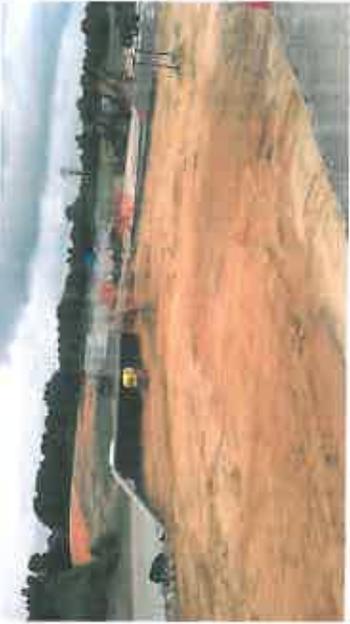
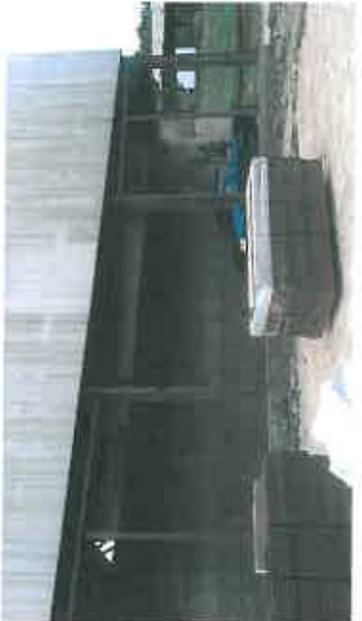
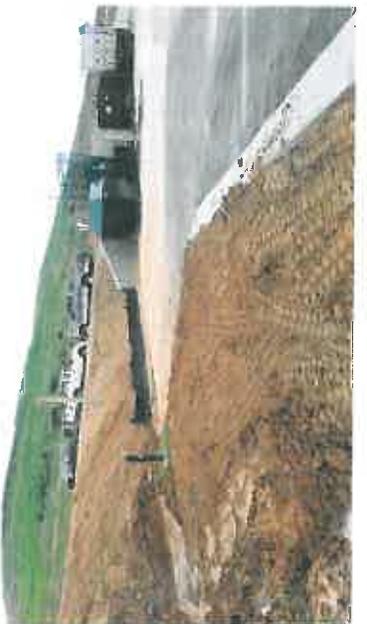
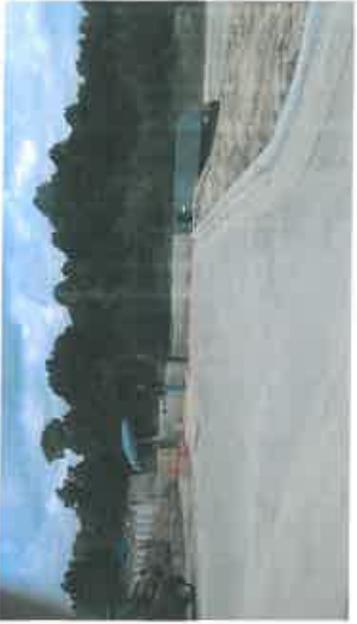
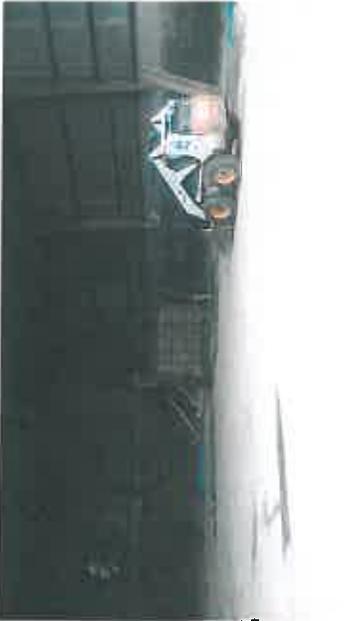
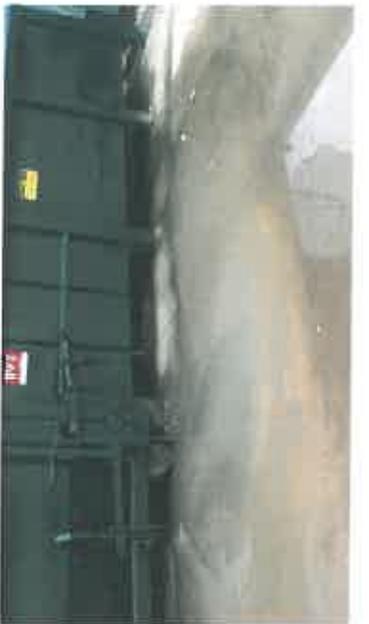
Visited the transfer station to at approximately 1:15 pm. WECC is currently dismanteling the rear metal panelling to prepare for form of the new 2' thick wall in the truck bay. I discussed the middle perling above the heighth of the proposed wall with Greg and the metal building sub-contractor due to the extensive rust damage. The metal building sub is to find out how they plan to reattach the metal panelling to the new concrete so a decision can be made on if the perling should be replaced. The acid wash of the concrete had been postponed until all concrete surfaces can be acid washed at one time. Crews currently installing rebar on wing wall repair.

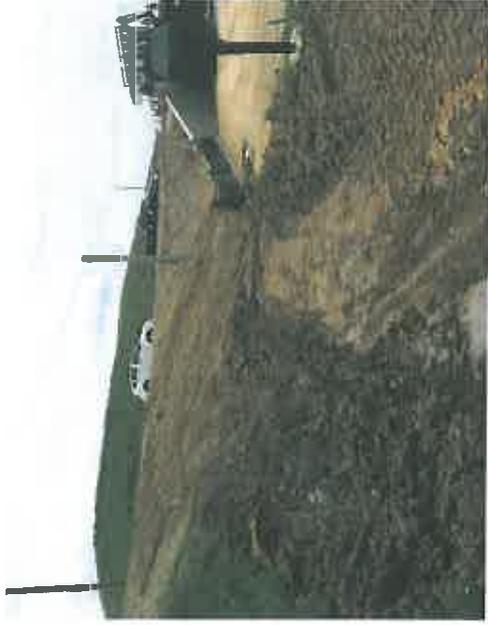
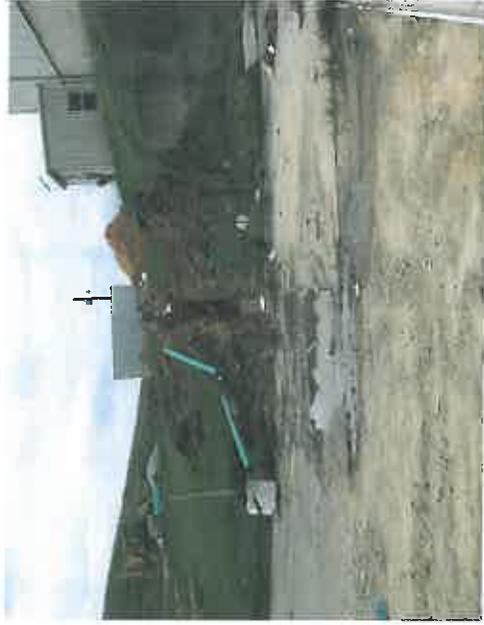
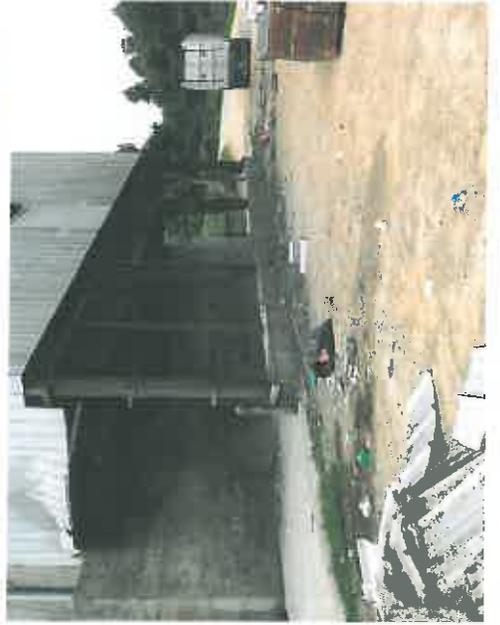
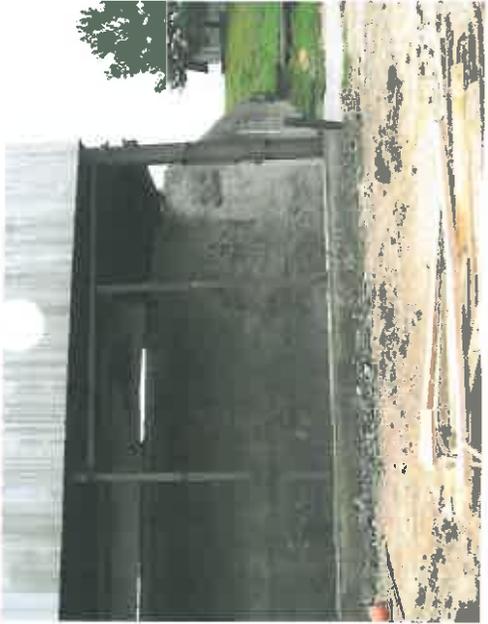
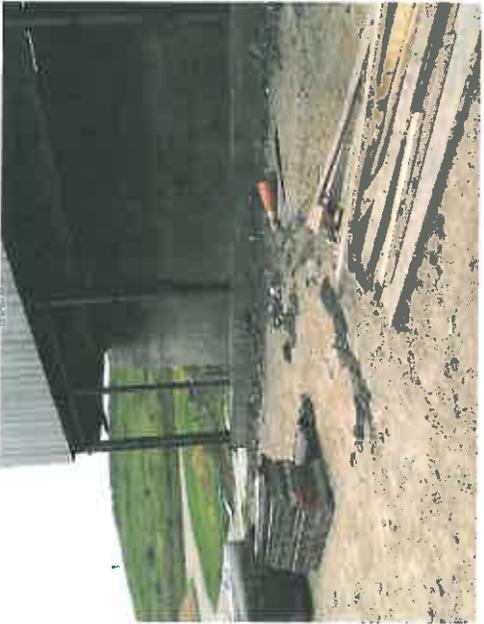
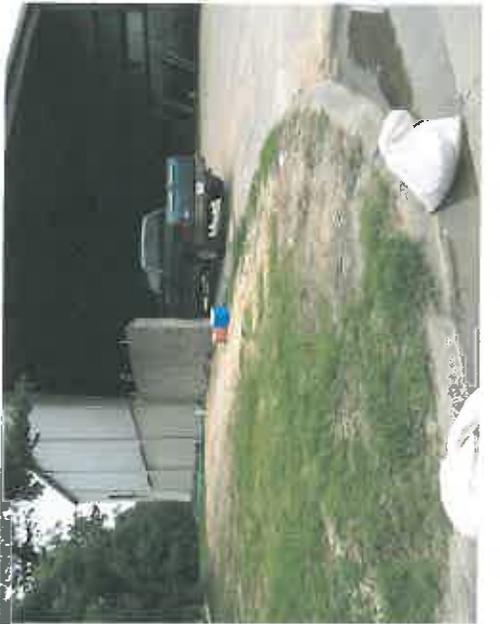
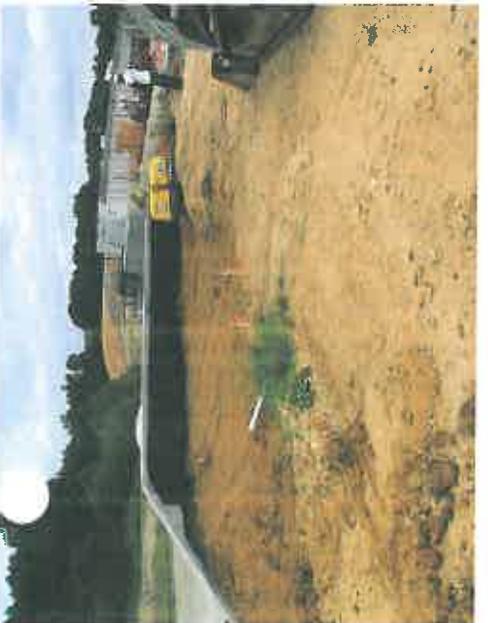
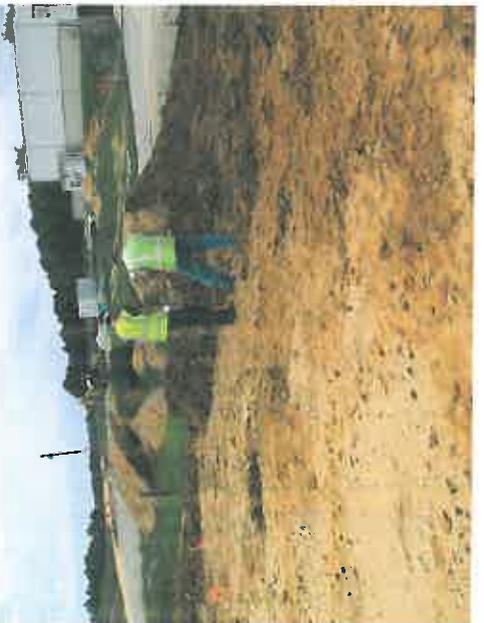
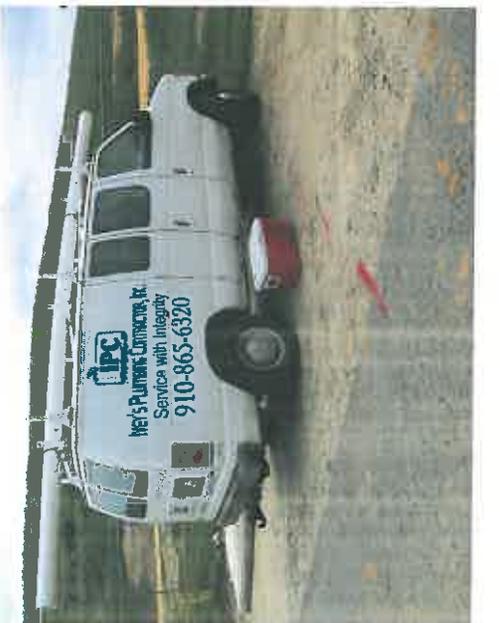
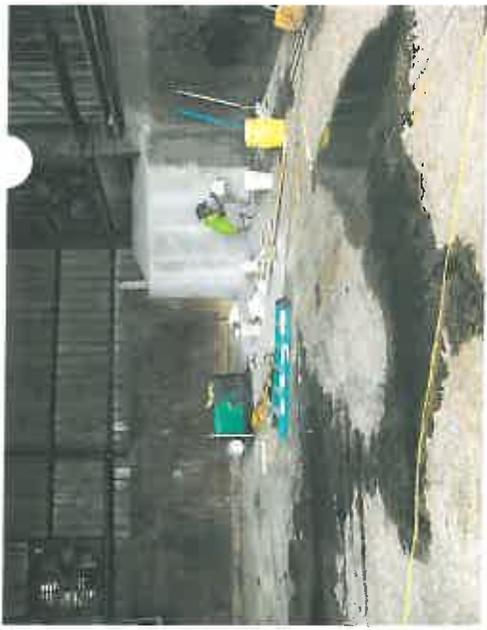
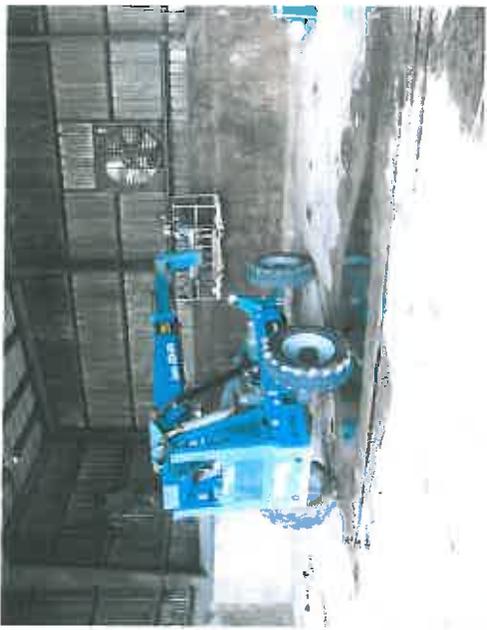
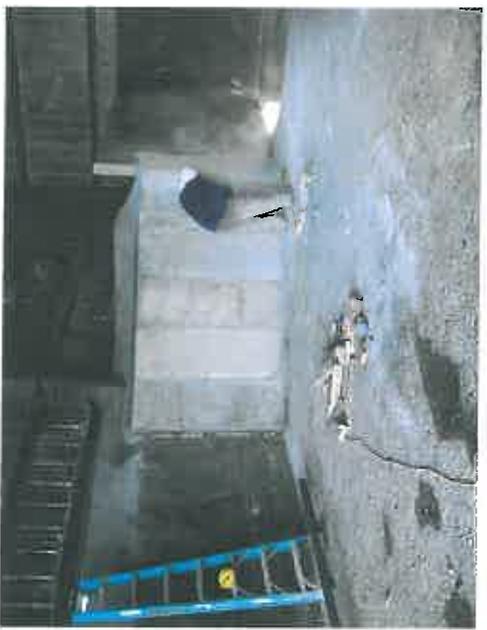
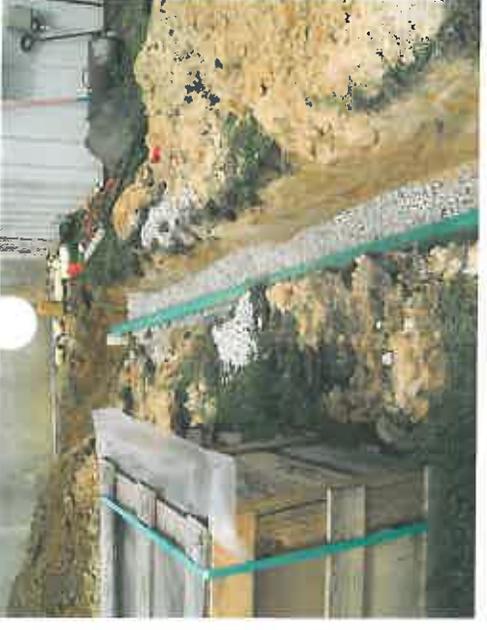
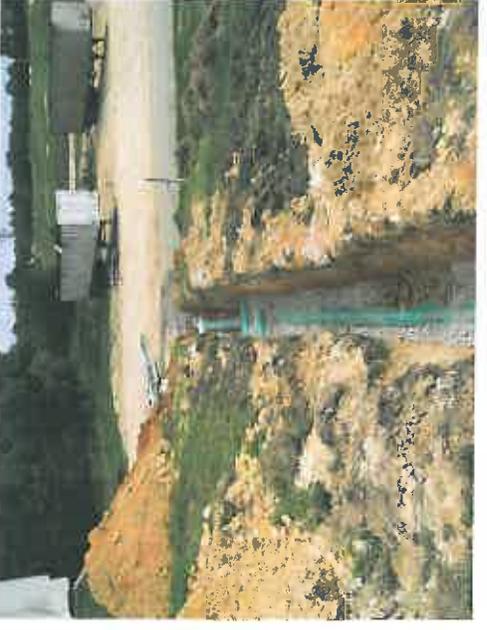
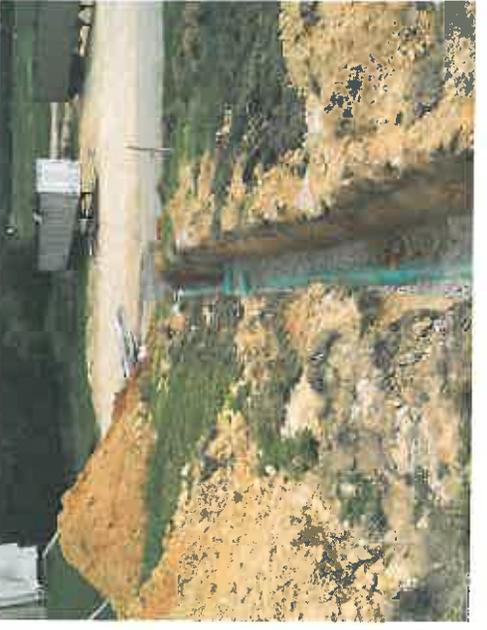
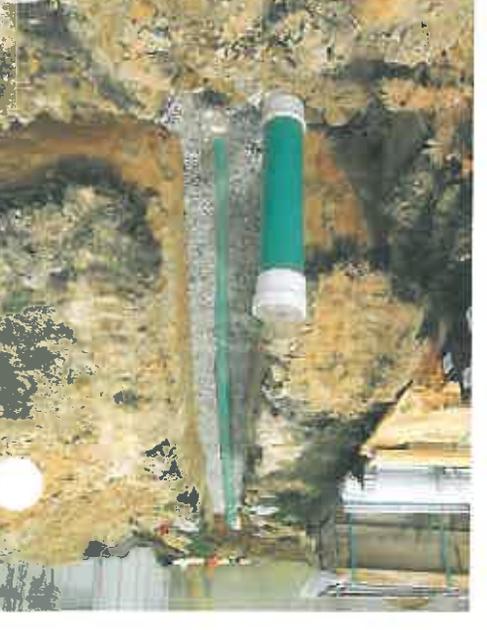
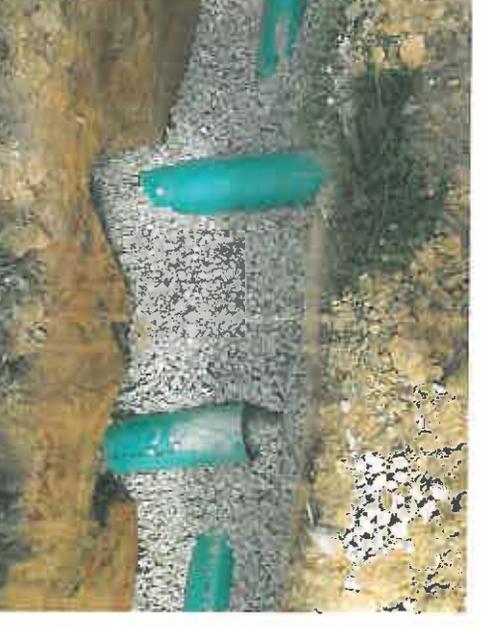
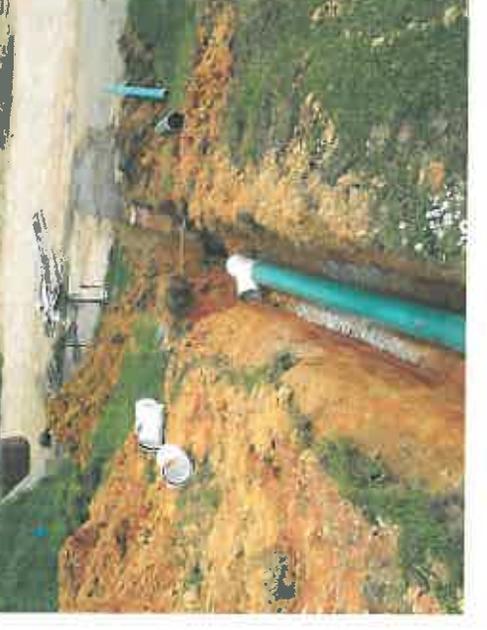
7-11-13

Weather Conditions Cloudy expecting rain, temp. in upper 80's

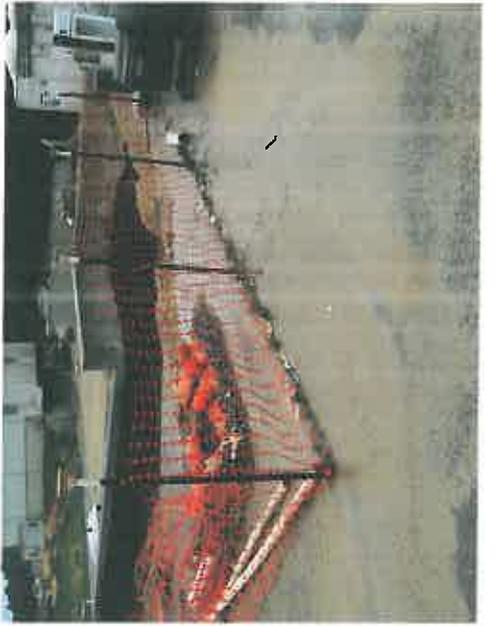
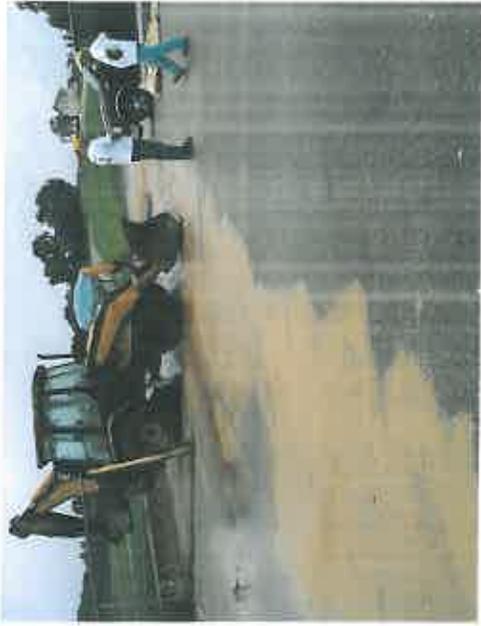
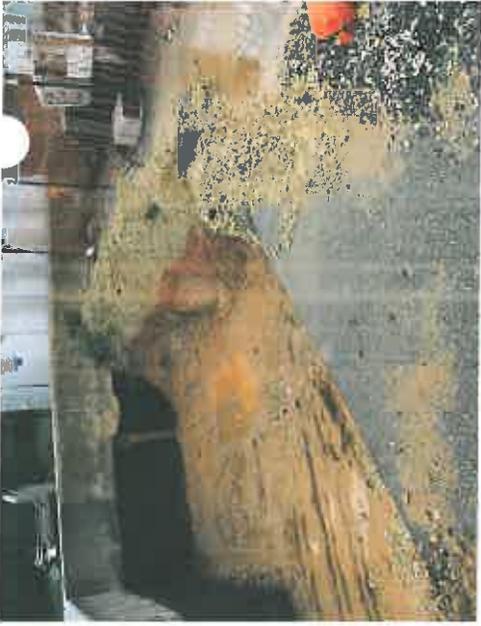
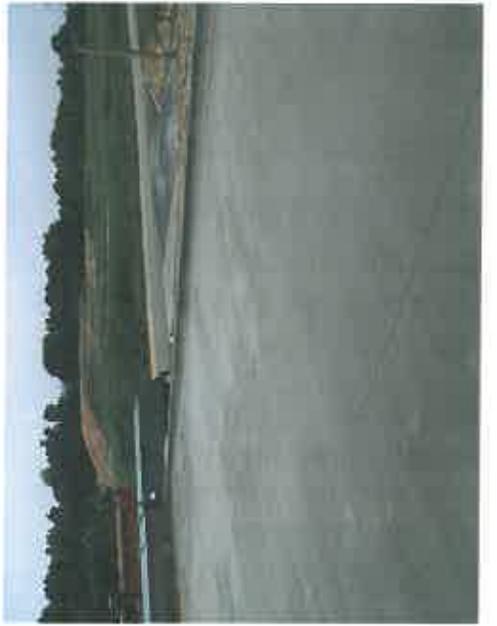
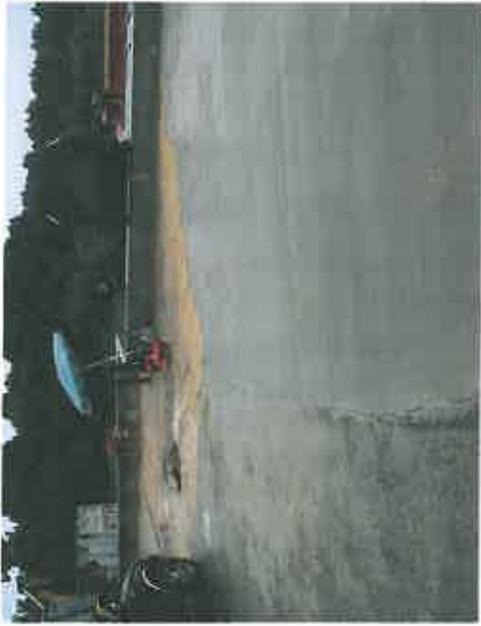
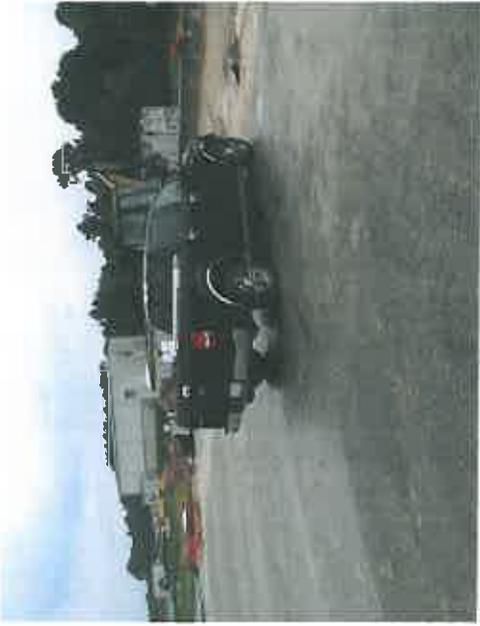
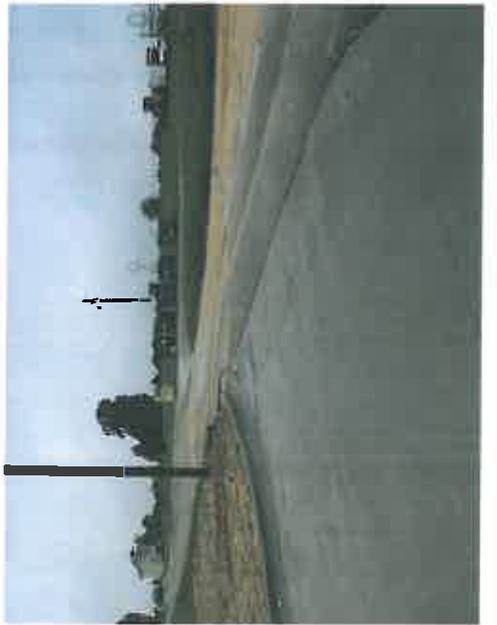
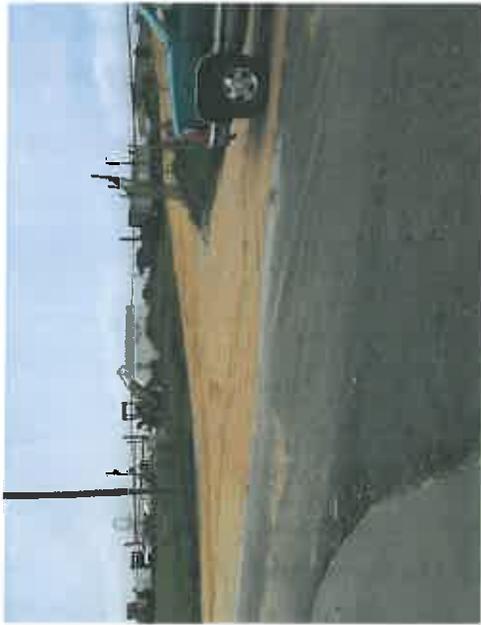
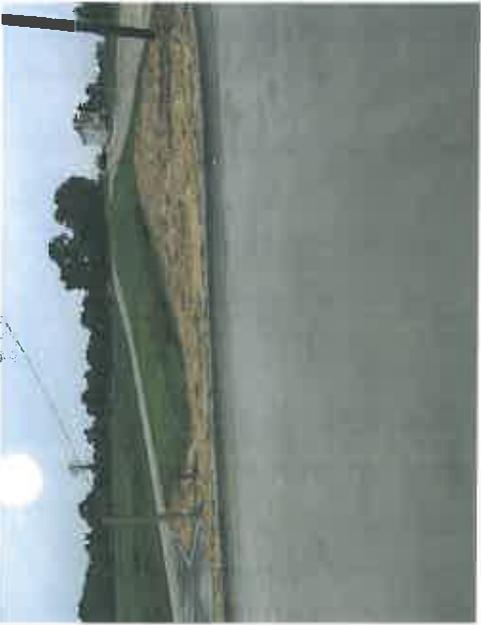
pictures attached.

Visited the transfer station site. Wing wall repairs are complete. Clarrrified with Ralph the specs call for continuous seam weld on the trash bin modifications and repair. Discussed a plate repair on the lower front left corner. I will email out a request for pricing on the plate repair and the needed additional support on bottom rear plating.

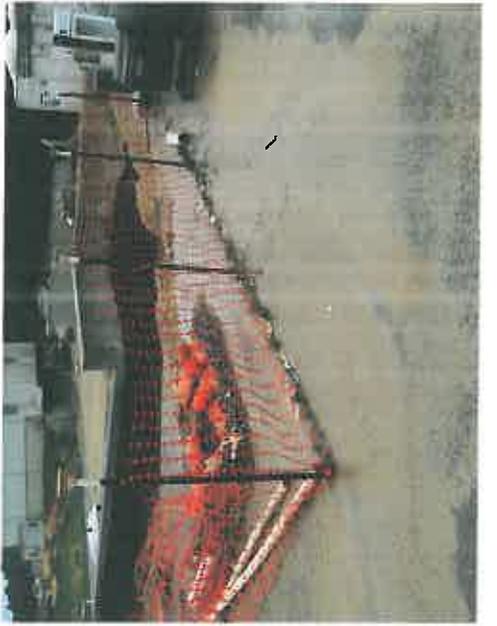
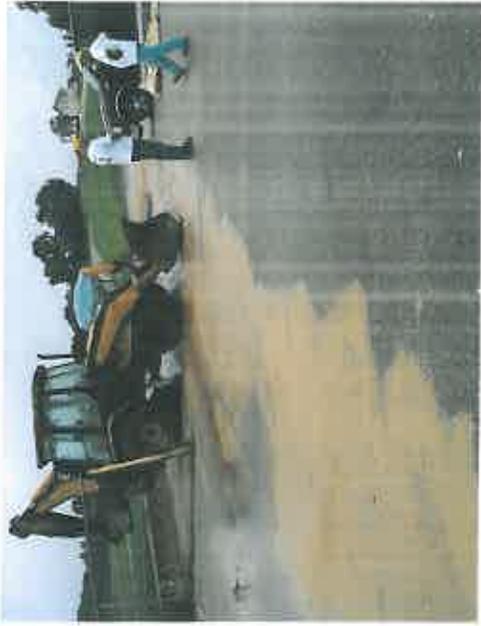
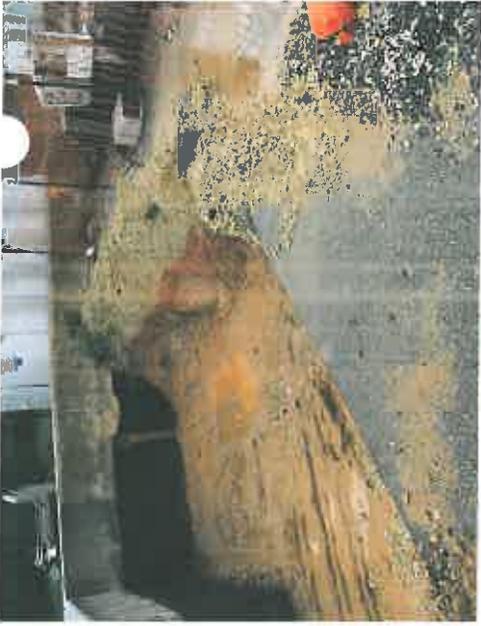
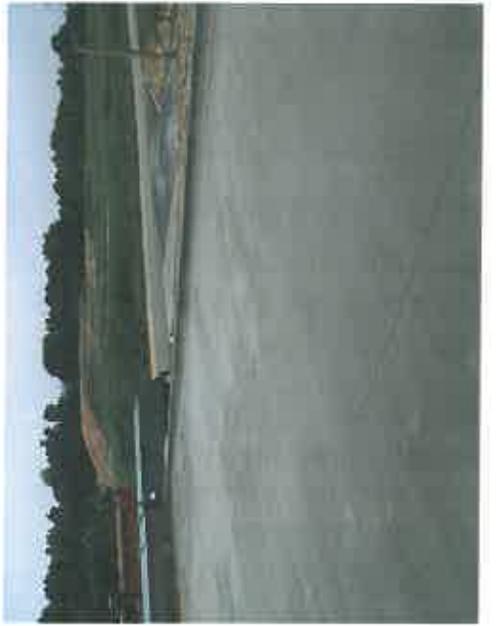
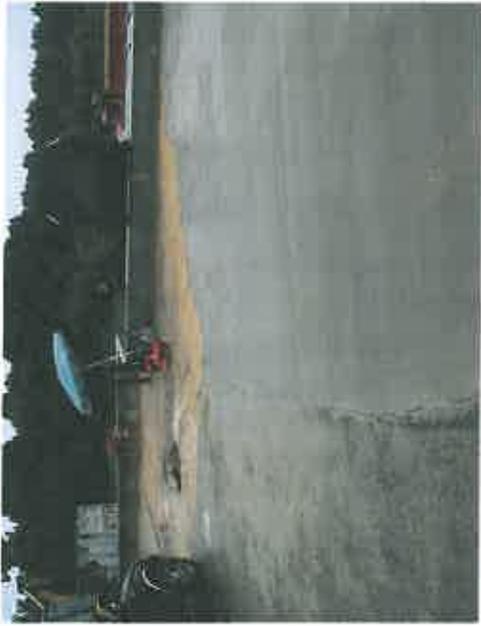
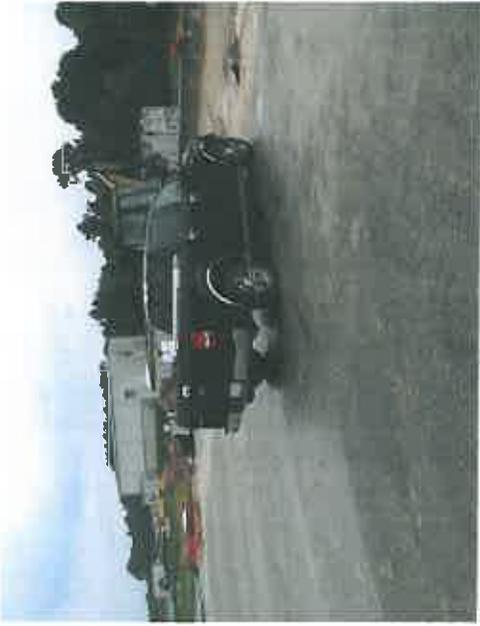
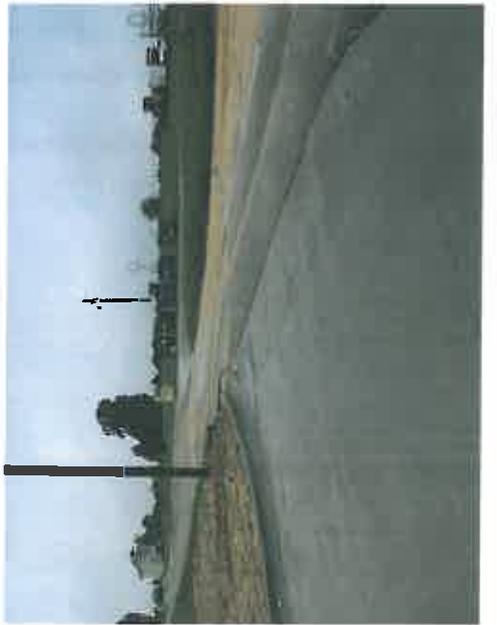
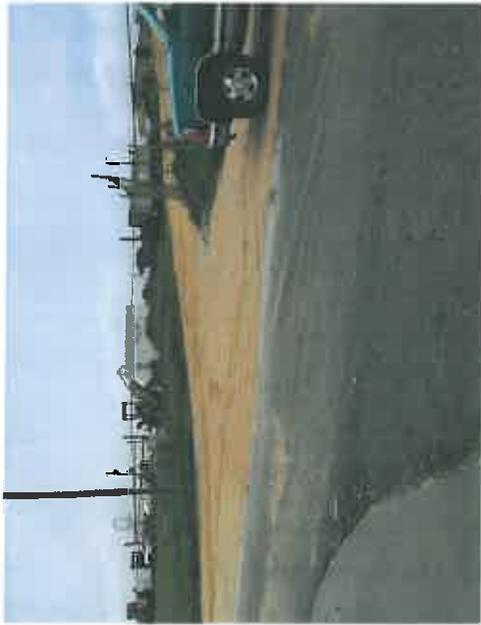
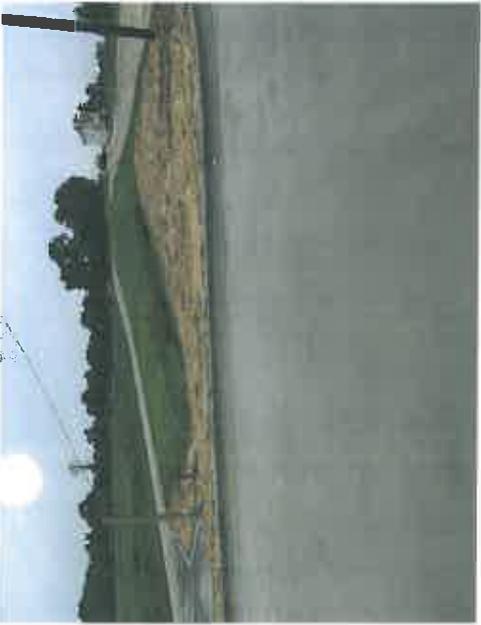
pictures attached.

Visited the transfer station site. Wing wall repairs are complete. Clarrrified with Ralph the specs call for continuous seam weld on the trash bin modifications and repair. Discussed a plate repair on the lower front left corner. I will email out a request for pricing on the plate repair and the needed additional support on bottom rear plating.

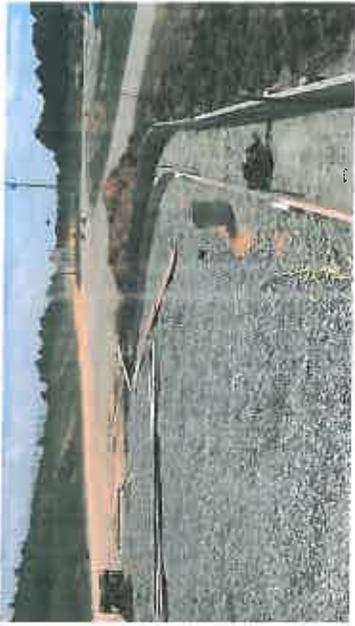
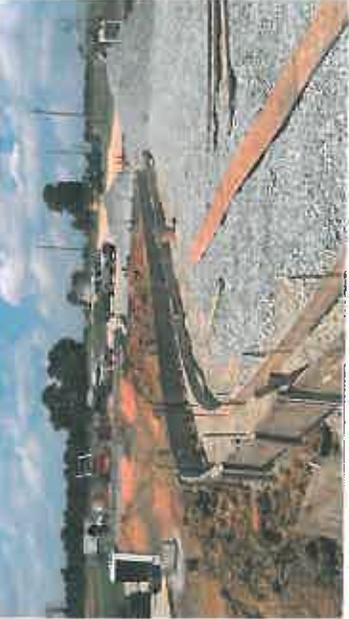
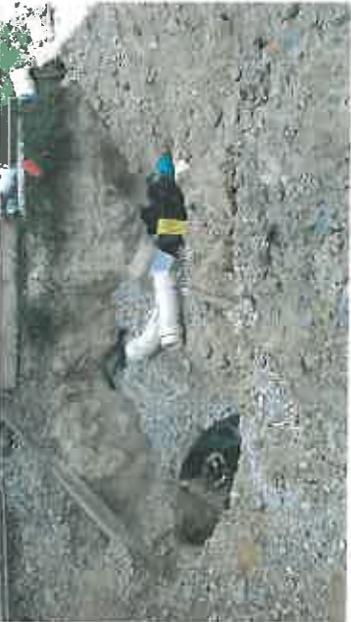
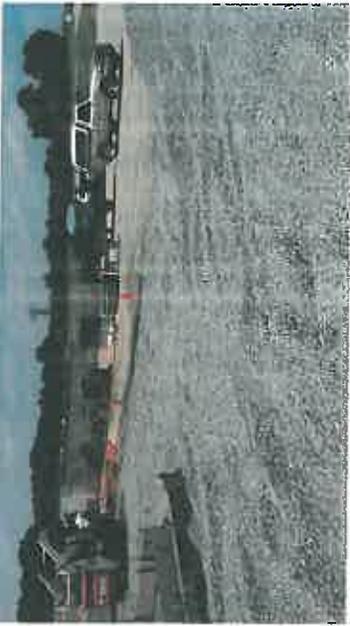
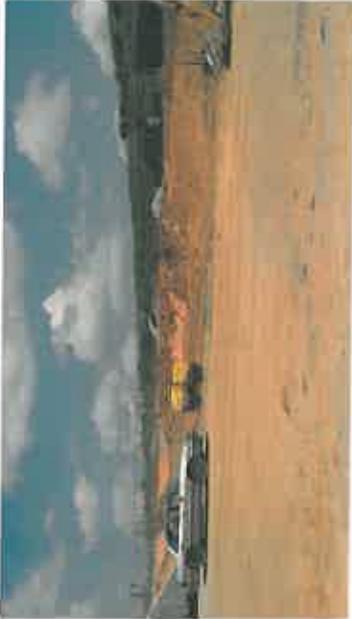
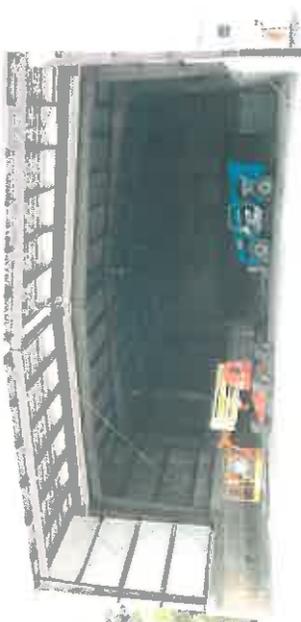
Visited Transfer Station with Ralph. Discussed the concrete diversion berm at the apron approach. Ralph to find out from Randy where to mount light switches. Discussed grading out the sidewalk and door pad for proper drainage. Randy mentioned previously during my visit on obtaining a price for repairing above haul truck door on both sides.

Field Order and RFP to be issued for south upper slab modifications, compactor drain modifications, hose bib addition, and Transfer Station Haul Truck door repairs.

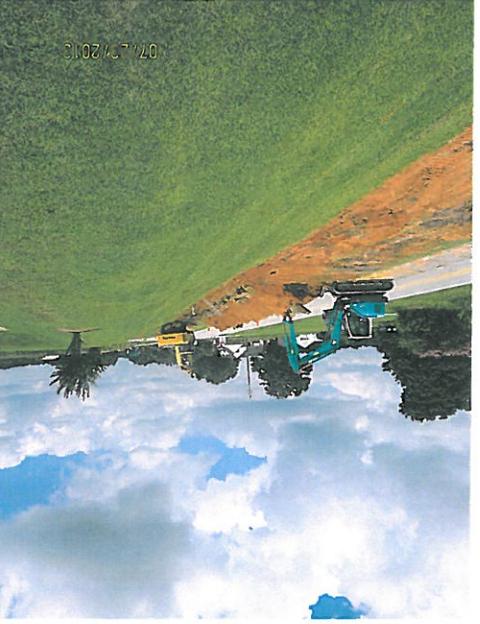
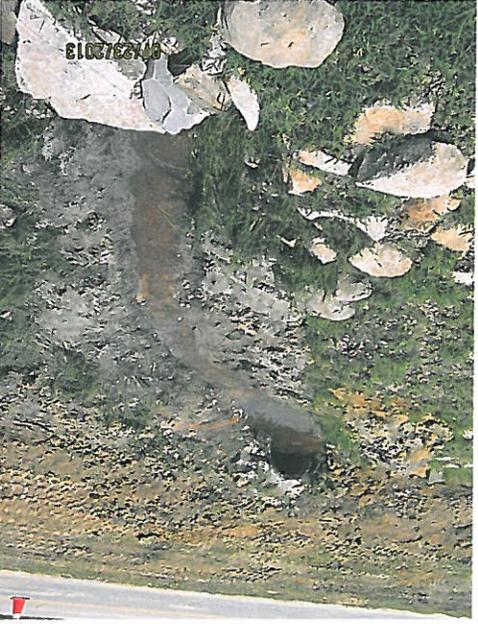
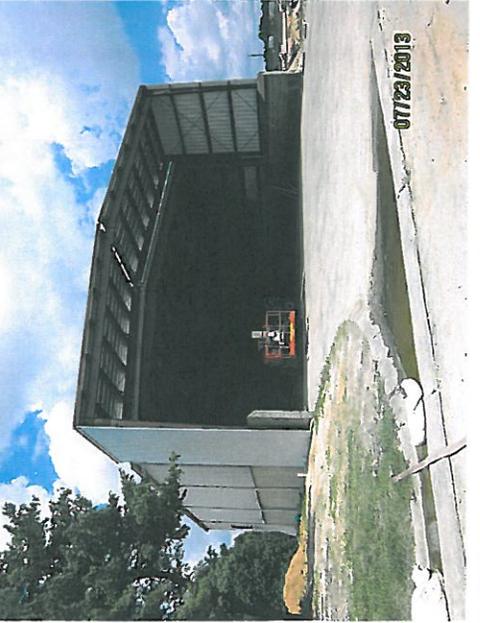
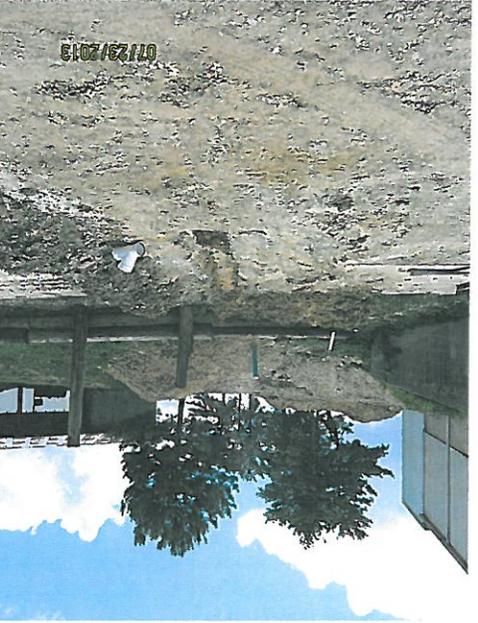
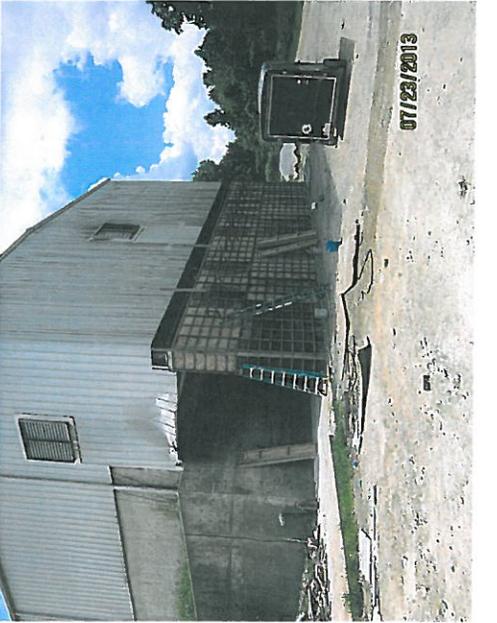
Met with WECC's Ralph and discussed the progress of the Transfer Station and Convenience Center projects. Discussed the stop work order on the South end of the convenience center sent out this morning. Concrete should be poured this week on the tipping floor overhang repair. Metal building extension should be completed and electrician brought in this week.
