SITE VISIT REPORT

Project: Dunn Erwin Landfill CAP Projects

Job No.: 3002B

Location: Dunn-Erwin Landfill, Dunn, NC

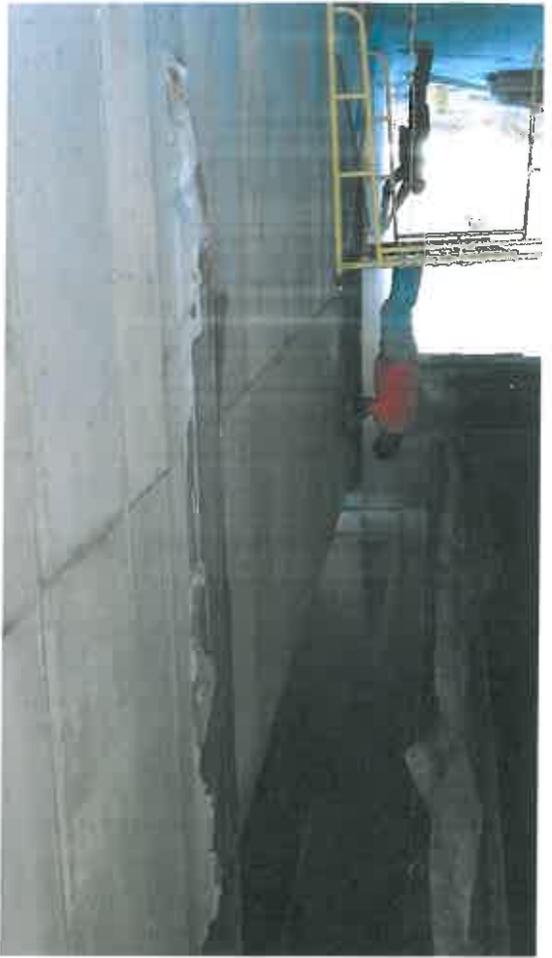
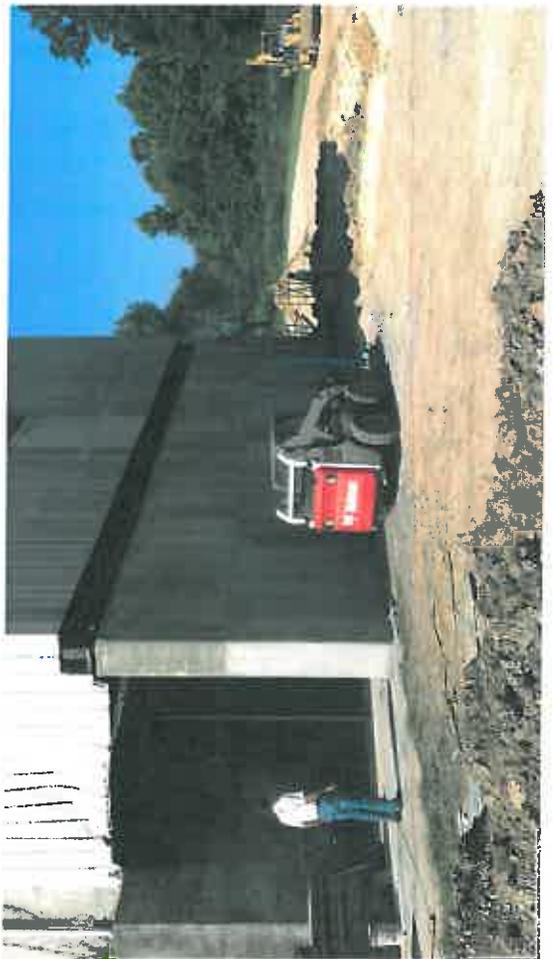
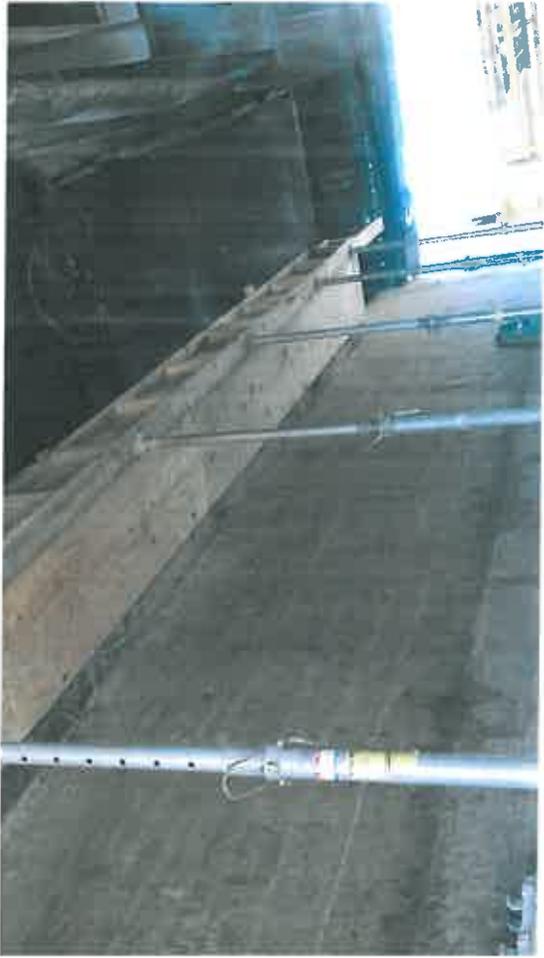
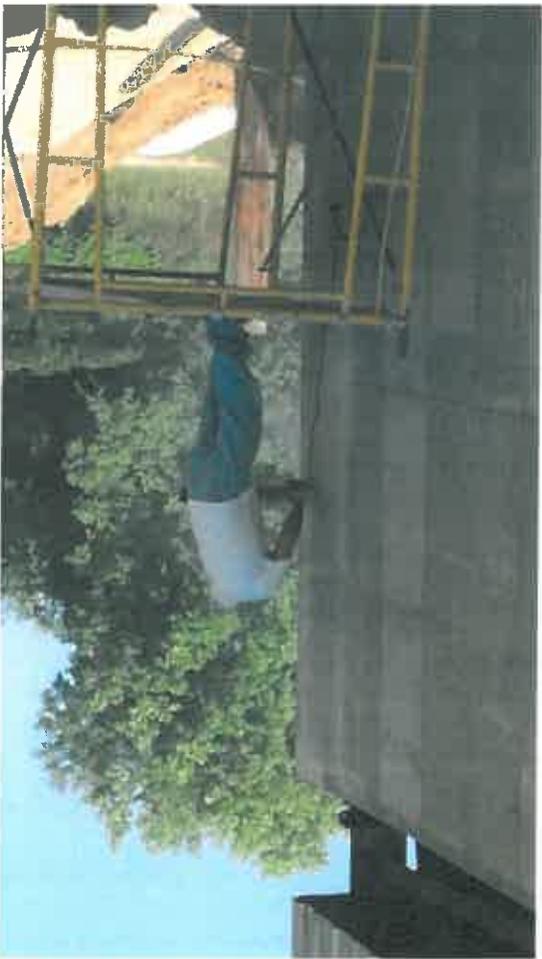
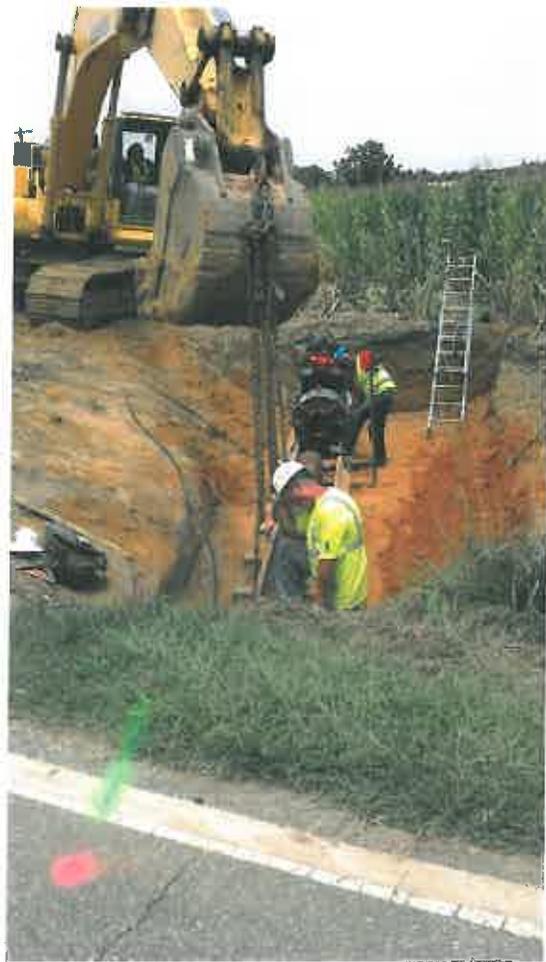
Arrived onsite at approximately 9:45 am. Crews working on cleaning lower wall pour at transfer station. Upper tipping floor repair has been poured. Work continues on metal building trim out.

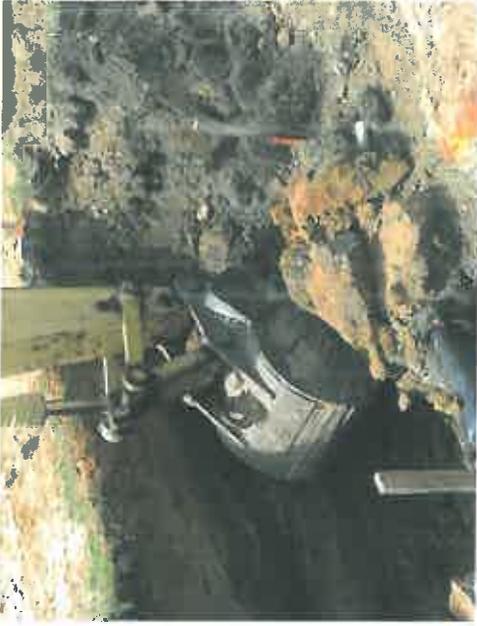
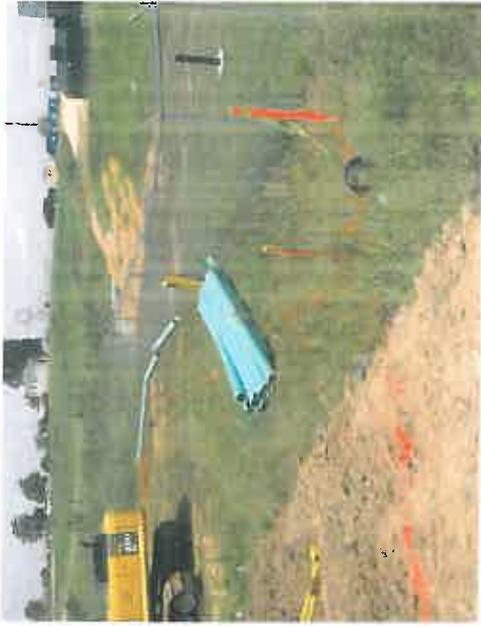
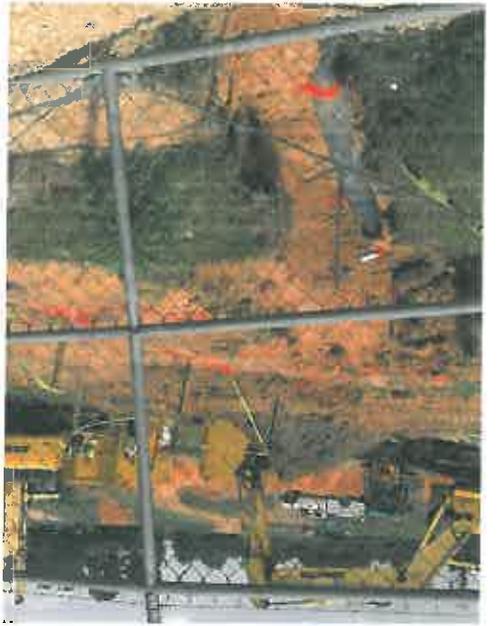
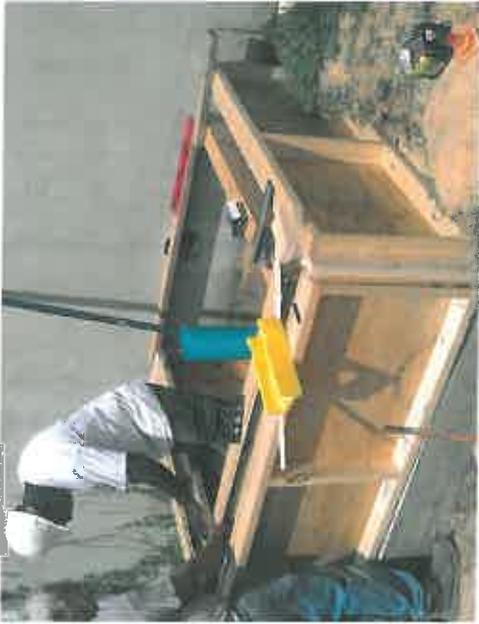
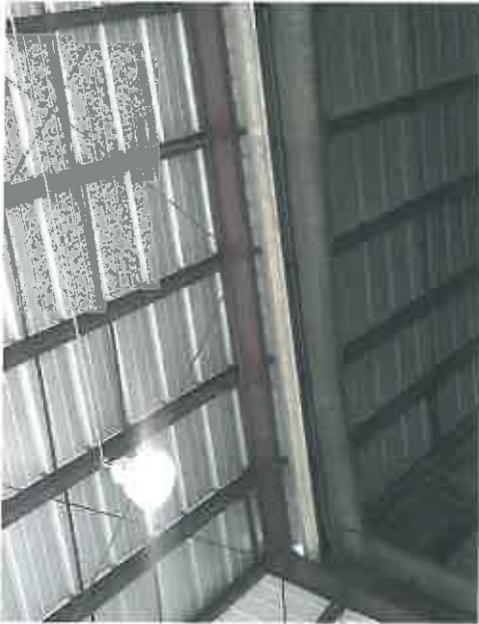
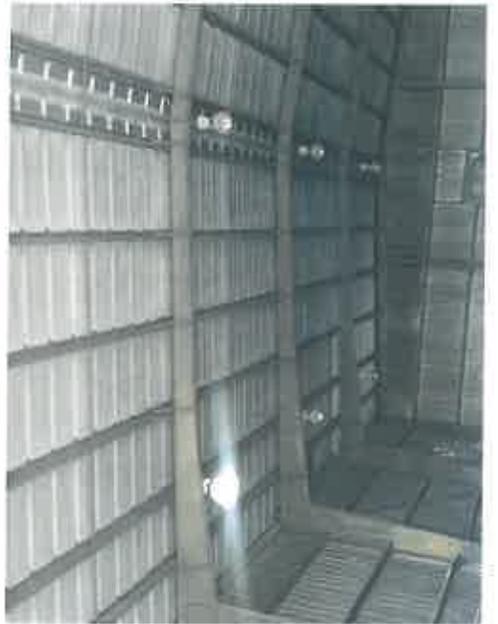
I met Amanda, Randy, Ralph and Vicki Payseur at the Transfer Station. The upper tank was completely full from the concrete washing and acid wash activities currently occurring. Vicki indicated the pH was at 6.2. We noticed the current wash water was escaping the lower berm where it was cracked and previously sawn and discharging across the access road. Vicki tested the pH in the road side ditch as 6.17. Based on these results, no pH buffer is necessary prior to hauling the tank water to the WWTP. WECC was constructing the floor drain enclosure form work on the outside of the building. The concrete subcontractor was beginning to place wire mesh on the floor. The new building lights were operational but none of the old lights were working. Discussed with WECC and Amanda trying to find out what kind of bulb was needed to replace the old ones. Plumbing subcontractor continuing to work on floor drain piping.
