FACILITY COMPLIANCE INSPECTION REPORT
Division of Waste Management
Solid Waste Section

FACILITY NAME AND ADDRESS:
 Jackson County MSW & C&D Transfer Facility
 Scott Creek Transfer Station
 48 Recycle Place
 Sylva NC 28779
 828-586-7509

PURPOSE OF SITE VISIT:
 Comprehensive Inspection of MSW Transfer Station

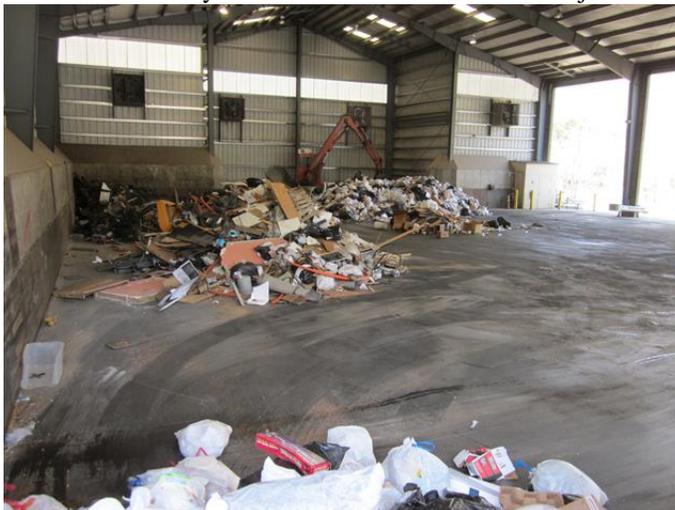
10. The transfer station was observed in operation. Smaller loads and private individuals have access to a separate area from large commercial haulers to place waste for transfer.
11. The tipping floor was observed as being in very good condition. There was a lot of waste on the floor during the inspection due to truck maintenance. **It is required by Permit 5003T, Operating Conditions 8(a) & 8(b) that the tipping floor must be cleaned at least daily and waste not be stored on the tipping floor after operating hours. Waste may be stored on on-site in water-tight covered trailers for a maximum of 24 hours or a maximum of 72 hours when the facility is closed during weekends or holiday.** Any leachate resulting from the waste on the floor was collected by the drain which flows to the leachate collection system. No noticeable vectors or objectionable odors were observed.

Tipping floor as seen from the non-commercial disposal area

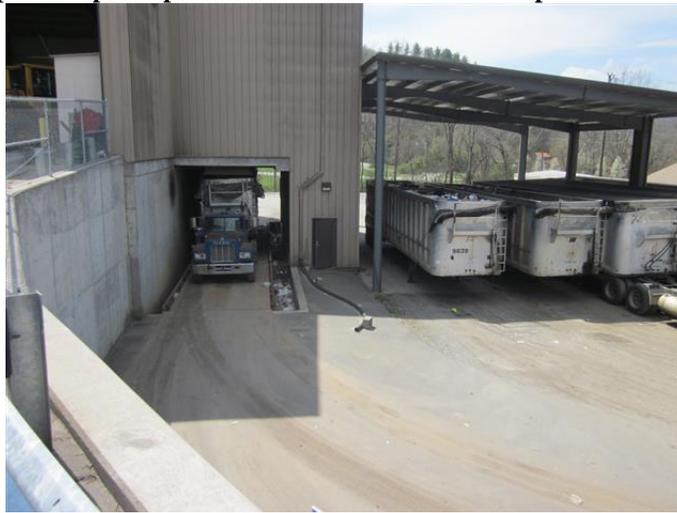
shed until removal by a contracted trucking company. The shed is paved with concrete which has a drain that is connected to the leachate collection system. The drainage system grate across the entrances appeared to be in very good condition. **There was debris located around the semi-trailers that appear to have been fallen in the process of loading the trailers. These must be picked up and placed in the trailers for final disposal before the end of the day.**

Semi-trailer in loading and covered storage area

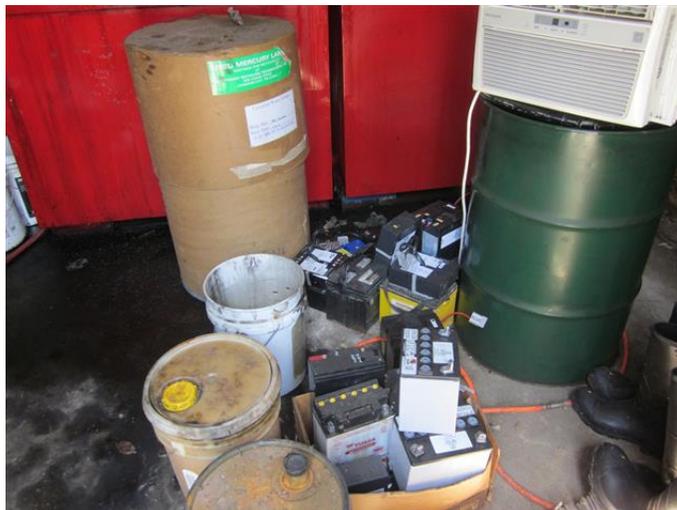
14. The former transfer station was being used as the cardboard and paper collection area. This area had a some debris on the ground. This area must be maintained this area in a clean and sanitary manor.
15. The tire, battery, white goods and metal collection area was observed located on a concrete surface. No batteries were observed. The white goods were stored upright. The removal of Freon is done by a contractor. All tires were observed stored in a semi-trailer.

Used battery collection area

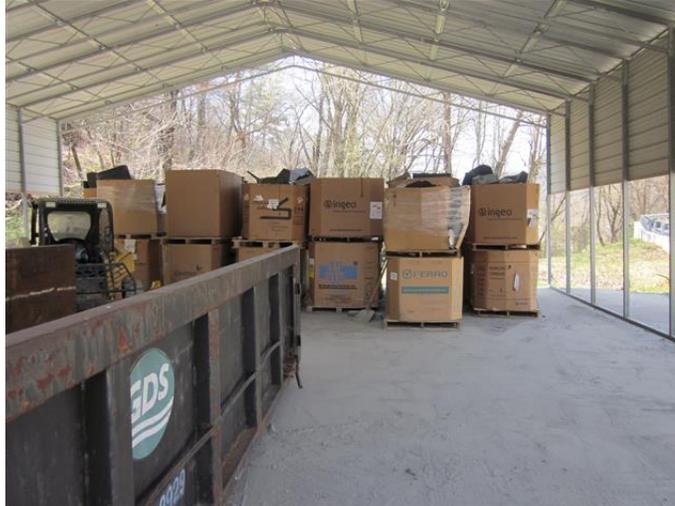
19. There was an electronics collection area that appeared well managed and covered.

Electronics in cardboard boxes awaiting recycling

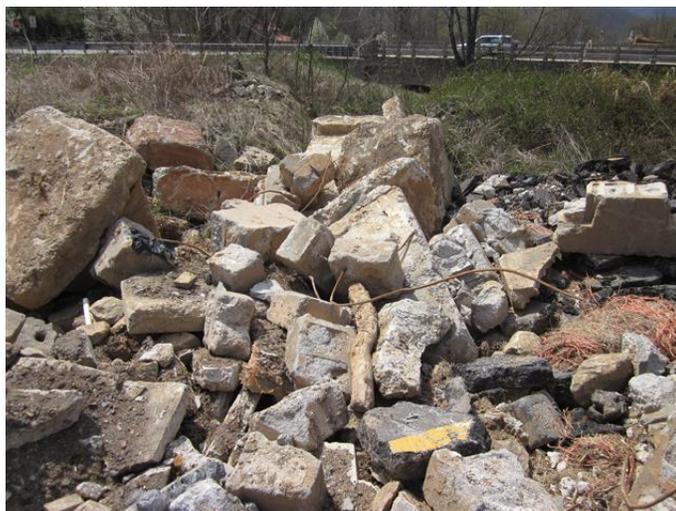
18. The facility is permitted to accept yard trash; however, none was present during the audit.
19. There is an area that is managed for beneficial fill that was observed. **Metal was observed sticking out of the concrete along with small amounts of wood, hay and hay bailing twine. North Carolina Rules require that beneficial fill is limited to concrete, brick, concrete block, uncontaminated soil, gravel and asphalt; all other material must be removed.**

Beneficial Fill Area with metal, wood, hay and bailing twine
