**FACILITY COMPLIANCE INSPECTION REPORT**  
**Division of Waste Management**  
**Solid Waste Section**

**Date of Site Inspection:** February 7, 2013      **Date of Last Inspection:** April 11, 2011

**FACILITY NAME AND ADDRESS:**  
 Johnston County MSWLF, Closed MSWLF and CDLF  
 680 County Home Road  
 Smithfield, NC 27577

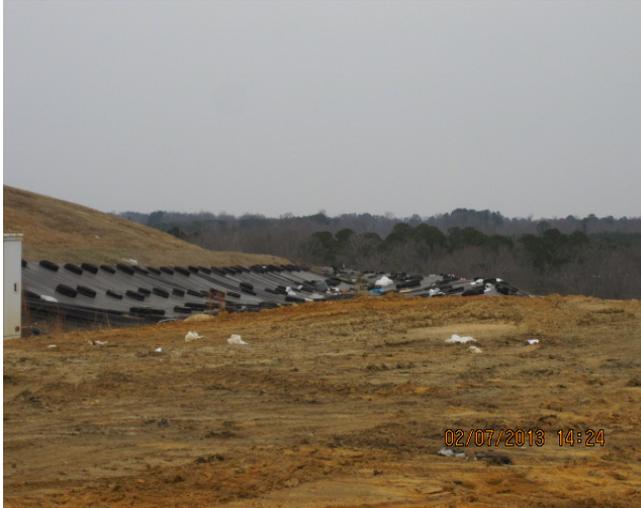
7. There was quite a bit of windblown observed, due to the recent high winds. There were two people seen picking up windblown.
8. Mr. Proctor stated that the C&D landfill is taking in less than 100 tons a day. The MSW landfill is averaging 230 tons a day. Days that auto fluff is brought in, the tonnage at the MSW landfill increases to approximately 300 tons per day. A demonstration ADC is starting at the MSW landfill. The auto fluff was not brought in or being used as ADC, during this inspection.

Windblown waste

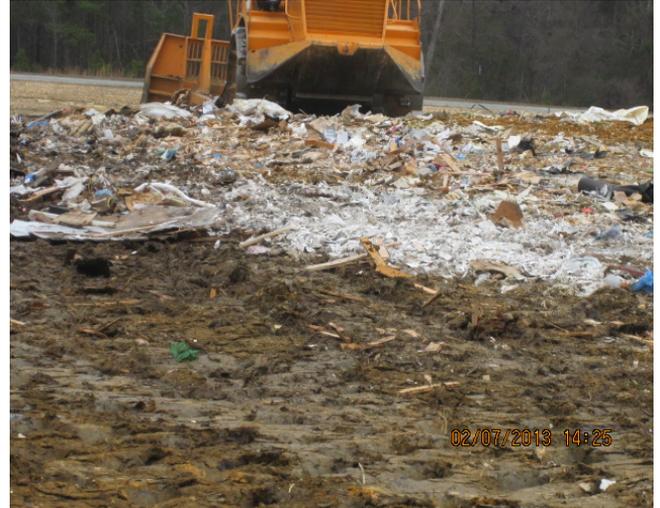
1. The working faces at the C&D and the MSW landfills were kept small and appeared to be well compacted with no unacceptable wastes observed.
2. **Cover is needed in an area to the west of the working face at the MSW LF to prevent the exposure of waste.** Soil was being brought to this area during the inspection. **Insure that all waste is covered with a minimum of 6 inches of soil.**

Working face at C&D

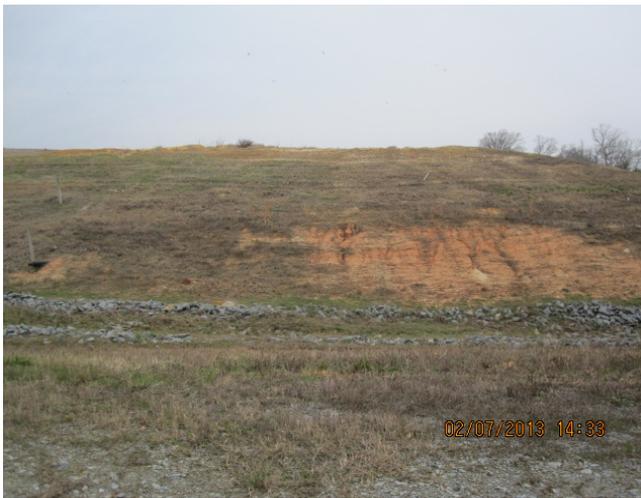
5. There are some bare areas on perimeter side slopes and just a few areas of slight erosion were noted. Mr. Proctor stated that these will be repaired and a reseeding of all cells will be happening this spring.

One of areas with erosion needing repair

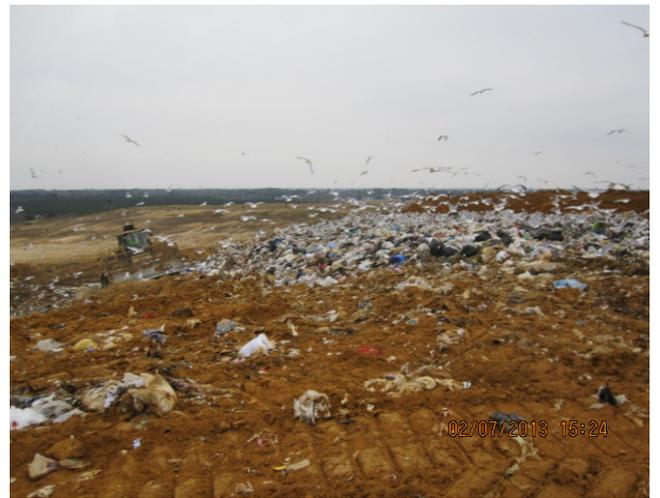
Working face of MSW LF

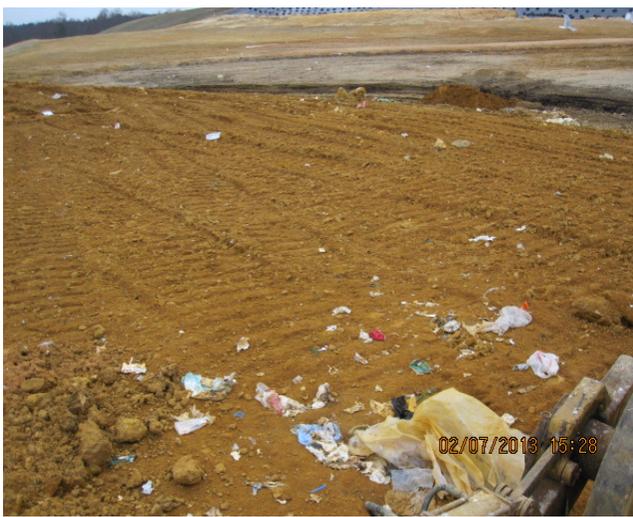
Uncovered waste at MSW LF

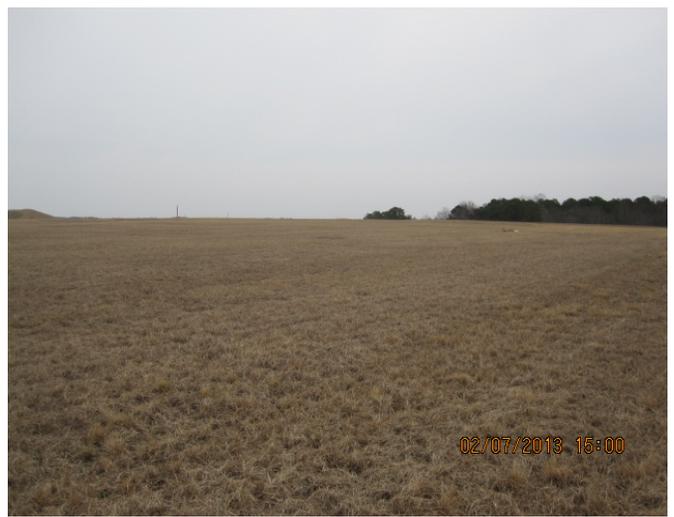
3. There was no visible ponding of water over waste, including the surface of the flat closed Phase 1-2 MSWLF, very good.
4. There were no major seeps on any of the side slopes. There were just a few areas that appeared to be somewhat wet. Mr. Proctor stated that they are working on seeps on a continuous basis.

No ponding water on old closed MSW LF Phase 1-2
