FACILITY COMPLIANCE INSPECTION REPORT

Division of Waste Management Solid Waste Section

Jones County Landfill
 Landfill Rd (NC SR#1343)
 Trenton, NC

5201-20140513INSP

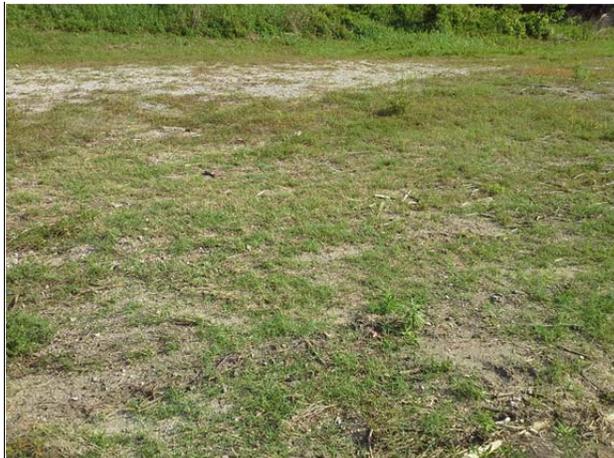
- 9) A cover crop of native warm season grasses has been established throughout the landfill. Overall, the cover crop has been well established; however, small areas of sparse cover were noted throughout the landfill. *Please grade, seed, and mulch these areas to establish a groundcover suitable to prevent erosion of your landfill cap system. All repaired areas should be graded at a slope not greater than 3:1.

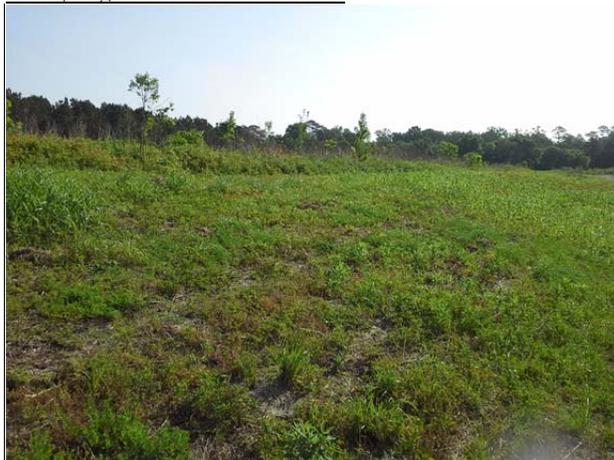
- 10) The landfill cover crop is mowed annually. Portions of the landfill cover crop have been mowed. *Please complete mowing operations as soon as possible.
- 11) Small trees and other woody vegetation have been allowed to grow in various areas of the landfill. *Please remove all trees and other woody vegetation from the landfill.

- 12) *Corrective measures are required as a result of this Facility Compliance Inspection.
