FACILITY COMPLIANCE INSPECTION REPORT
Division of Waste Management
Solid Waste Section

Date of Site Inspection: **January 21, 2014**

Lake Norman Landfill, Inc.
 7099 Quarry Lane
 Stanley, NC 28164

Comprehensive Compliance Audit

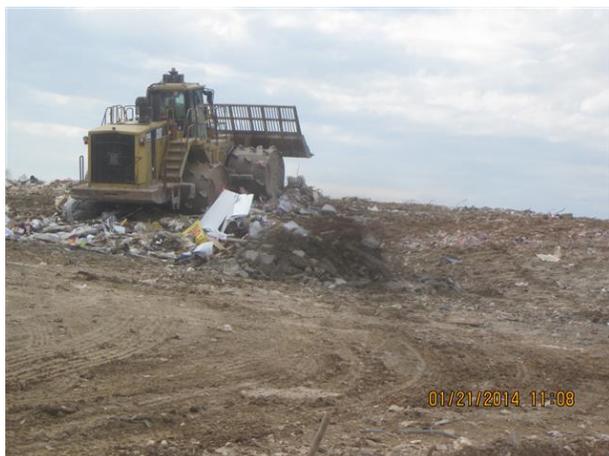
1. Compactor at the working face.

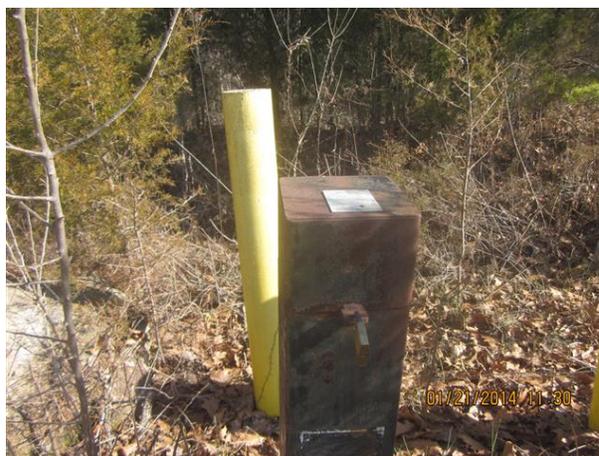
2. Typical groundwater monitoring well with ID tag and padlock.

- 21. No woody vegetation or trees were observed on the landfill.
- 22. Grass cover on the south and east slopes is well established.
- 23. A random inspection of groundwater and methane monitoring wells were properly identified with “well tags” and secured with padlocks. **Please ensure that all monitoring wells are marked with “IDs” that match the “IDs” that are indicated on facility maps and in facility monitoring reports.**

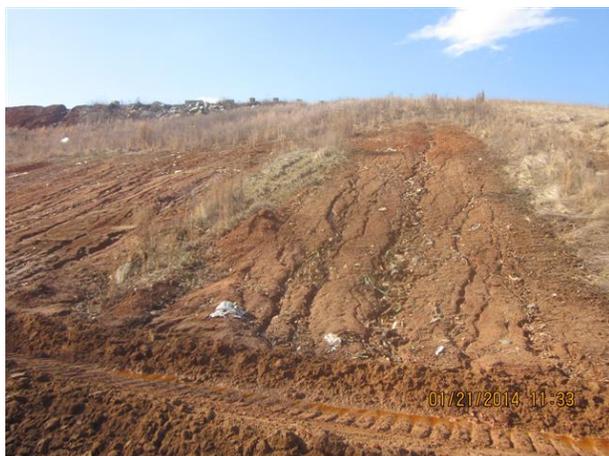
15. As a result of the recent rain events, several areas of surface erosion developed on the northeast slopes of the landfill. These areas were in the process of being re-graded at the time of the inspection and arrangements have been made to re-seed the areas. No waste or sediment was observed outside of the limits of waste. (Photos #3& #4)

3. One of several areas of surface erosion on the NE slopes needs to be repaired and still needs to be seeded.

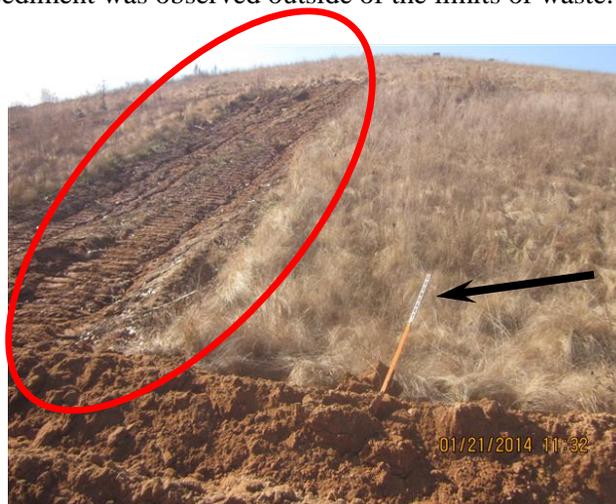
4. One of several areas of surface erosion on the NE slopes that has been repaired and still needs to be seeded. (Note the edge-of-waste marker at the lower right.)

13. There edge-of-waste markers were in place at the time of the audit. (Photo #4) **Please ensure that the edge-of-waste markers are properly maintained and readily visible at all times.**

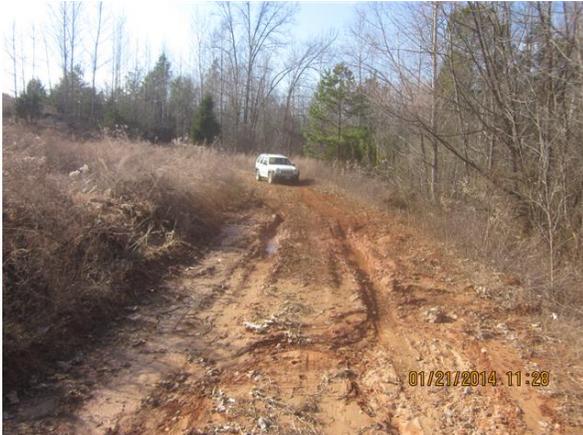
5. Looking SW down the monitoring well access road, near the sediment basin: Note the wet and muddy condition of the road.

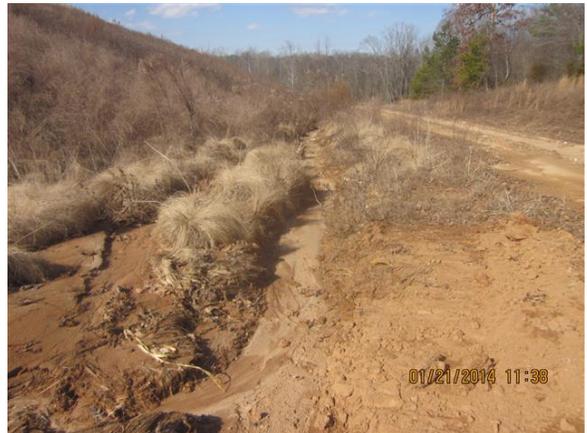
6. Looking NW down the down the monitoring well access road on the NE side of the landfill: Note that the perimeter ditch is filled with sediment.

- 16. A “roll off box” is staged near the working face for the collection of scrap tires and other unacceptable wastes that the landfill staff removes from the waste stream.
- 17. There was very little windblown litter observed.
- 18. The access roads to the C&D landfill were well marked and well maintained.
- 19. The access road to the groundwater and landfill gas monitoring wells can become muddy near the sediment basin. **Please ensure that the access road remains passable at all times.** (Photo #5)
- 20. The perimeter stormwater ditch on the NE side of the landfill is filled with sediment and need to be cleaned out and re-worked. (Photo #6)
