FACILITY COMPLIANCE INSPECTION REPORT
Division of Waste Management
Solid Waste Section

Date of Inspection: May 15TH and 30TH, 2014

International Automotive Components (IAC)
 [Formerly Collins & Aikman Products Co.]
 1240 Parker-Padgett Road (SR-1240)
 Old Fort, N.C. 28762

Partial inspection of closed landfill.

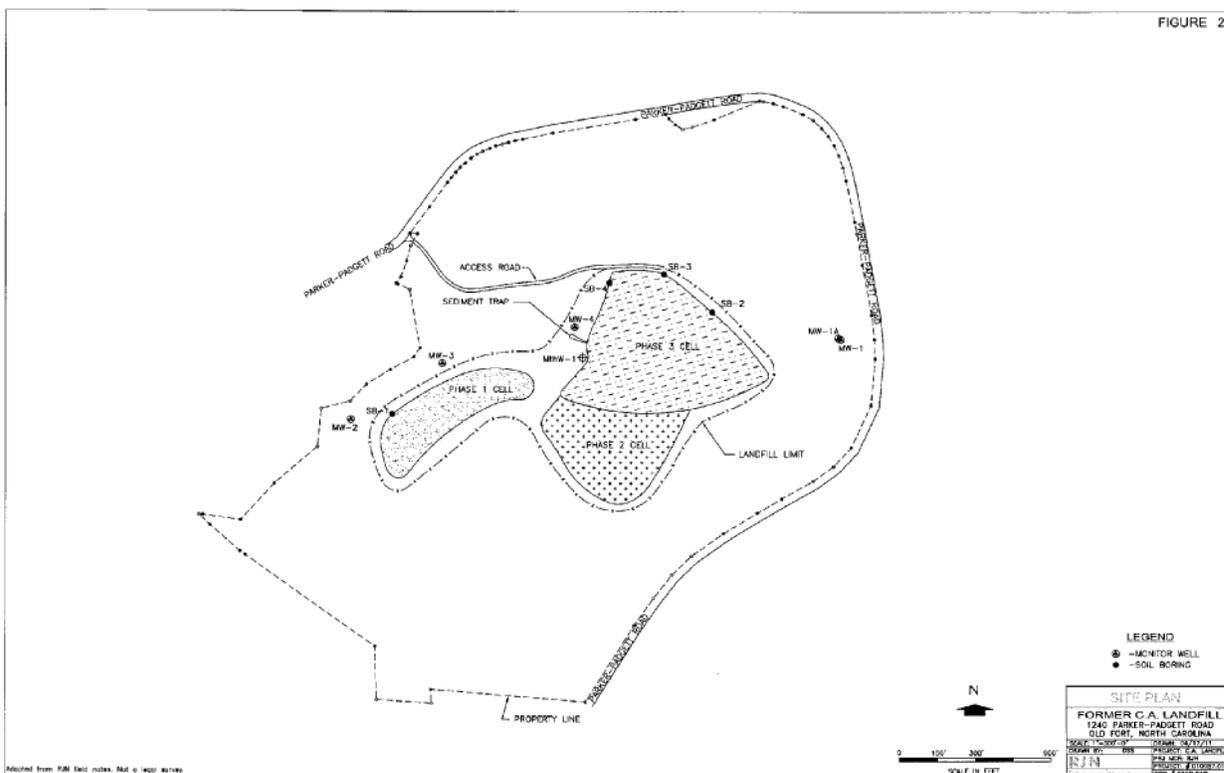
Site Map from “Final Investigation Report” 6/7/11 RJN Environmental Inc. (DIN 14162)

6. The landfill was initiated by *Collins & Aikman* in 1982 and its use was terminated in 2005.
7. Based on review of the Solid Waste Section’s records believed that the facility consisted of three phases as represented in Figure 1, and that:

- a) Phase 1 was operated early 1982 to late 1982 in the central west portion of the site.

- b) Phase 2 was operated from late 1982 to 1985 in the area south of the drainage feature in the central eastern portion of the site
 - c) Phase 3 was operated from 1985 to 2005 in the area of the drainage feature north of Phase 2.
8. The entire site covers approximately 86-acres with the actual landfill area covering approximately 12-acres.

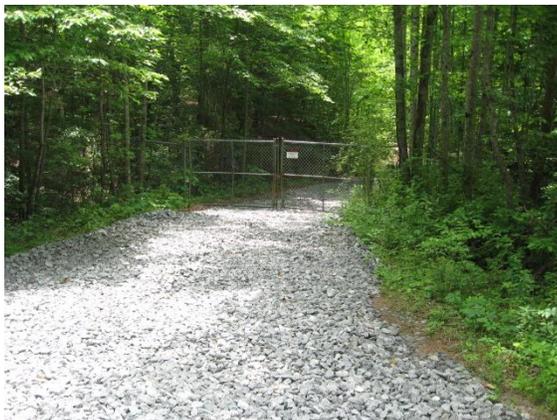
- 9. Access is on the NW corner of site, off of Parker-Padgett Road. This access is controlled by a locked gate. (Photo #1)
- 10. Proper landfill signage is displayed at the access gate. (Photo #1)
- 11. The access roads at the landfill are in good condition. (Photos #1 and #2).

1. Looking from Parker Padgett Rd. at the entrance gate to the landfill.

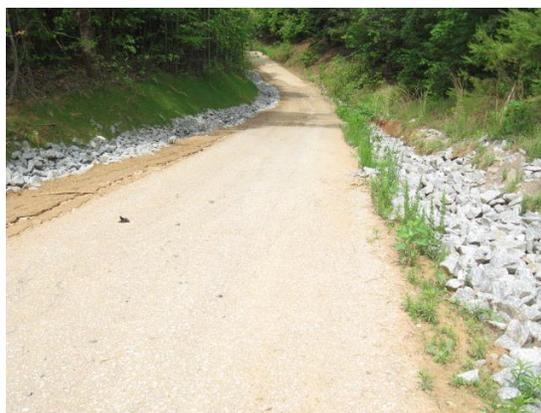
2. Looking (N) down the access road to Phase 2. (Note the stormwater ditches lined with “rip-rap”.)

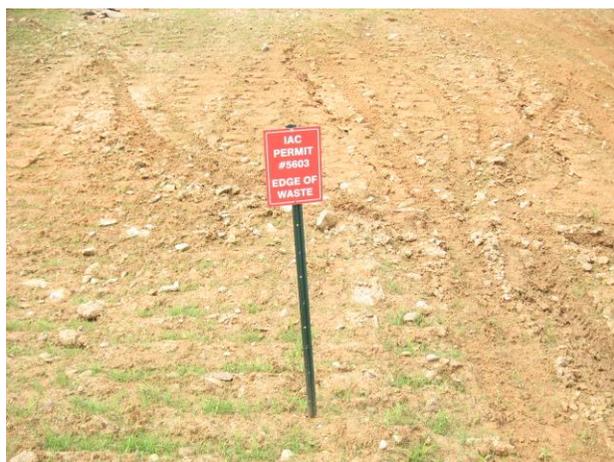
- 1. Edge-of-waste markers for Phase #3 and along the access road are in place. (Photo #3)
- 2. “No Trespassing” signs have been posted at the property line along Parker Padgett Rd. (Photo #4)
- 3. Vegetative cover is beginning to emerge on the cap of Phases #2 and #3. (Photos #5 and #6)
- 4. No seeps of leachate from the landfill, or excessive erosion of the cap or were observed. No exposed waste was observed.

3. Typical edge-of-waste maker.

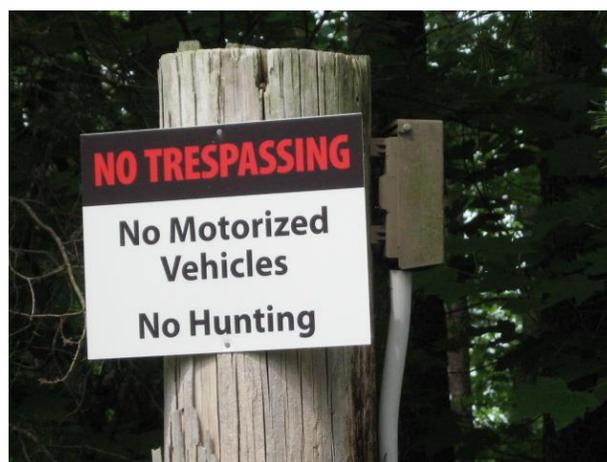
4. Typical “No Trespassing” sign posted on Parker Padgett Rd.

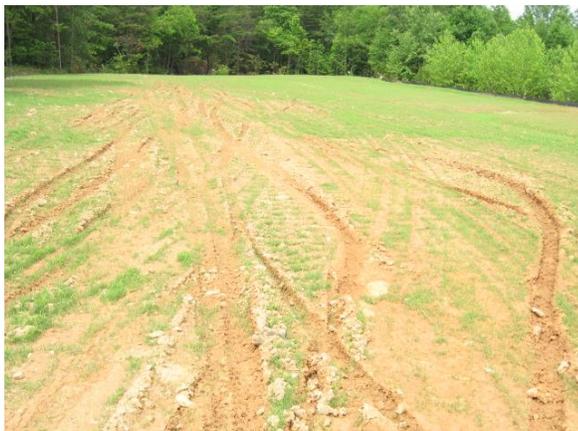
5. The cap of Phase #1 is covered with trees and woody vegetation. **In accordance with the (approved) August 13, 2013 (Document ID Number [DIN] #19406) Closure and Post Closure Plan, quarterly maintenance of Phase #1 will “include a search for dead or fell trees. If these are encountered, they be removed, and if necessary the integrity of the cap will be restored. Any accumulation of thick brush will be removed and accumulations of thick stands of trees will be thinned to allow easy access to all areas of the cap.”**
6. **As access from the east side of the site is not controlled, the areas of both Phase #2 and #3 have become subjected to the un-authorized use by recreational vehicles (i.e. – dirt bikes and ATVs). Photo #5**

5. Looking (SW) across the top of Phase #2 and #3. Note the ruts in the cap caused by ATVs and motorcycles.

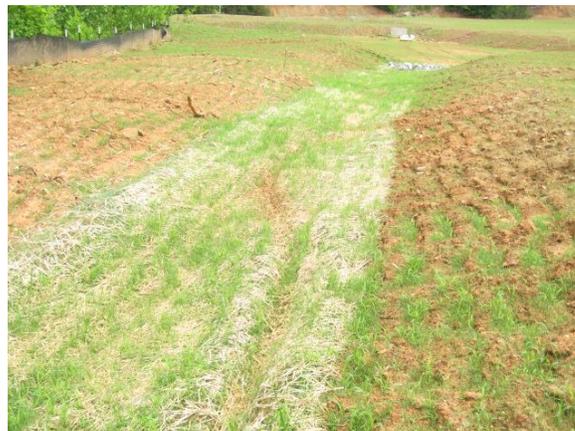
6. Looking (N) down the (W) edge of Phase 3 at the emerging vegetative cover. Note the silt fence upper left.

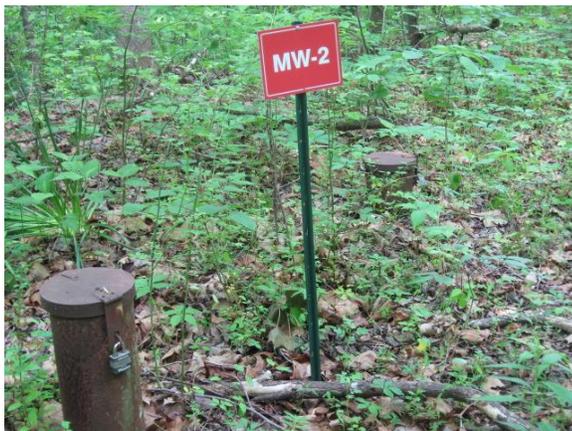
7. Inspection of the groundwater monitoring wells found all of the wells to be properly maintained and in good condition: secured with locks and clearly identified. (Photos #7 and #8)

7. Groundwater monitoring well #2.

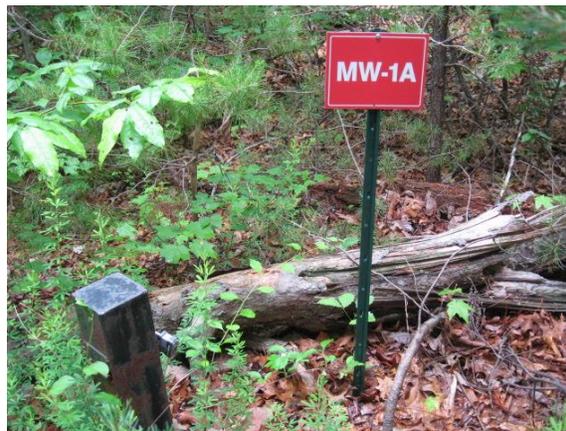
8. Groundwater monitoring well #1A.

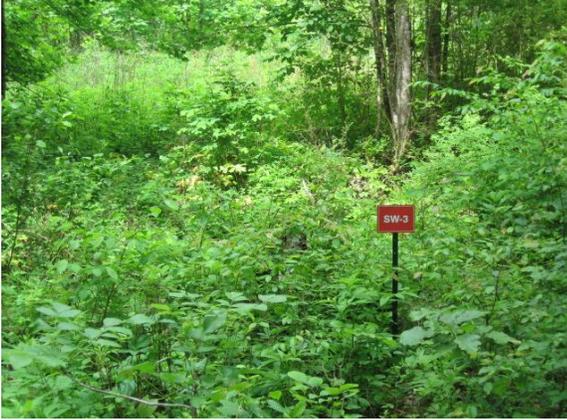
8. The locations of the surface water monitoring locations were marked with permanent signs (Photos #9 and #10)

9. Surface water monitoring point #3 marked with a permanent sign.

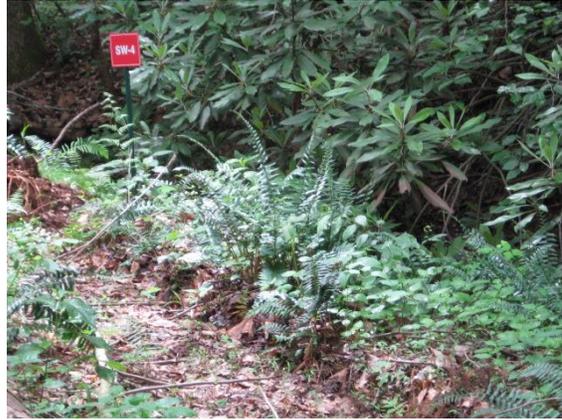
10. Surface water monitoring point #4 marked with a permanent sign.
