FACILITY COMPLIANCE INSPECTION REPORT
Division of Waste Management
Solid Waste Section

Date of Site Inspection: February 26, 2014

C&D Landfill Inc.
 802 Recycling Lane
 Greenville, North Carolina 27834

Comprehensive inspection of a Construction and Demolition Landfill

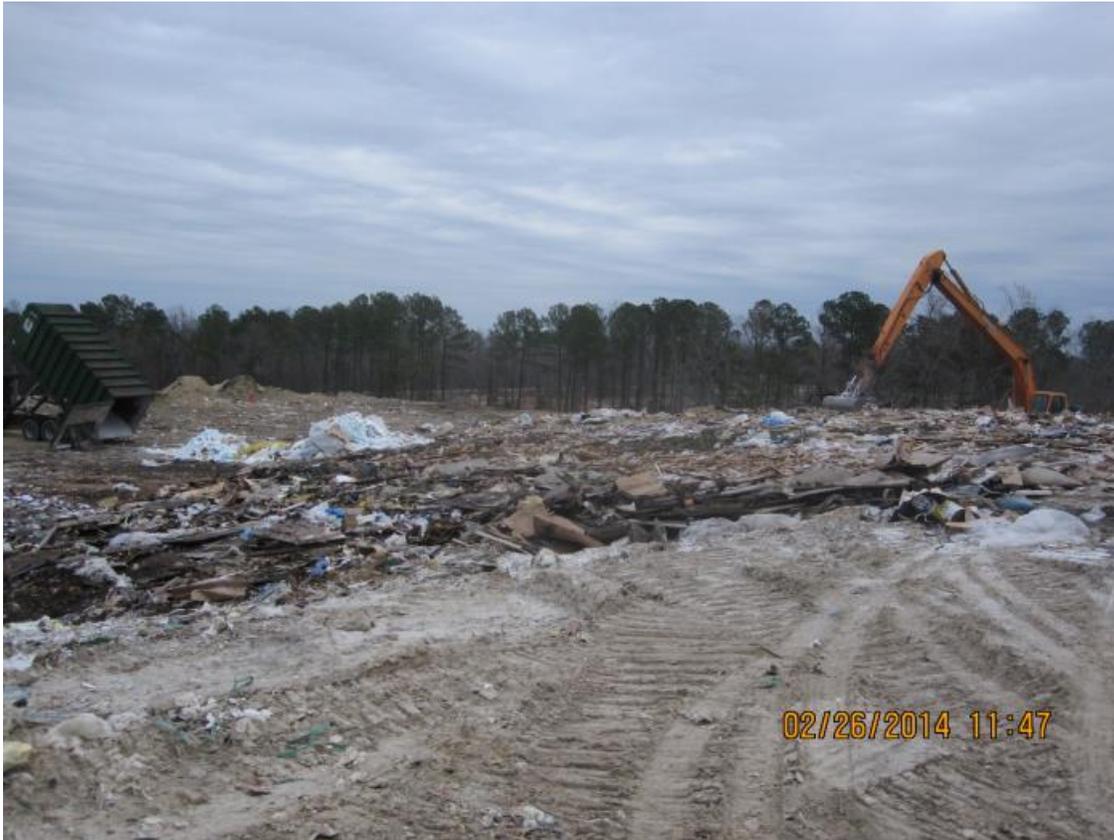
Large amount of uncovered waste material observed on the landfill

- 3) **The violation of 15A NCAC 13B .0203(a), General Permit Conditions 5&6 and 15A NCAC 13B .0542 (a)&(f) is due to C&D Landfill Inc. not properly covering the waste material disposed of in the landfill. Virtually the entire surface of the landfill had uncovered waste.**

15. Efforts need to be made to ensure that waste is covered as required. This is the second Notice of Violation issued for this facility in 6 months for cover issues. A notice of Violation for insufficient cover was issued on August 28, 2013. The violation was listed as resolved in an inspection report dated October 14, 2014. C&DLF was again found to be out of compliance during this inspection.

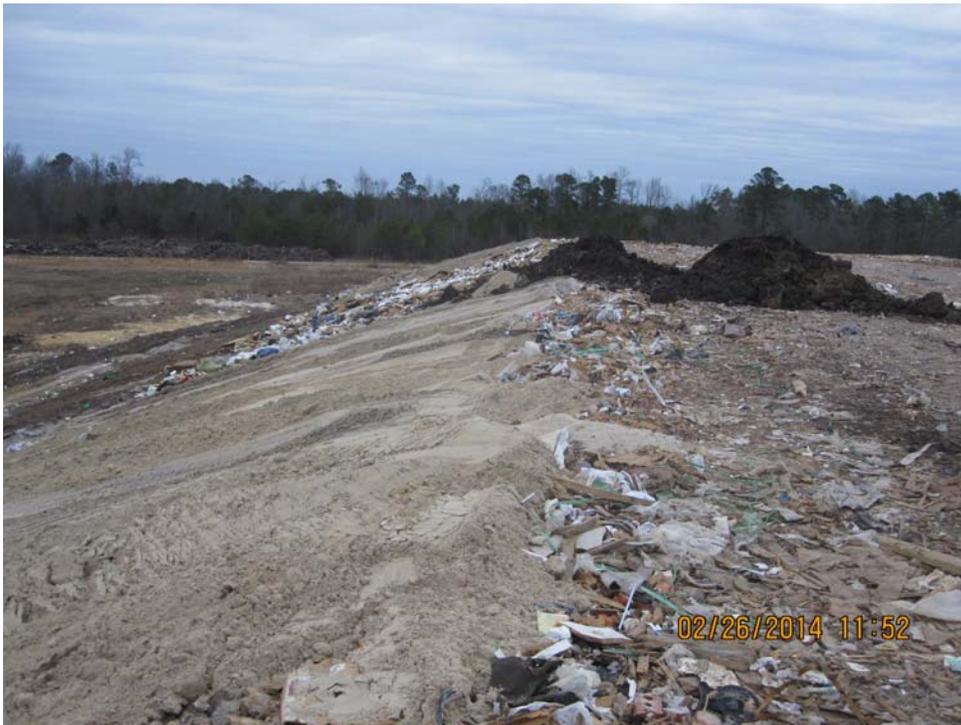
More uncovered waste observed on the surface and slope of the landfill

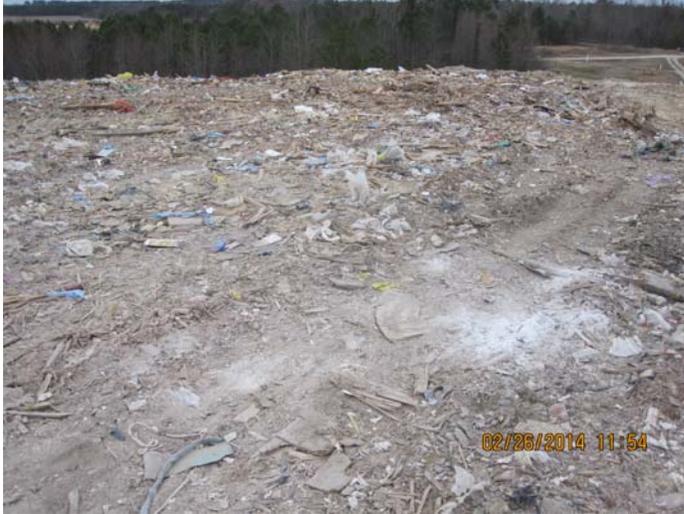
the landfill

More uncovered waste observed on the surface of

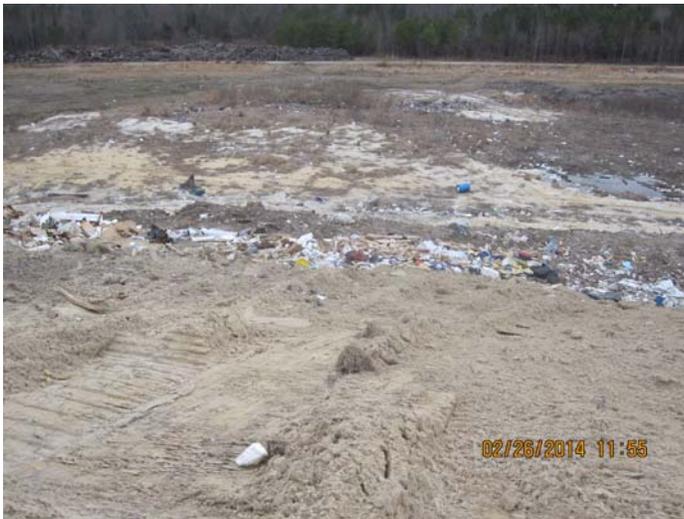
slope.

More uncovered waste observed on the surface and

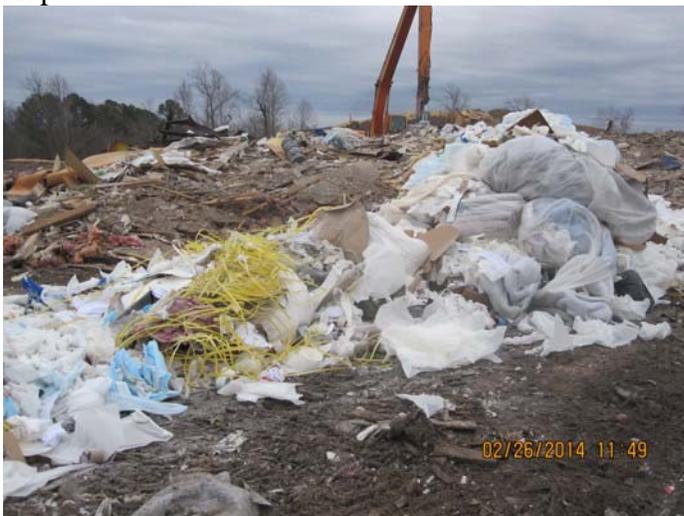
Load of MSW dumped on landfill during the time of the inspection. Landfill staff did not seem to recognize this material as not being acceptable for this landfill.

- 1) **The violation of 15A NCAC 13B .0203(a) General Permit Conditions 5&6 and 15A NCAC 13B .0542 (a)&(c) is due to C&D Landfill Inc. receiving waste material that met the definition of MSW rather than C&D.**

- 6) **The violation of 15A NCAC 13B .0544 (e) (3) is due to the fact that several types of non-approved waste were observed on the landfill during the inspection including non-perforated drums, MSW and possibly industrial type waste. Some of this waste appeared to have been on the surface for several days and no apparent effort was made to remove it. It would appear that landfill staff did not recognized that this waste as not being approved for this landfill**

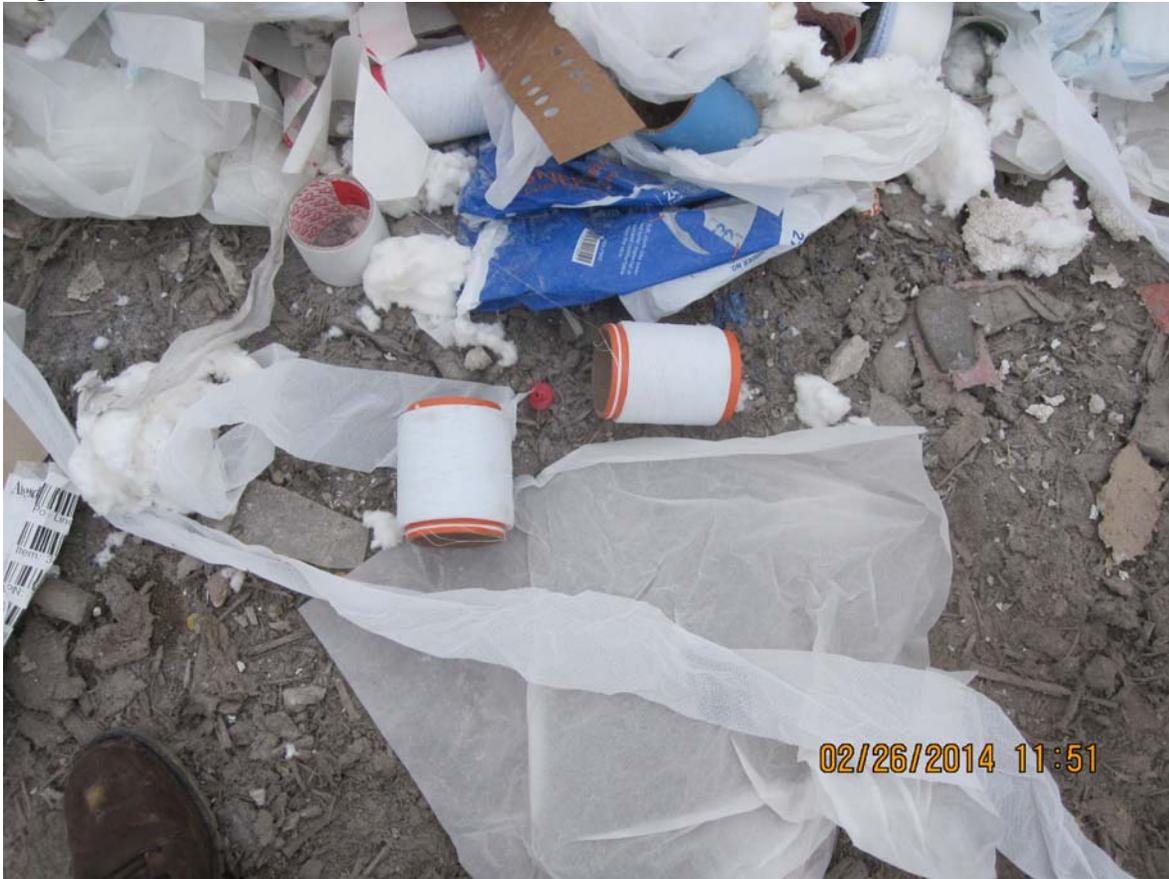
Closer view of the MSW observed dumped during the inspection.

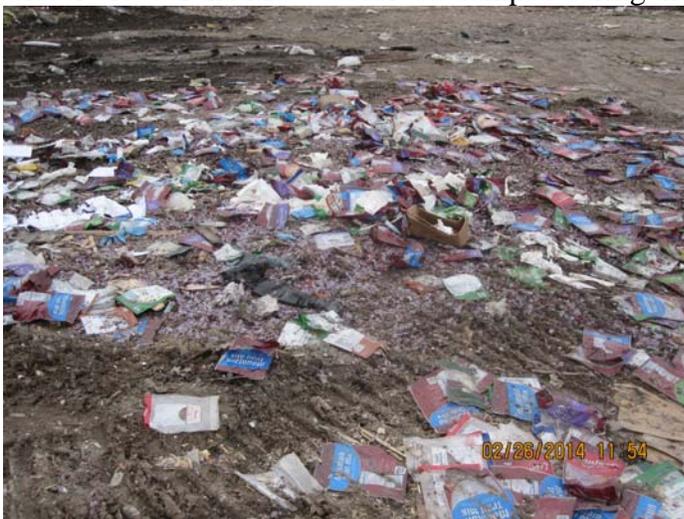
More MSW observed on the landfill. This material, bags for mountain trail mix was observed in several areas of the landfill leading to the assumption that this was not an isolated event. Proper training and diligence of landfill staff should have prevented this material from being accepted.

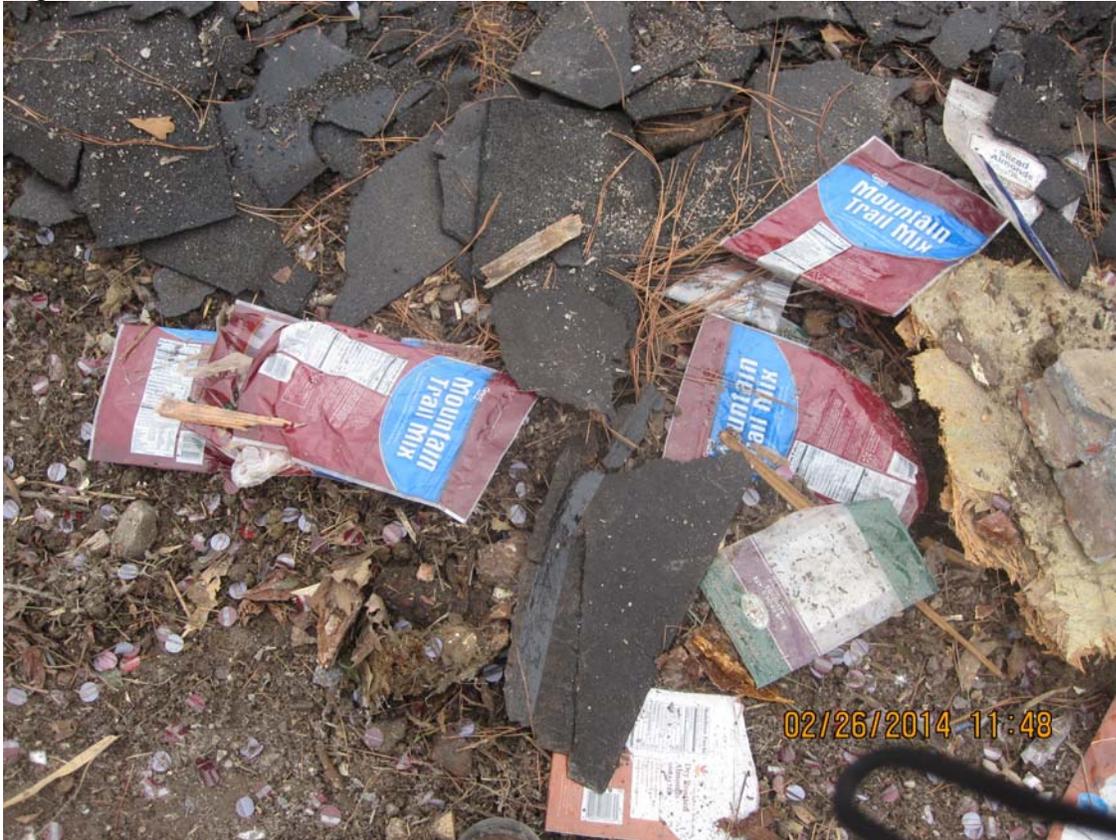
This material observed in several areas of the landfill does not meet the definition of C&D waste and appears to have been dumped several days ago.

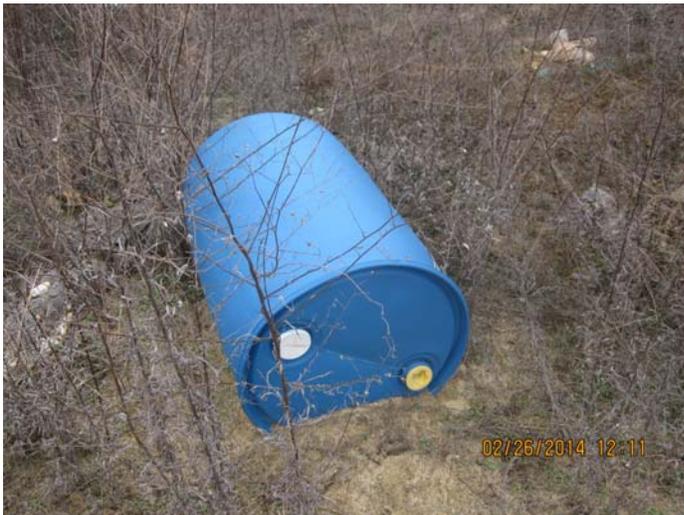
A drum observed on the slope of the landfill. The drum had been in place long enough for soil to have washed around it. The drum was not perforated. Again, landfill staff should have recognized that this waste should not be on the landfill.

- 2) **The violation of 15A NCAC 13B .0203(a) General Permit Conditions 5&6 15A NCAC 13B .0542 (a)&(e) is due to C&D Landfill accepting non-perforated plastic drums at the landfill. Three were observed.**

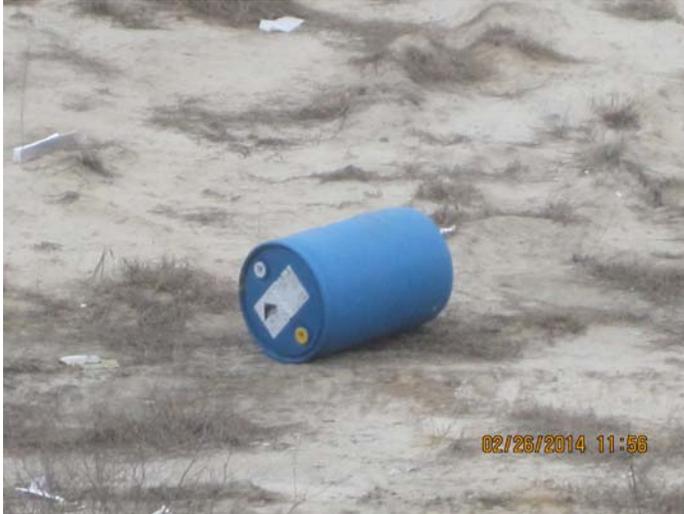
Another drum observed below the slope of the landfill. The drum was not perforated.

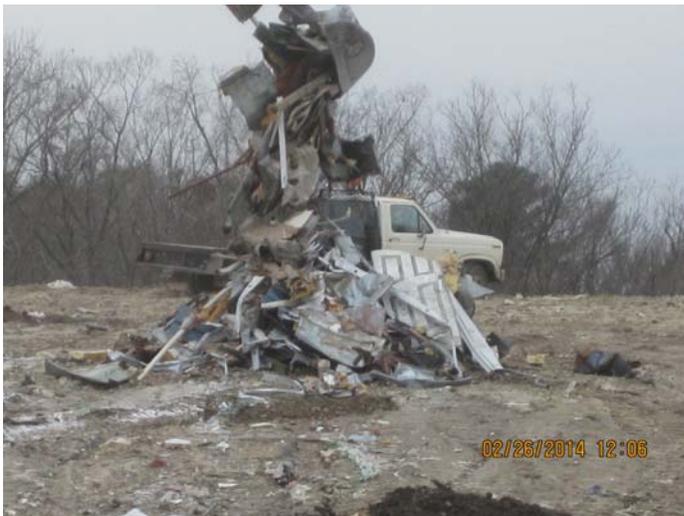
Metals separated from the C&D and stored on the surface.

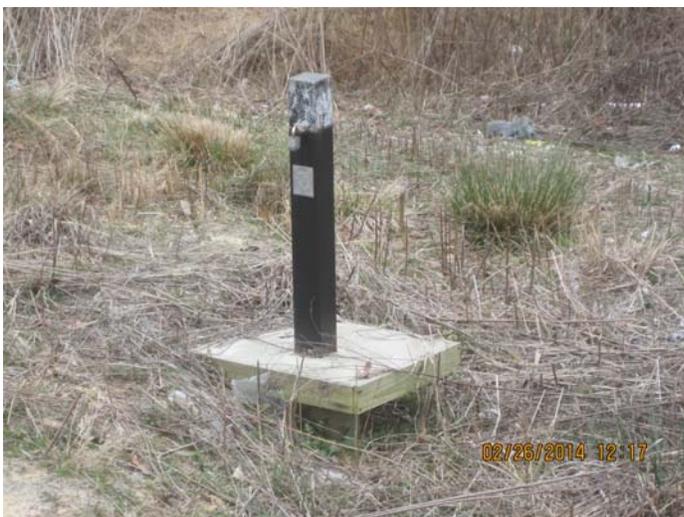
8. The last GW monitoring event was conducted by Garrett and Associates on November 26, 2013 for Phase 1 Assessment and Phase 2 Detection Monitoring. For Phase 1- MW-1 (background), MW-2s, MW-4, MW-6 and MW-7(detection sampling) were sampled. For Phase 1 MW-3, MW-3A and MW-8 (detection and assessment) were sampled. For Phase 2 MW-9A (background), MW-10, MW-11, MW-12s, MW-13, MW-14 (detection only) were sampled. Surface water sampling included for Phase 1 SW-1, SW-2, SW-3 (detection), for Phase 2 SW-2. A GW assessment plan was submitted to the Division on 6/22/2009. The wells that were checked were locked. Soil has eroded from the base of one of the wells. Photo is below.

Erosion was found around one of the GW monitoring wells.
