FACILITY COMPLIANCE INSPECTION REPORT
Division of Waste Management
Solid Waste Section

Date of Site Inspection: July 29, 2013 **Date of Last Inspection:** December 19, 2012

North Wake County MSW Landfill
 9004 Deponie Drive
 Raleigh, NC 27615

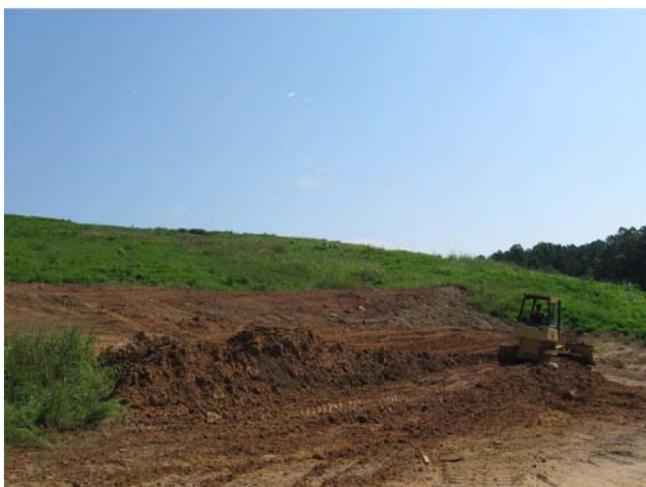
4. The unlined MSWLF (1984) is fenced and secured by a locked gate and is not accessible to the public. Repairs to the slope on the southern side of the landfill were underway at the time of the inspection.

Slope repair on unlined MSWLF.

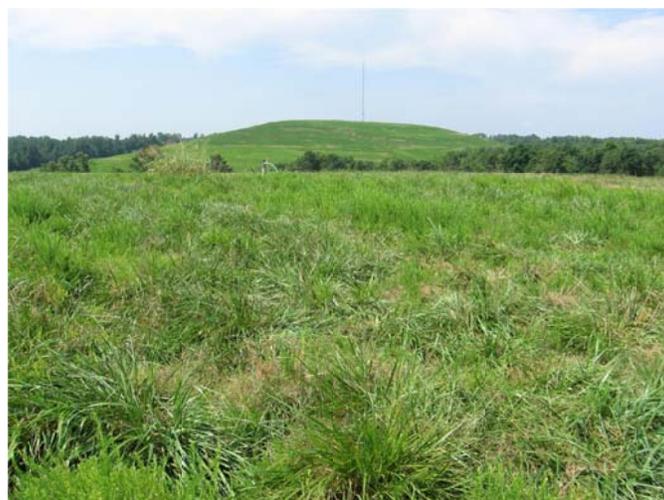
1. The landfill caps are covered with native grasses and are mowed several times a year (October and May). The cover was in good condition for all units at the time of the inspection; no notable bald spots were observed. Some settling was evident on the cap of the unlined MSWLF but no evidence of ponded water or bare spots were observed.

Cap of unlined MSW with lined MSW in background.
