# FACILITY COMPLIANCE INSPECTION REPORT

## Division of Waste Management Solid Waste Section

Washington County C&D Landfill  
 718 Landfill Rd  
 Mackeys, NC 27970

9404-20131126INSP

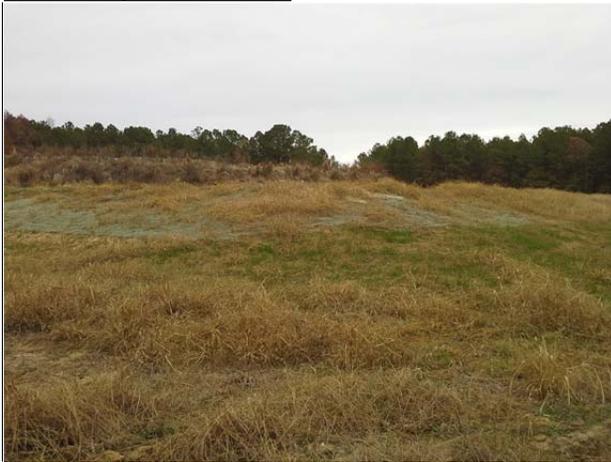
- 13) Permanent Edge of Waste Markers are in place around the footprint of the landfill and are being maintained as required.
- 14) The Phase II lateral expansion has been seeded and mulched; however, germination of the cover crop has been insufficient to prevent erosion. \*As per our conversation, please re-seed and mulch this area to establish a groundcover suitable to prevent erosion.

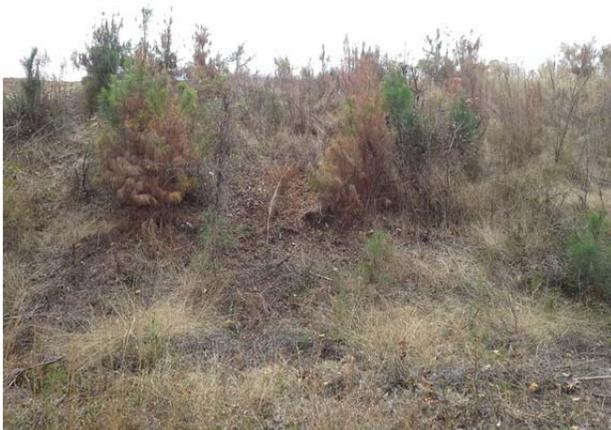
- 15) Windblown debris is being well managed at this time. Minimal windblown debris was noted on the landfill sideslopes and no windblown debris was observed leaving the facility during this Facility Compliance Inspection.
- 16) Brush and woody vegetation were noted on the landfill sideslopes. \*As per our conversation, plans need to be underway to remove all brush and woody vegetation. Upon removal of this vegetation, please work to establish a permanent groundcover suitable to preserve site stability and prevent erosion of your landfill cap system on all facility sideslopes.

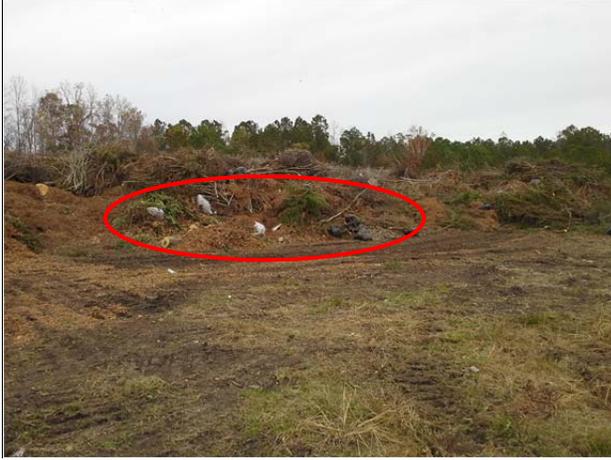
- 22) All Land Clearing debris is managed in the Land Clearing Debris Management Area.
- 23) All vegetative waste is staged on site for grinding and removal from the site for use as boiler fuel. \*Several plastic bags of vegetative waste were observed disposed in the vegetative waste pile. As per our conversation, please remove these bags and in the future, please ensure that all plastic bags are removed from the waste stream before it is placed in the vegetative waste staging pile.
