FACILITY COMPLIANCE INSPECTION REPORT
Division of Waste Management
Solid Waste Section

Miller Farm LCID Landfill
 Miller Farm Road
 Morehead City, NC 28557

Comprehensive Facility Compliance Inspection

N0190-20140701INSP

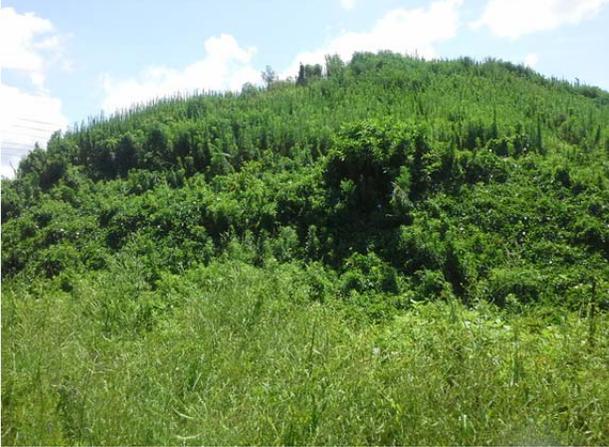
- 10) Permanent markers have been installed around the perimeter of the landfill to identify the landfill footprint boundaries.
- 11) Soil has been stockpiled in an area adjacent to the landfill access ramp for use in maintenance and repair.
- 12) The Facility operator has blocked the access road at the landfill entrance for safety.
- 13) No new disposal activity was noted as having occurred since the last Facility Compliance Site Inspection.
- 14) *Please continue to fill, compact, and cover all areas of differential settlement to provide for positive drainage of surface waters away from the landfill. All sideslopes and repaired areas should be graded at a slope not greater than 3:1 and seeded and mulched to establish a groundcover suitable to prevent erosion.
- 15) Overall, this Facility has a well-established cover crop of native warm season grasses and coppice-type cover.

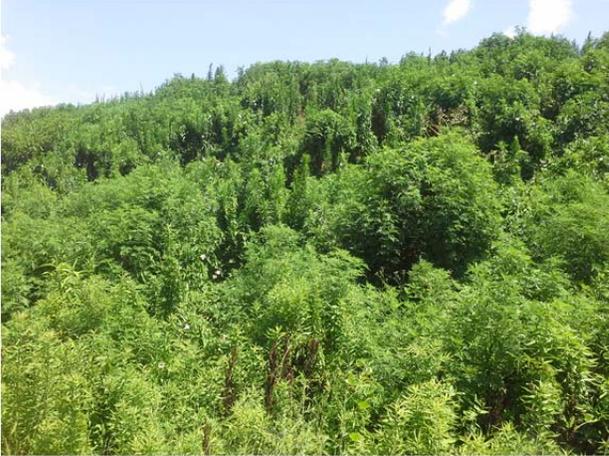
- 16) *The Facility sideslopes need to be mowed and maintained to prevent the growth of brush and woody vegetation with can shade out and otherwise inhibit the growth of the desired grass cover crop.

- 17) *Corrective actions are required as a result of this Facility Compliance Inspection.
