FACILITY COMPLIANCE INSPECTION REPORT
Division of Waste Management
Solid Waste Section

Date of Site Inspection: 8 May 2014

Coastal Dragline Services LCID Landfill
 175 Brown Farm Road
 Vanceboro, NC 28586

N0668-20140508INSP

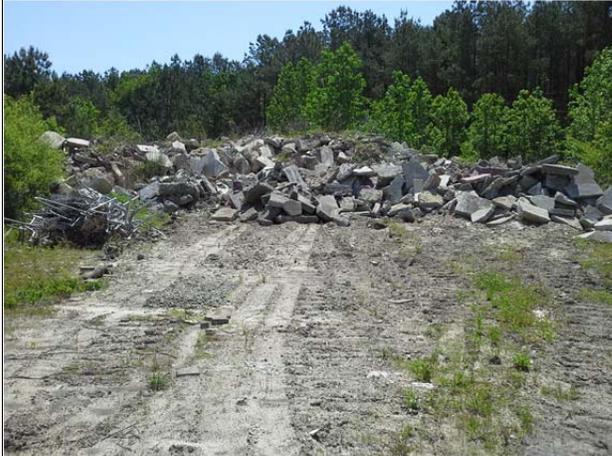
- 8) Scrap concrete is being staged adjacent to the LCID landfill for future grinding and re-use. *Please note that the State rules regarding recovered materials state that for a material to qualify as a recovered material, the majority of the material (51% or more) must be sold, used, or re-used within twelve months.

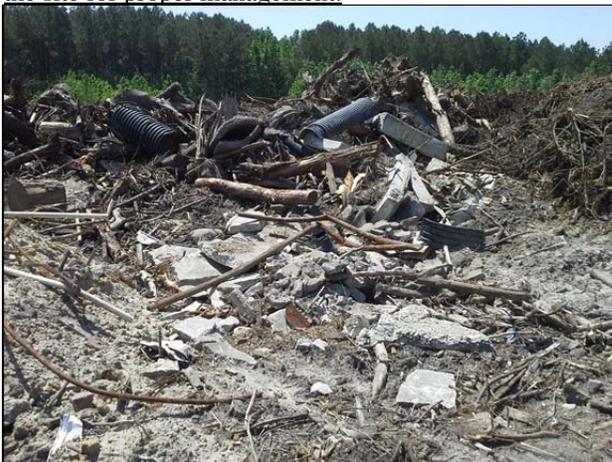
- 12) The waste type was reviewed. Overall, the waste being disposed is LCID waste, however, sections of PVC drain tile and metal pipe was observed disposed in a load of LCID waste. *Please collect and remove these unpermitted wastes from the site for proper management.
