**FACILITY COMPLIANCE INSPECTION REPORT**  
**Division of Waste Management**  
**Solid Waste Section**

**Date of Site Inspection:** 11 September 2013    **Date of Last Inspection:** 19 June 2013

Garner LCID Site  
 Lake Road  
 Havelock, NC 28557

Comprehensive Facility Compliance Inspection

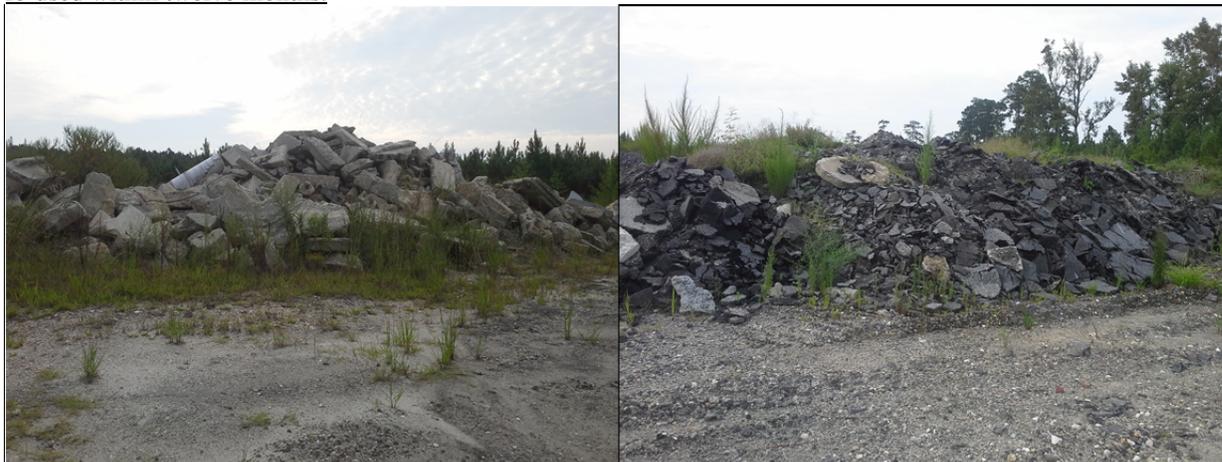
- 10) Inert debris consisting of scrap concrete and asphalt is being stockpiled on the property in an area separate from, but adjacent to, the landfill for later crushing and re-use. \*Please note that the State rules regarding recovered materials state that for a material to qualify as a recovered material, the majority of the material (51% or more) must be sold, used, or re-used within twelve months.

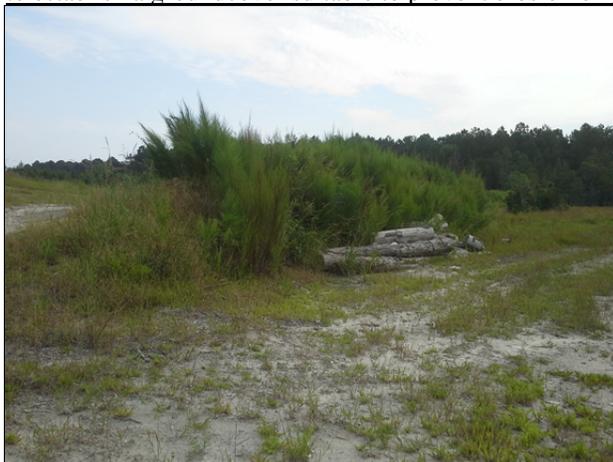
- 11) Soil has been stockpiled for use as cover in an area adjacent to the Facility access road.  
12) \*The outside slopes need to be compacted and graded at a slope not greater than 3:1. Please seed and mulch these areas to establish a groundcover suitable to prevent erosion of your landfill cap system.

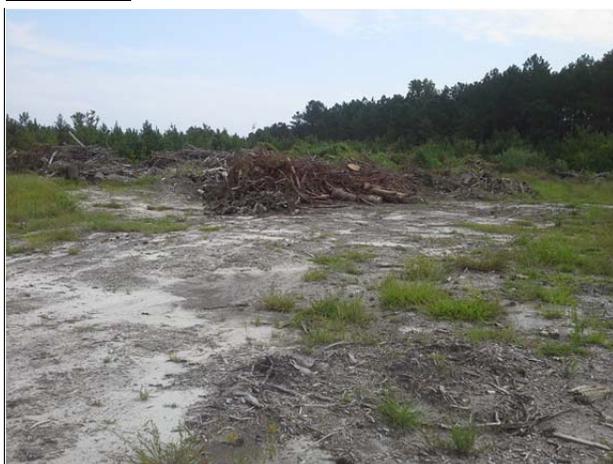
- 13) \*Please ensure that all waste is covered monthly, or when the active working area reaches one acre in size, whichever occurs first.
