**FACILITY COMPLIANCE INSPECTION REPORT**  
**Division of Waste Management**  
**Solid Waste Section**

**Date of Site Inspection:** 18 June 2014

Anna Wink LCID Landfill #2  
 Anna Wink Road  
 Newport, NC 28570

N1073-20140618INSP

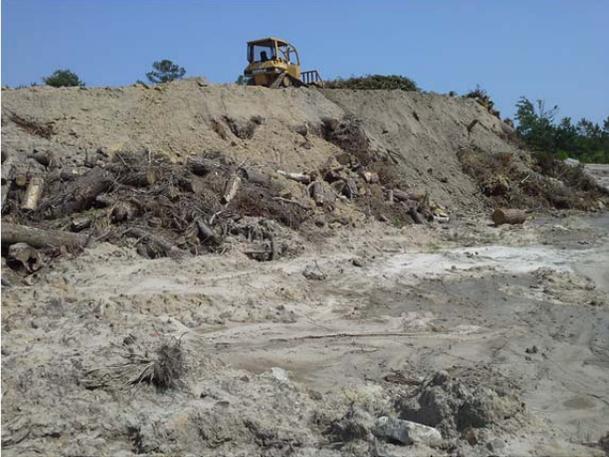
- 8) The perimeter of the landfill has not been marked as required. \*Please install permanent markers around the disposal area footprint.
- 9) The perimeter road has been cleared to provide access around the toe of the landfill.
- 10) \*All landfill sideslopes need to be covered, graded, and maintained at a slope not greater than 3:1.

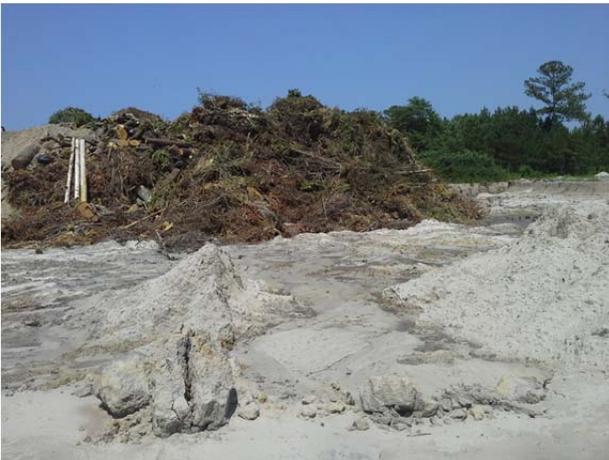
- 11) \*All outside slopes need to be seeded and mulched to establish a groundcover suitable to prevent erosion of your landfill cap system.
- 12) Please ensure that the active working area is covered monthly, or when the active working area reaches 1 acre in size, whichever occurs first.
- 13) Waste has been pushed from the working face over the southern sideslope. \*Please ensure that the active working area is maintained in a compact area and that the landfill is constructed using a lift-type progression. All outside slopes should be compacted and covered as soon as possible.

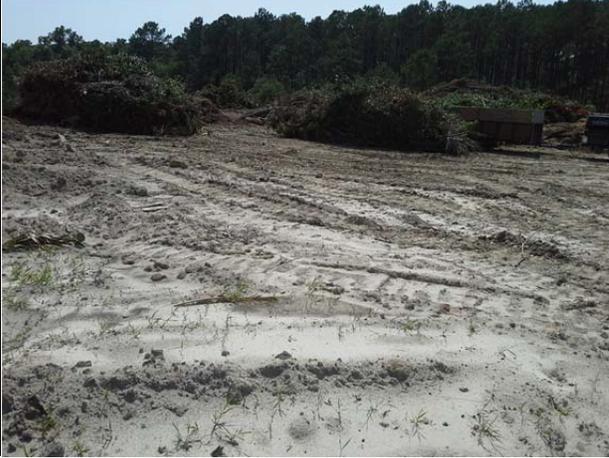
- 15) No off site erosion was observed during this Facility Compliance Inspection.
- 16) No violations were observed during this Facility Compliance Inspection.
