FACILITY COMPLIANCE INSPECTION REPORT
Division of Waste Management
Solid Waste Section

Date of Site Inspection: October 3, 2013 **Date of Last Inspection:** August 1, 2008

Inert Debris (Stump Dump) LCID Landfill
 1017 Center Grove Church Road
 Moncure, NC 27559

Comprehensive Inspection (to ensure that the notified land clearing and inert debris (LCID) landfill is in compliance with 15A North Carolina Administrative Code (NCAC) 13B .0563, .0564, and .0566)

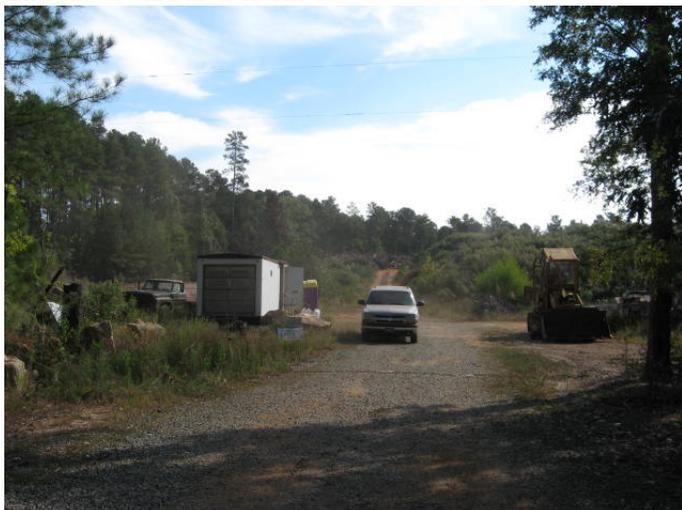
Entrance to LCID landfill

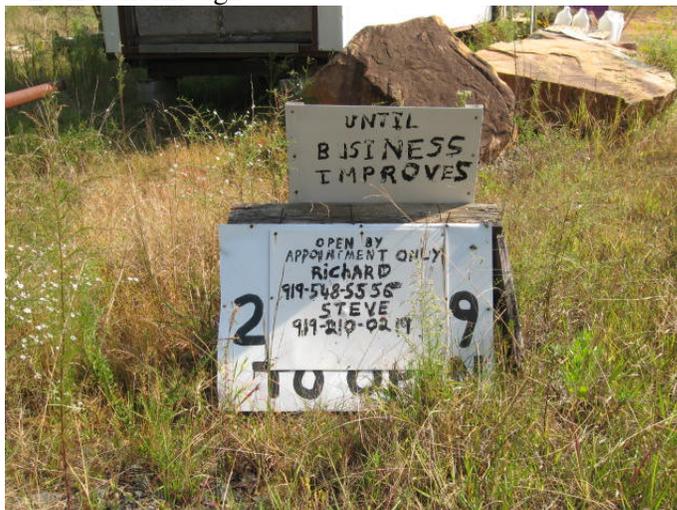
18. The facility has proper signage. Although, it should be made to be easily visible.
19. As discussed on September 27, 2013 via telephone conversation, Mr. Candelori shall submit an updated land clearing and inert debris landfill notification to specify that he is the property owner, to include: update contact information and facility name change.

LCID landfill sign

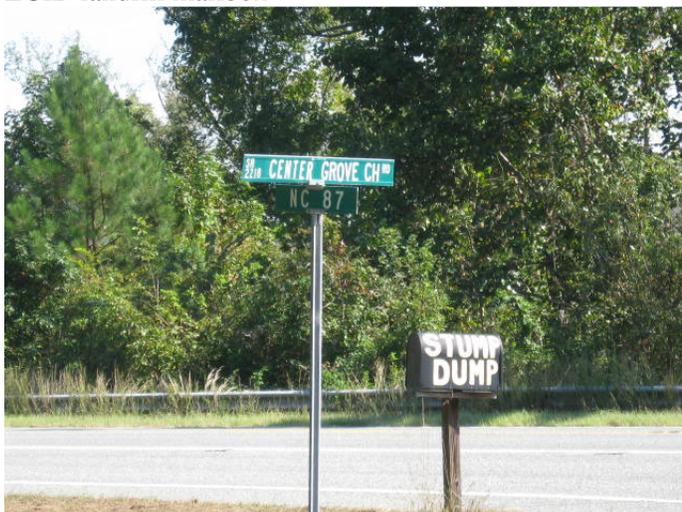
2. A large mailbox stating "Stump Dump" is at the corner of Center Grove Church Road and NC 87/US 15/US 501 South/Sanford Road.
3. A large sign stating "Stump Dump", setback within the tree line, is posted on Center Grove Church Road. Turn right onto Center Grove Church Road and right again onto Center Grove Church Road to LCID landfill entrance on the right.

LCID landfill mailbox

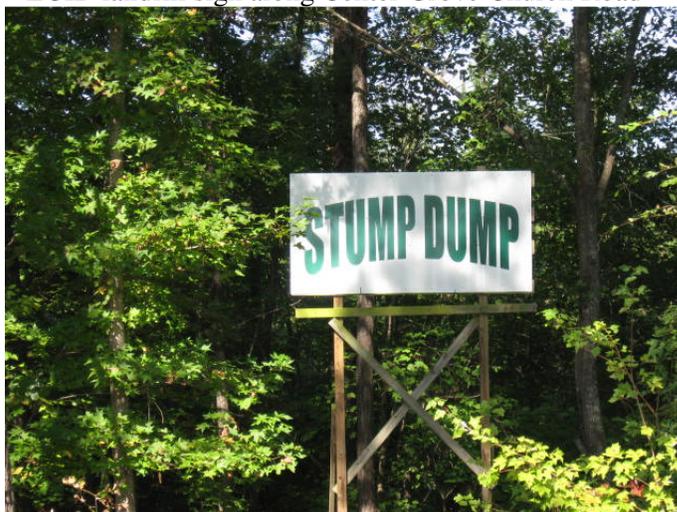
LCID landfill sign along Center Grove Church Road

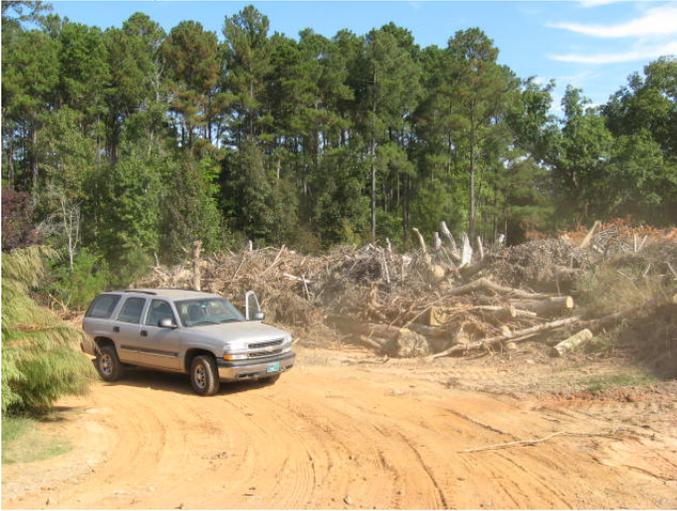
6. The LCID landfill consists of two areas. One section has land clearing debris (LCD) and the other section has inert debris, primarily concrete.
7. If the LCID landfill is > 2 acres material must be relocated such that the fill area is < 2 acres or a LCID landfill permit must be obtained. To discuss obtaining a permit, contact Geof Little, Permit Engineer – SWS Permitting Branch, at: 919-707-8252.

Land clearing debris (lower level)

10. Ensure all LCD is covered with soil within 30 days of receipt of this inspection report.
11. Ensure inert debris is graded accordingly and covered with soil.

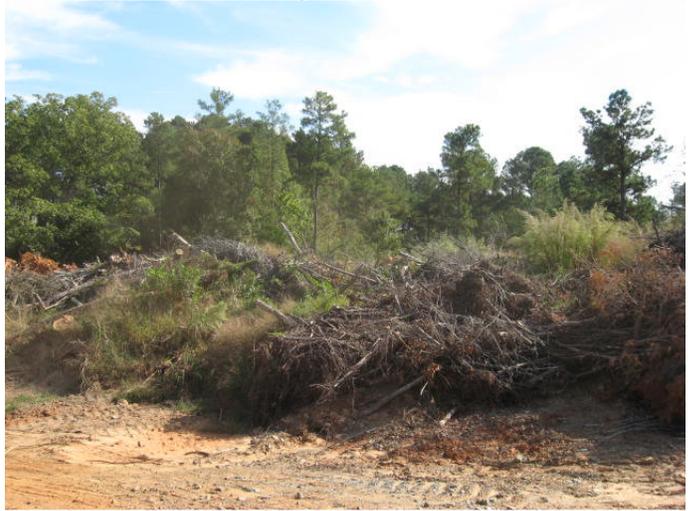
Additional land clearing debris at lower level

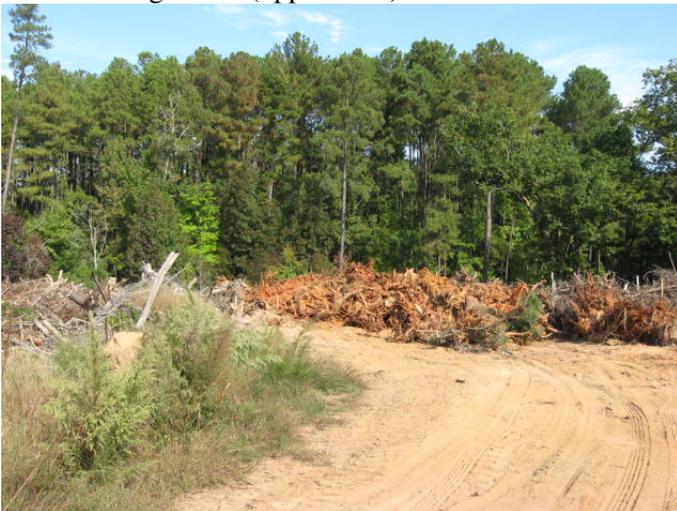
Land clearing debris (upper level)

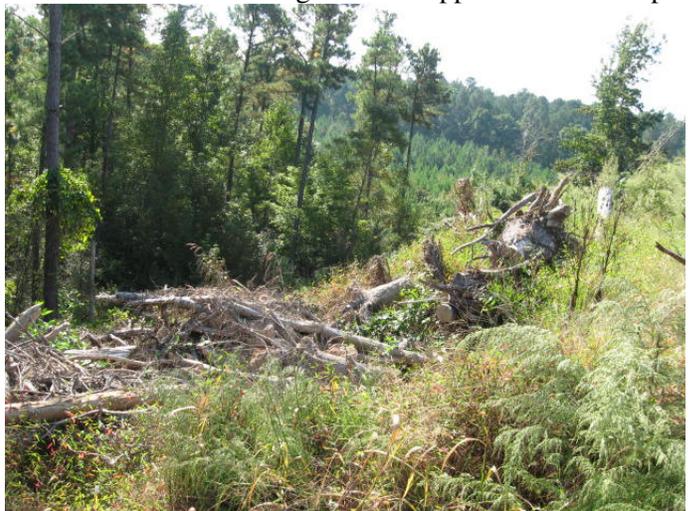
Additional land clearing debris at upper level side slope

9. Side slopes should be graded and covered with soil such that a 3:1 slope ratio is obtained or a ratio of which no indication of erosion or runoff is observed.

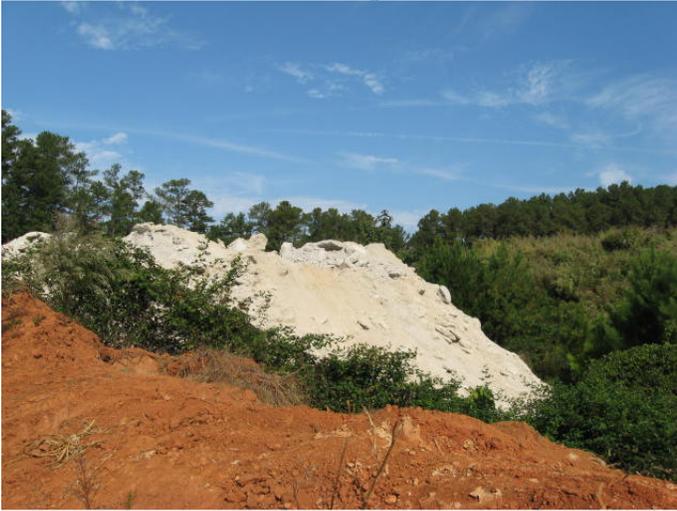
13. It appears that the inert debris section of the LCID landfill is located on adjacent property.
14. Ensure the LCID landfill disposal area is \geq 100 feet from adjacent property owned by you and Sandra Williams.

Inert debris – hardened cement powder mix

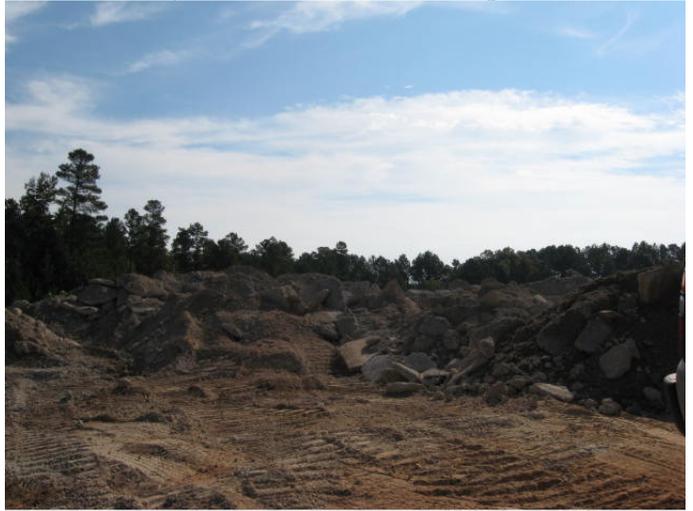
Concrete, adjacent to hardened cement powder mix mound

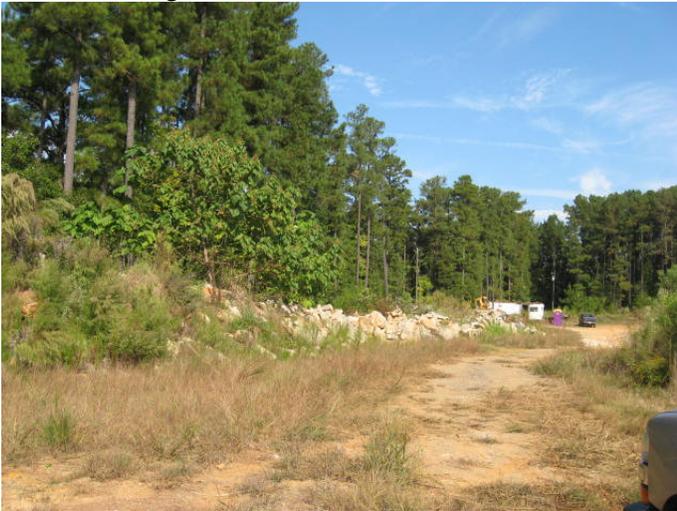
15. There was no indication of erosion or runoff.
16. Access roads are of all-weather construction.
17. The facility is secured by a steel cable and padlock.

Concrete along access road to inert debris fill area
