FEDERAL/STATE-LEAD MONITORING REPORT

Quick Stop #50 (Incident #2857)

11761 McColl Road

Terracon Project No. 70149609

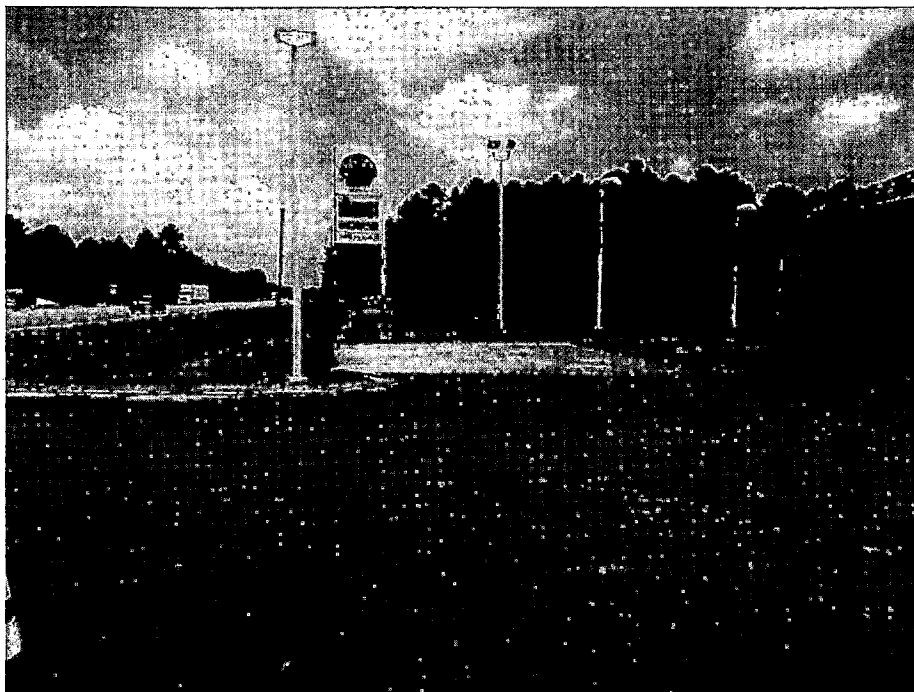
Photo #3 View of the current UST basin location

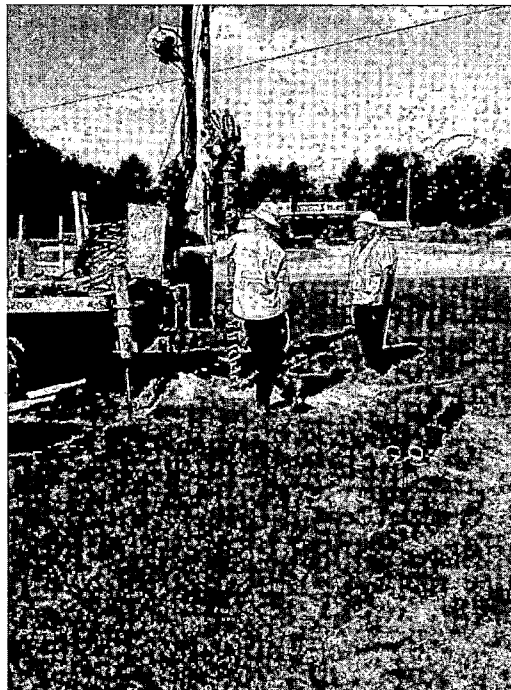
Photo #10 View of the installation of MW-11
