Phase I and II Environmental Site Assessment

TANGLEWOOD CROSSING

5273 Highway 158 Advance, Davie County, North Carolina

November 29, 2010

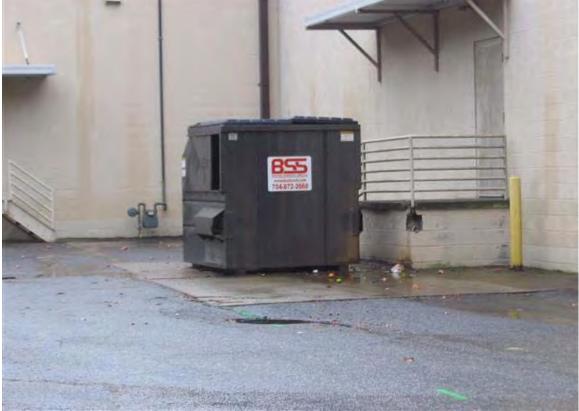
EA personnel noted no evidence of any substantial amounts of solid waste located at the Project. EA noted non-hazardous solid waste stored in six dumpsters and non-hazardous food grease stored in three bins located at the rear of the Project buildings.

Photograph #9- Typical dumpster

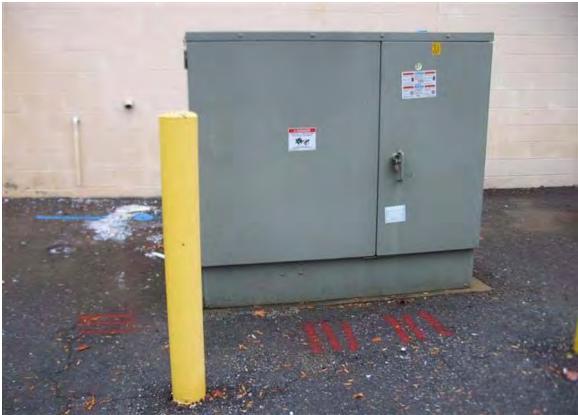
Older transformers and other electrical equipment could contain polychlorinated biphenyls (PCBs) at a level that subjects them to regulation by the U.S. EPA. PCBs in electrical equipment are controlled by United States Environmental Protection Agency regulations 40 CFR, Part 761. At the time of the inspection, EA observed three pad-mounted transformers on the western portion of the Project and four pole-mounted transformers along the southern Project boundary. The transformers are labeled as owned and operated by Duke Energy and appeared to be in good condition. In addition the Food Lion tenant space maintains and operates one cardboard compactor in the shipping and receiving area. No indication of staining, leaks or fire damage was observed on or around the units. No other potential PCB-containing equipment was observed on the Project.

Photograph #10- Typical pad-mounted transformer on the northwestern portion of the Project

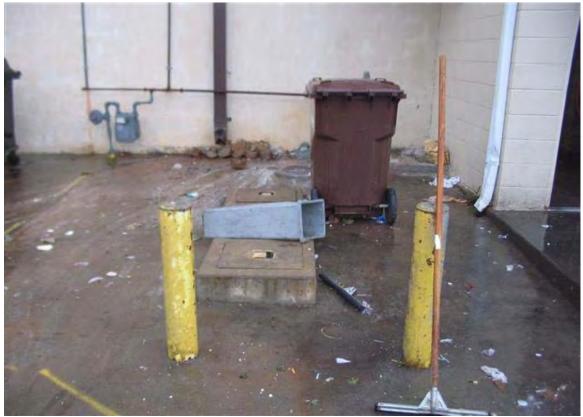
EA personnel observed a grease trap/sump behind Jimmy the Greek Restaurant tenant space (Building 1) and a grease trap/sump behind Project Building 2 for the Venezia Italian Family Restaurant and King Buffet Chinese Restaurant tenant spaces. The traps/sumps are reportedly used to collect food grease from the dish washing operations prior to discharging to the municipal sanitary sewer system. The traps/sumps are not anticipated to have impacted the environmental quality of the Project.

Photograph #11- Food grease trap and grease bin at rear of Building 1 for restaurant tenant space

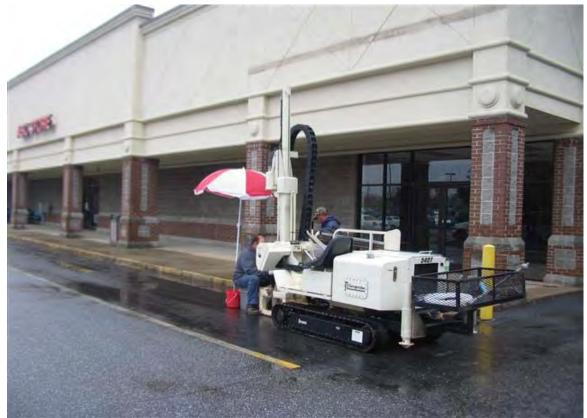
Photograph #13- Sample point for S-1-16/WS-3 in front of the former dry-cleaning facility

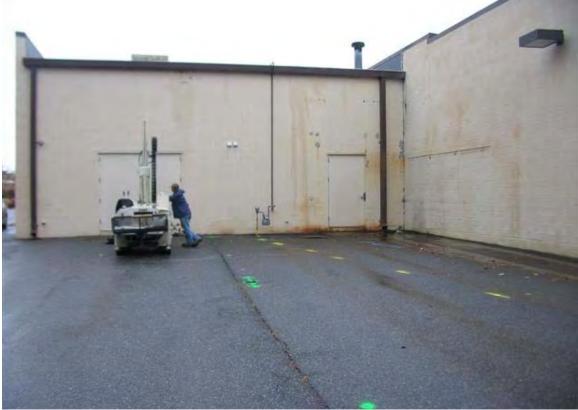
Photograph #14- Sample point for S-3-4/WS-4 at rear of the former dry-cleaning facility

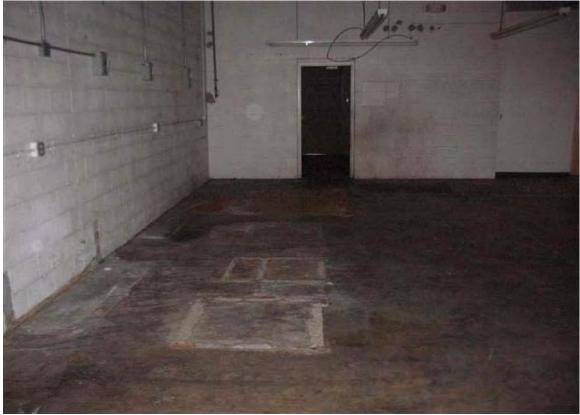
EA noted several areas within the former dry-cleaning facility tenant space where the concrete floor slab was corroded. These areas are most likely where the former dry-cleaning equipment was stored. Dry cleaners use substantial amounts of dry-cleaning solvents, including perchloroethylene, in the dry-cleaning process. Perchloroethylene and other similar chlorinated organic dry-cleaning chemicals are classified by the U.S. EPA as hazardous substances and their use and disposal are highly regulated by federal and state laws. However, use and disposal of the chemicals were not regulated in the past, and leaks and spills of the chlorinated compounds associated with storage and disposal of chemical filters and waste solvents (into trash receptacles and septic systems), as well as discharges from leaking equipment and pipes have resulted in significant ground water contamination incidents at many properties occupied by dry-cleaning establishments. The specific chemical properties of chlorinated solvents facilitate their

Photograph #15- Corroded concrete in area of former machinery inside the former dry-cleaner tenant space

- EA recommends reporting the findings of this investigation to the North Carolina Department of Environment and Natural Resources (NCDENR), Winston-Salem Regional Office, Inactive Hazardous Sites Branch (IHSB) in accordance with the technical and administrative requirements for site assessments and site cleanups pursuant to the Inactive Hazardous Sites Response Act of 1987 (N.C.G.S. 130A-310 et.seq.). The IHSB will determine specific additional assessment and/or remediation required of the owner of the on-site dry-cleaner or responsible party. In the interim, EA also recommends collecting additional soil and/or groundwater samples at the Project in an attempt to further delineate the extent of Tetrachloroethene (PCE) contamination detected in on-site soil and groundwater.

- EA also recommends conducting an indoor air quality/vapor intrusion study of the Project building(s) in order to determine if harmful vapors are migrating into the Project building(s) from the solvents detected in contaminated soil and groundwater below the former dry-cleaner building.

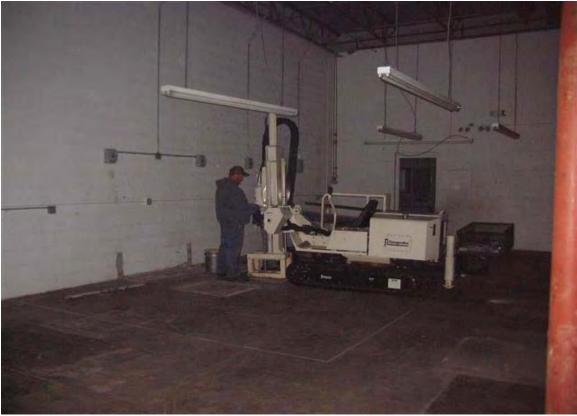
Soil boring S-4 was advanced inside the former dry-cleaning facility tenant space through the concrete floor slab, near the southern sidewall, to a depth of 4 feet below grade (BG). This area is where dry cleaning equipment was reportedly used and where corroded concrete is evident. Soils encountered consisted of dark brown silty clay at depths of 0-4 feet BG. One soil sample (S-4-3) was collected at 3 feet BG.

Photograph #16- Sample point for S-4-3/WS-5 within concrete floor slab of the former dry-cleaning facility

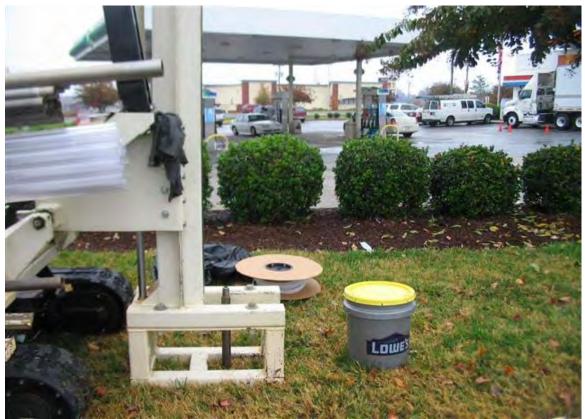
Considering the proximity of our sample point and the off-site UST basin, several petroleum constituents that were detected in groundwater sample WS-1 at the Project exceed NCAC 2L Standards and appear to be a result of off-site release(s) (leaks, spills and/or overfills) from the UST system located at the eastern adjacent 4 Brother's Food Store/BP station.

Photograph #19- Sample point WS-1 along eastern property boundary, adjacent to off-site USTs

• EA recommends reporting the findings of this investigation to the North Carolina Department of Environment and Natural Resources (NCDENR), UST Section, Winston-Salem Regional Office, to report the off-site petroleum release and determine current regulatory status of the incident. Additional assessment and/or corrective action may be required by the responsible party of the off-site release (4 Brother's Food Store) regarding the on-site groundwater concentrations identified in sample WS-1 at the Project. In the interim, EA also recommends collecting additional soil and/or groundwater samples at the Project in an attempt to further delineate the downgradient extent of petroleum contamination detected in on-site groundwater.

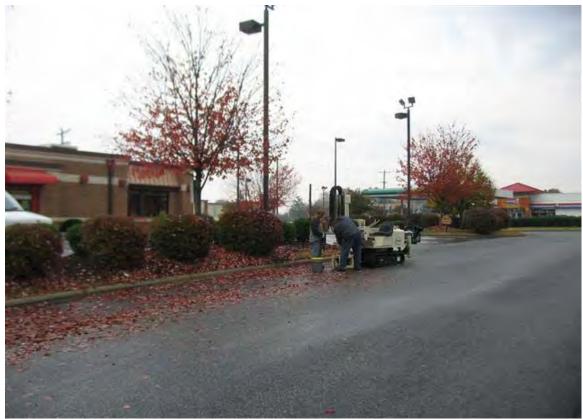
Photograph #20- Sample point WS-2 along northeastern property boundary

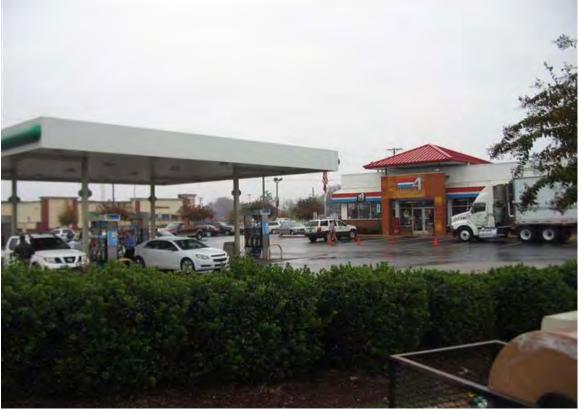
The Project is fronted to the east by Wendy's (former Quik-Pik Food Mart III), 4 Brother's BP Gasoline Station (former Mac Food's) and McDonald's (117 NC Highway 801 N), NC Highway 801 N, beyond which is the former Shell Service Station (136 NC Highway 801 N). These areas were observed to be topographically upgradient relative to the Project. Historical aerial photographs revealed that prior to construction of the current improvements in 1960's and 1990's; these areas existed as undeveloped or agricultural land with limited residential and commercial development since at least 1936. The former Quik-Pik Food Mart III, Four Brother's BP Gasoline Station, former Mac Food's and 801 Shell Service Station are located on the adjacent properties to the east and are detailed in **Section 5.1.2**.

Photograph #22- Adjacent properties to the east – Four Brother's BP Gasoline Station and McDonald's
