**PHASE I ENVIRONMENTAL SITE ASSESSMENT**  
**Proposed Chipotle Mexican Grill #32-0809 – Chapel Hill**  
**301 West Franklin Street**  
**Chapel Hill, Orange County, North Carolina**  
**Terracon Project No. 70067712**

Re: Phase I Environmental Site Assessment  
Proposed Chipotle Mexican Grill #32-0809 – Chapel Hill  
301 West Franklin Street  
Chapel Hill, Orange County, North Carolina  
Terracon Project No. 70067712

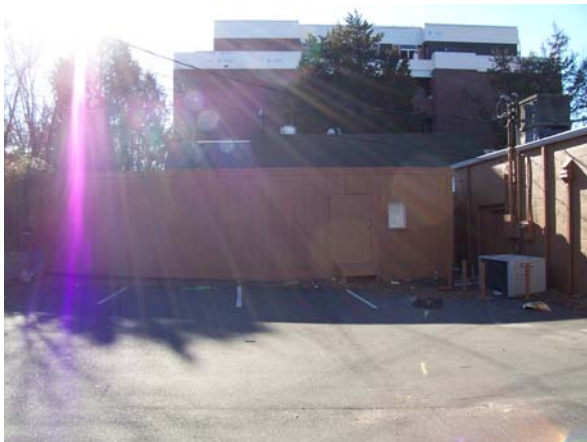
**Photo #3** View of onsite storage building (western exposure)
