Reference: **Part B Permit Application**
(Former) Porcelanite Facility
20 Victor Street
Lexington, North Carolina 27292
EPA ID #NCD 986 181 451

Part A
Part A Application

Part A Figures

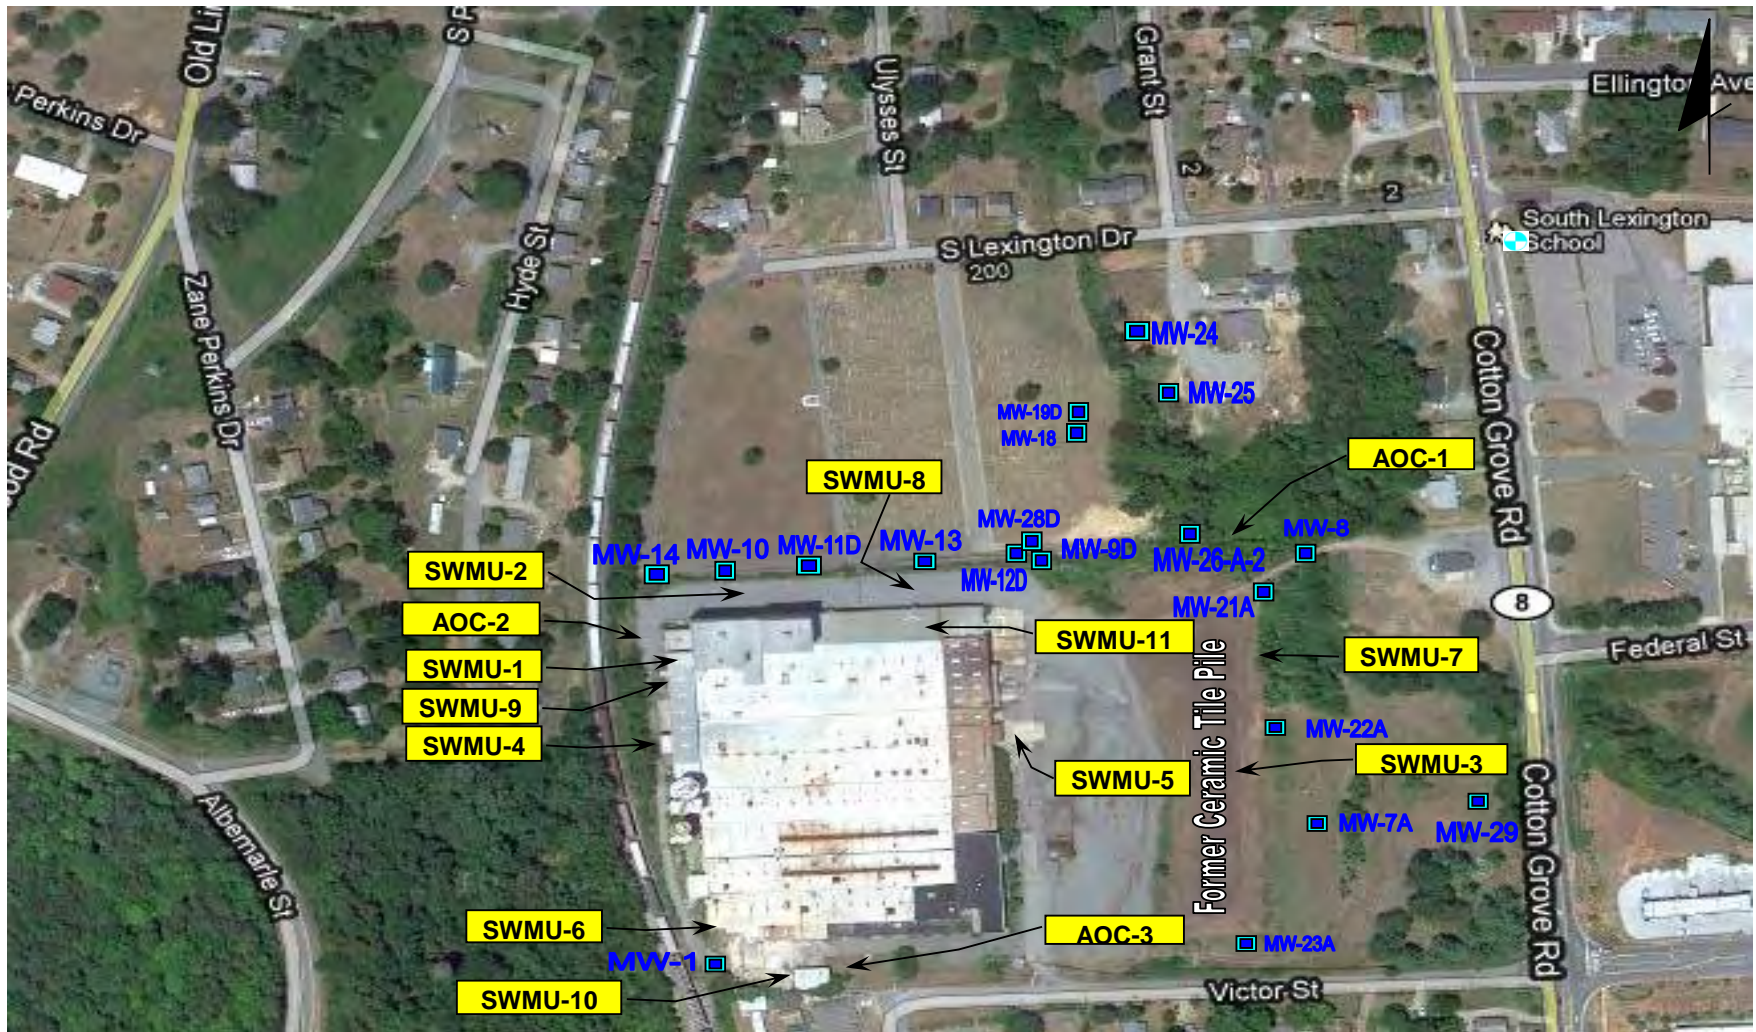
| | 15-006 Fig B-4 | | 2/24/2017 | SWMU and AOC Location Map |

An RFA report was completed on April 29, 2004 by an EPA contractor (Booz Allen, 2004) and submitted on February 16, 2005 (see Appendix B-1). The RFA identified eleven (11) SWMUs and three (3) AOCs as depicted on Figure B-4. The RFA identified the original Hazardous Waste Regulated Units as SWMU-2 (two Sludge Settling Ponds) and SWMU-3 (Ceramic Tile Pile). Based on the 2005 RFA, Table B-1 lists the SWMUs and AOCs identified along with the recommended course of action in 2004 and after reevaluation in 2016. Portions of the following SWMU and AOC descriptions and past investigation summaries are directly referenced from the February 2005 RFA.

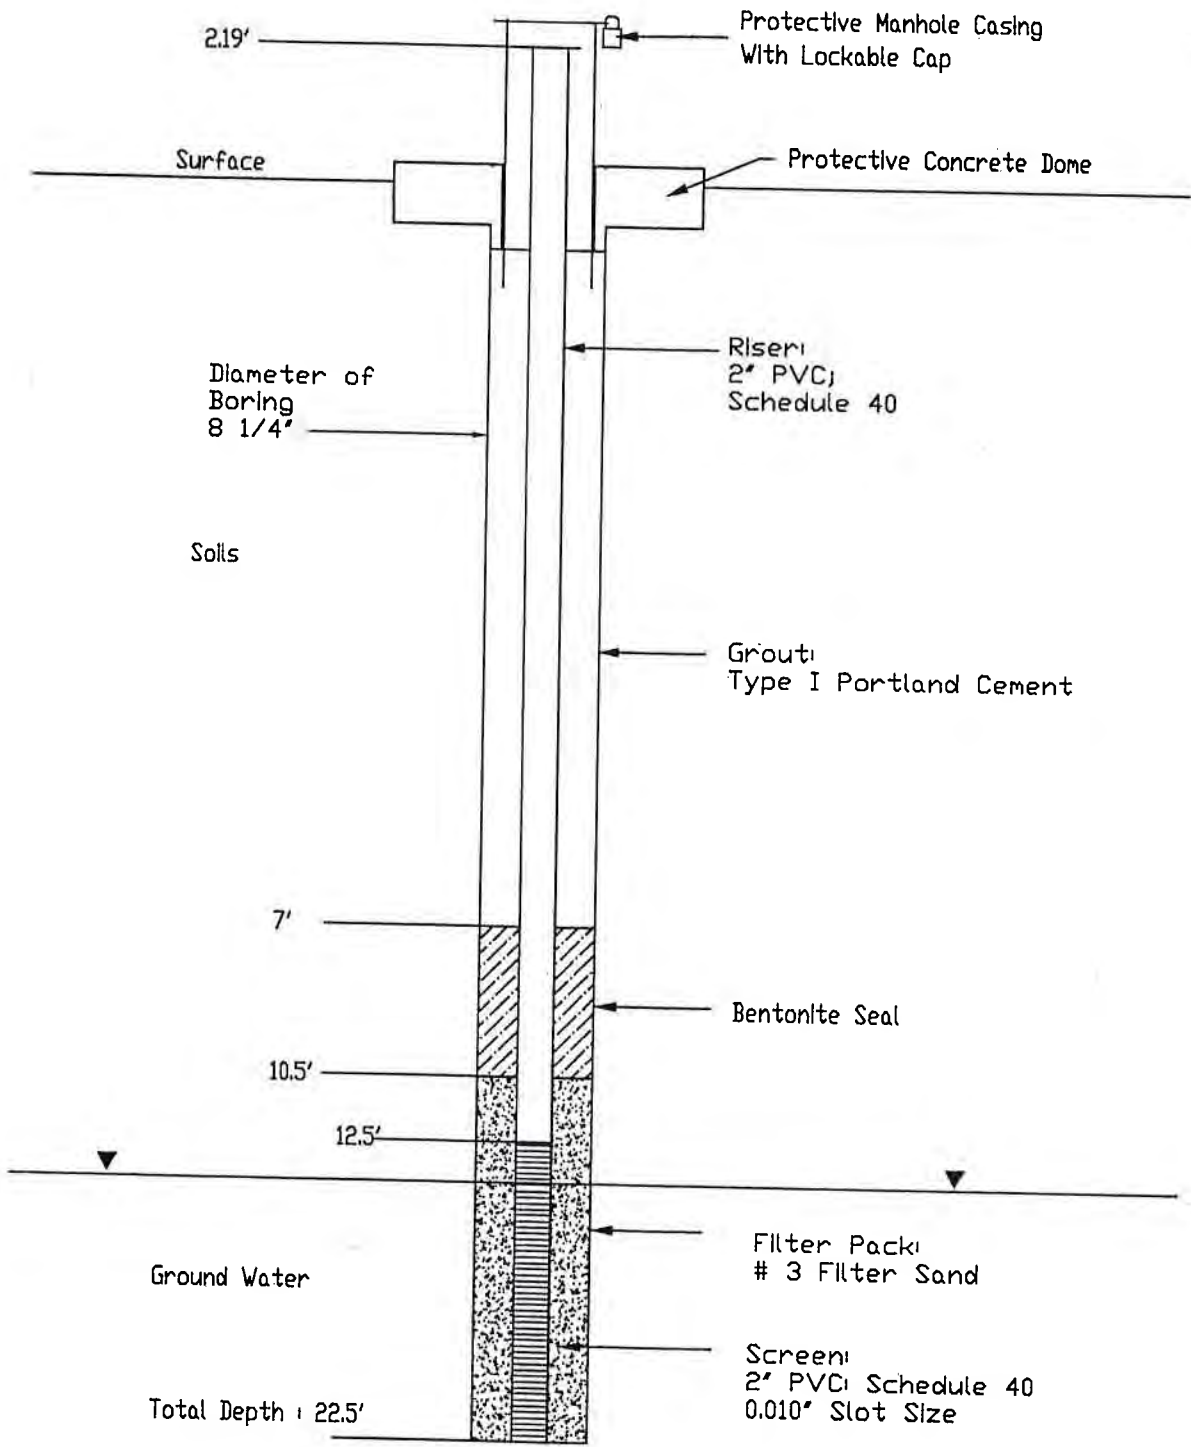
| Author mbb | Drawing 105804 | Layers | Date | Title Well Construction Diagram Monitoring Well MW-22A |

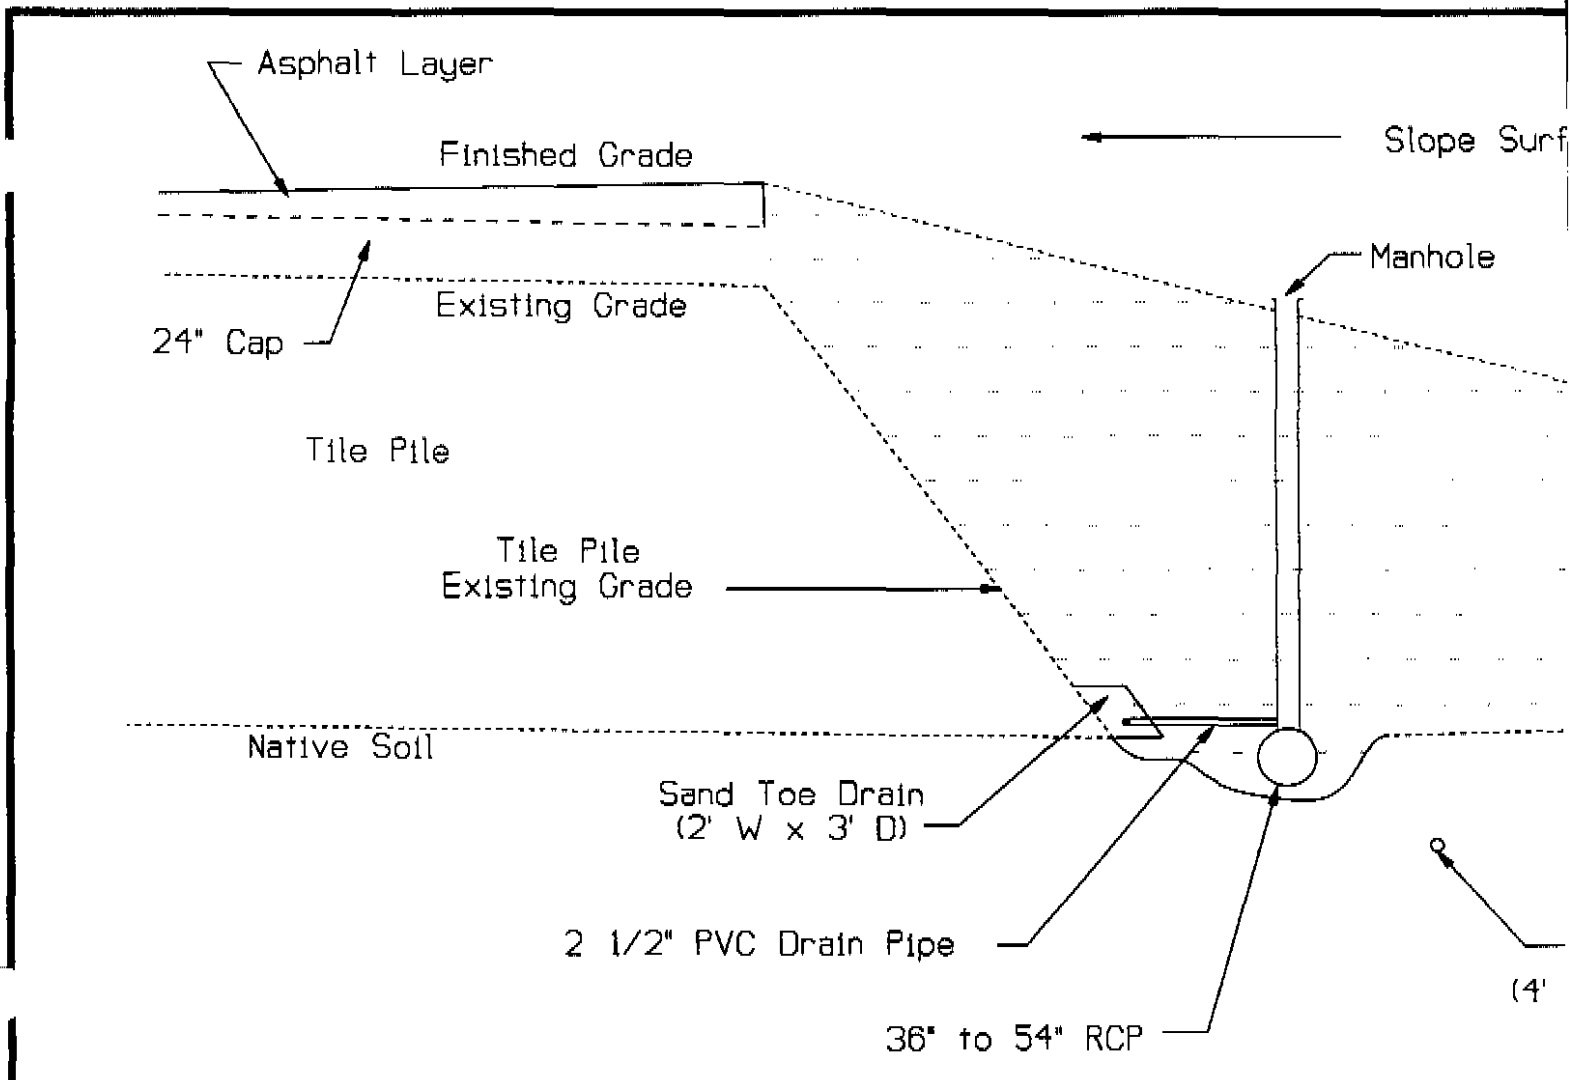
Toe Drain Detail

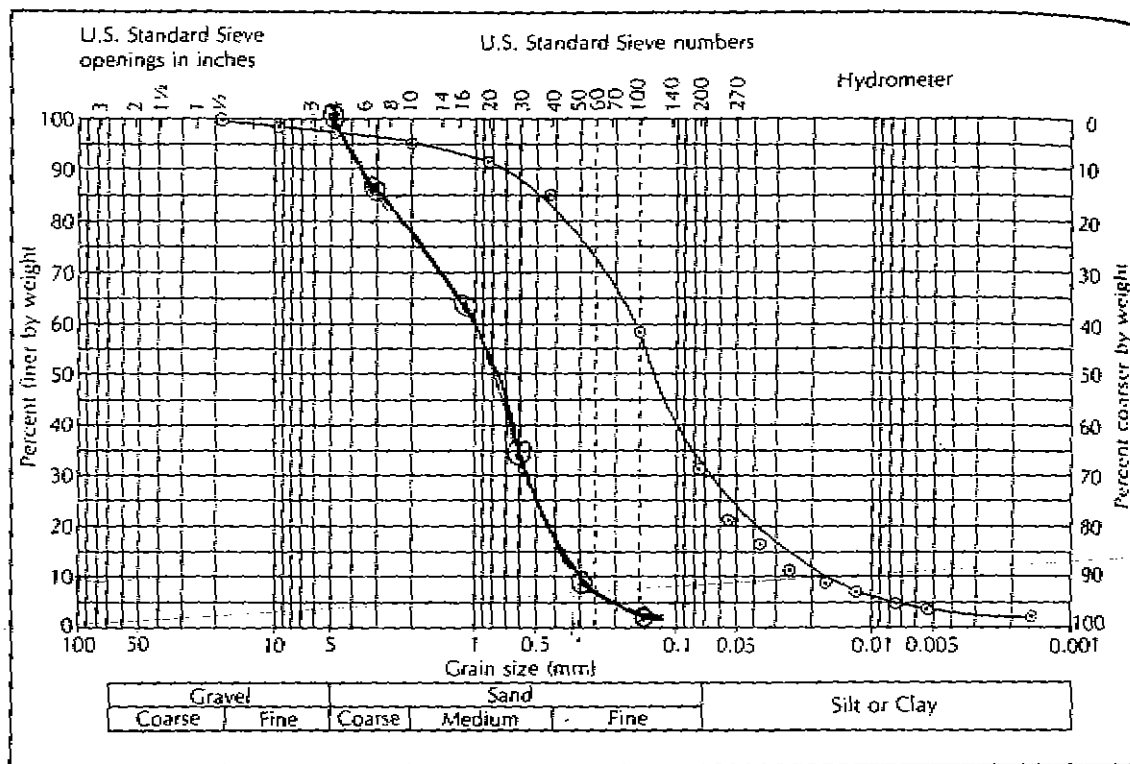
FIGURE 4.4 Grain-size distribution curve of a silty fine to medium sand.

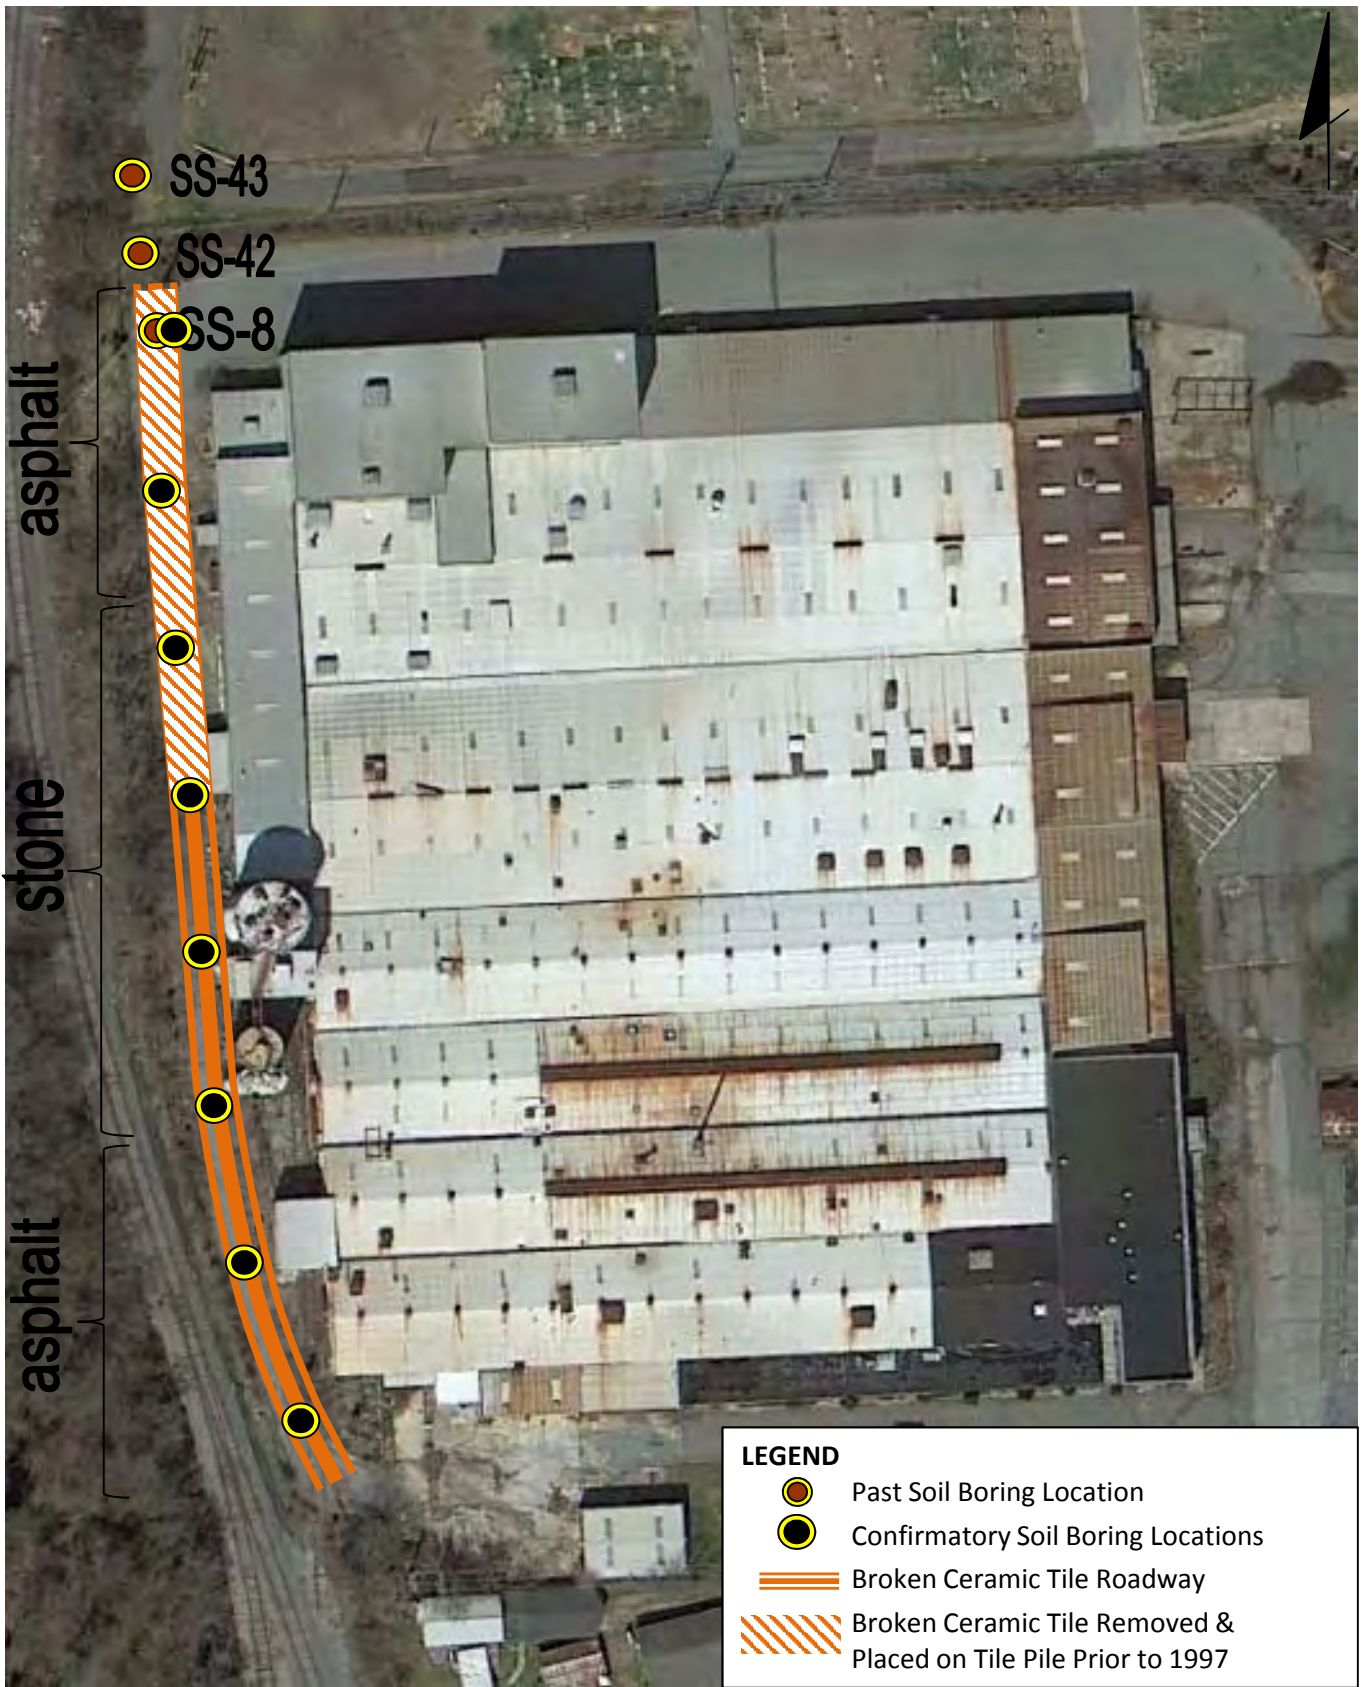
| <i>Author</i> | <i>Drawing</i> Part L Fig L-3 | <i>Date</i> 10.18.2016 | <i>Title</i> AOC-2 Proposed Soil Boring Location Map |
