Facility Name: Heaven Clothing

Address: 1500 Central Ave.

Complaint Investigation Report

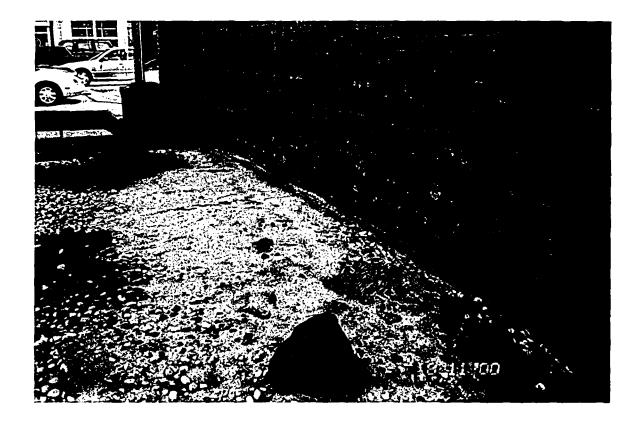
Picture 3

NOTE: SIGNIFICANT AMOUNT of SAND ODSERVED within the rock garden Sample was taken from the center of the most concentrated area. The dig area is in the center of picture.

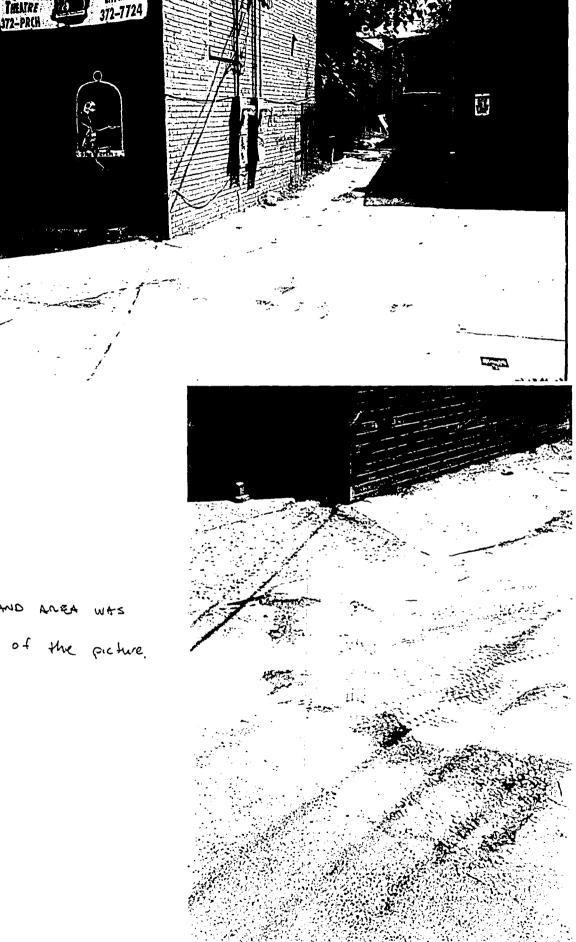
PICTURE 4

Fugitive SAND from the SANdblasting JOD. This is probably run-off from any recent rains.

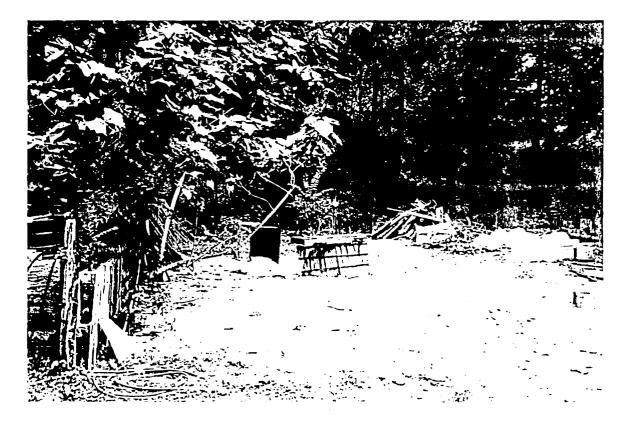
PICTURE 8

- PICTURE of SAMPLE I AL the site - To the left of Wood pile

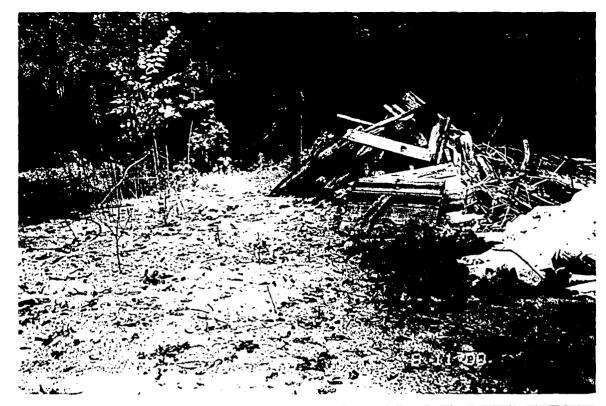
PICTURE 9

PICTURE SAMPLE # 018087

NOTE wood in left side of Picture Noted in Picture 8

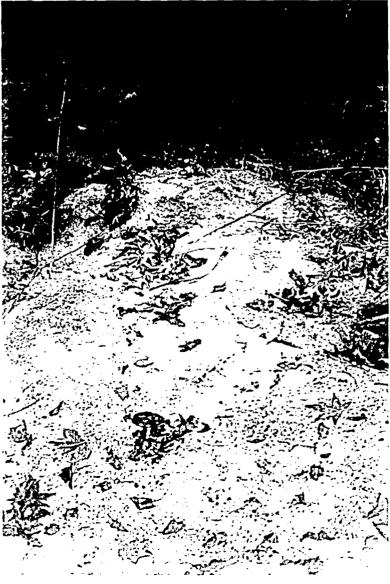
PICTUZE 10

Permane of SAMPle # 018089

Note Roddish / While sand material

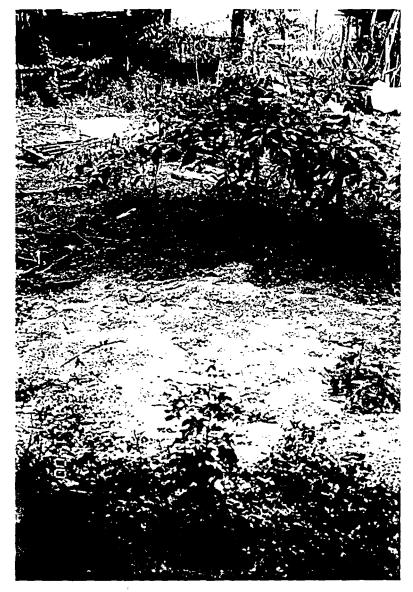
Picture 11

Ricture of SAMPle #018089

NOTE PAINT Chip in center of picture.

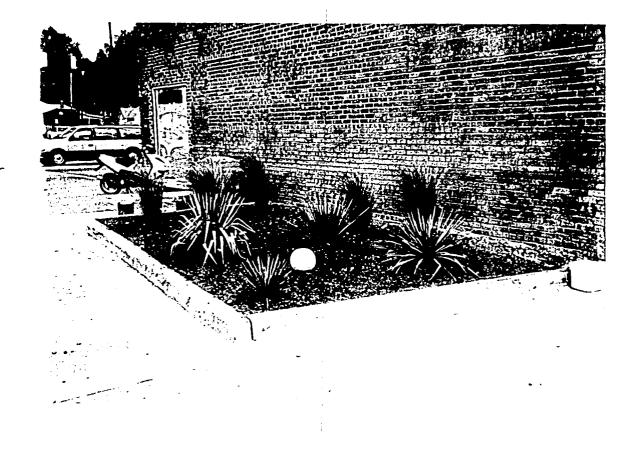
PICTURE 18 ____

Fugitue sand from the Rock GARDEN AREA.

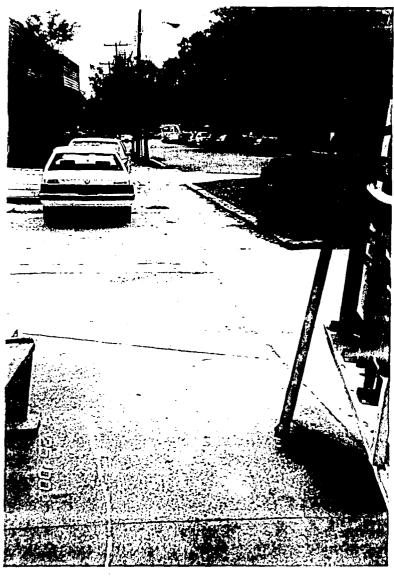
- PICTURE 19 SEPT. 25, 2000

Fugitive stand 4ts mighted to ROAD and ditch area.

5. Based on consultation with the HWS, soil samples will be collected from the surface of non-paved open areas that may have been affected by sandblasted material for total inorganic lead analysis by SW-846 3050/6010. These targeted open areas may include those areas documented in photos 19, 20, 21, 24, 43 and 44 of Joseph Parker's report. The rock garden where lead-containing sand was deposited will also be sampled from beneath any existing liner. Soil sampling will be conducted in general conformance with the attached HUD <u>Guidelines for the Evaluation and Control of Lead-Based Paint Hazards in Housing</u> (June 1995) Appendix 13.3 Soil Sampling Protocol For Housing.

- 1. In item two and three of the plan: Additional areas of concern and/or businesses that may be identified in the survey of air deposition must be added to the sampling activities identified in item four of the plan. The visual and sampling survey must include potentially affected areas and businesses along Gordon Street between Heaven Clothing and Duron Paints. This area is documented in photos 19 - 24 of Joseph Parker's report.

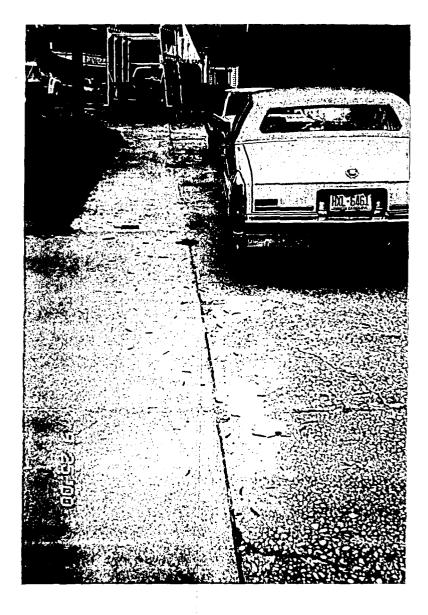
PICTURE 21

HEAVEN CLOTHING employee had been WAShing the area down with Water. Return shows migration away from building.

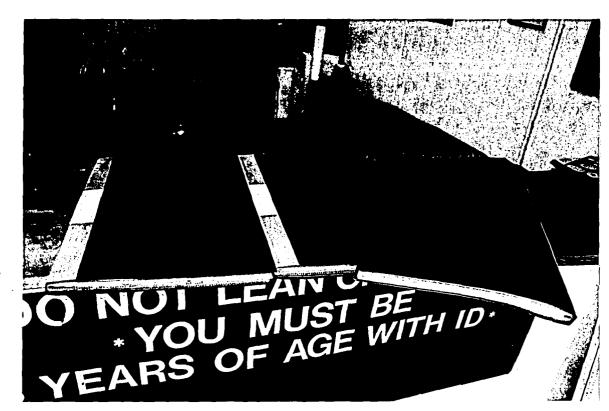
PICTURE 28

PICTURE documents the condition of the wall folders.

NOTE : DUST ON CORNERS

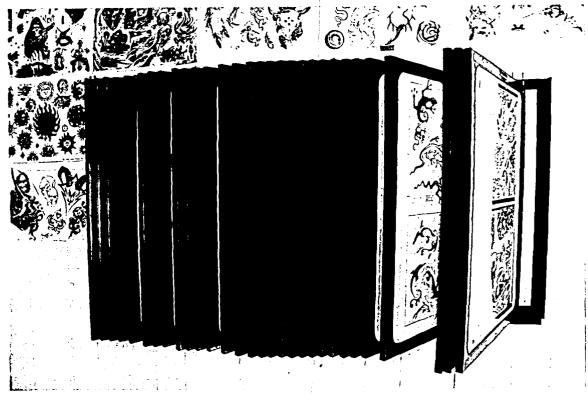
PICTURE 29

PICTURE documents the extent of the dust contaminvation within the work area of the studio.

NOTE: FINGER MARKS left from the WIPING of the contaminated dust ON the television.

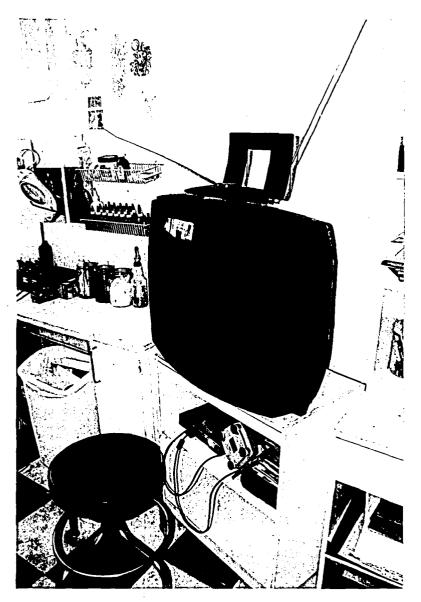
PICTURE 30

PICTURE documents extent of dust containation on equipment in studio.

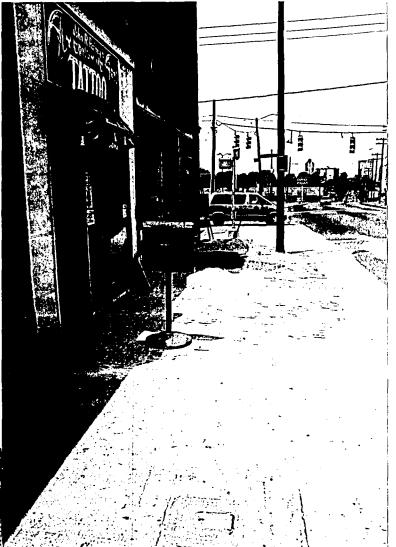
PICTURE 34

PICTURE documents the conditions in front of the Alternative Arts Tattoo Studio.

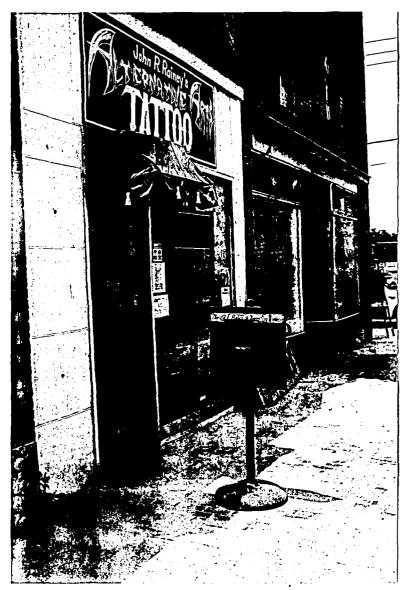
PICTURE documents the amount of SAND, either contraminated or unused, in the Front of the theavon Clothing Site

NOTE: THE # SAND IS SO deep that q. shovel CAN STAND UP.

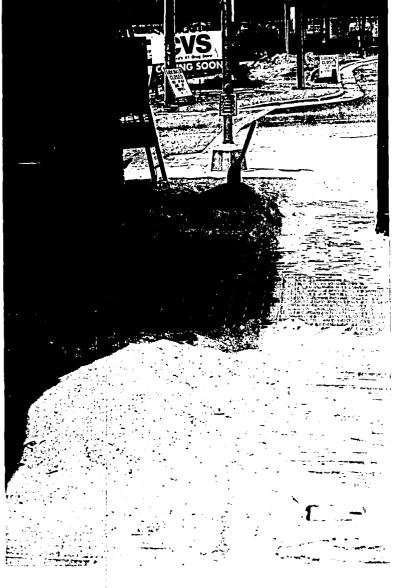
(- Picture 36

Arrothen picture of the outside of Alternative Ants Tattoo studio.

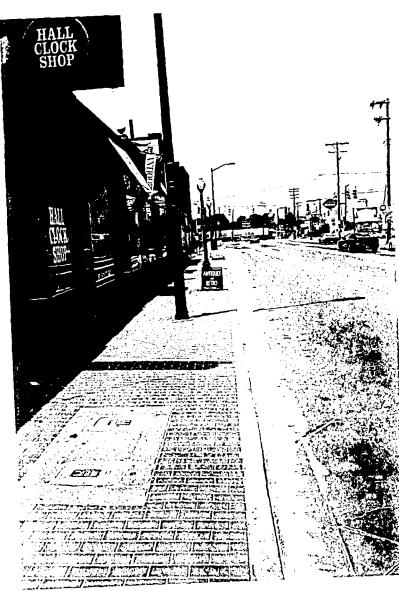
THIS picture documents the migration OF contaminated sand from the Heaven Clothing site. NOTE: SAND IN the ditch grea and IN the middle of the road.

Picture WAS foken Approximately 3-4 businesses owny from Meanon Clothing.

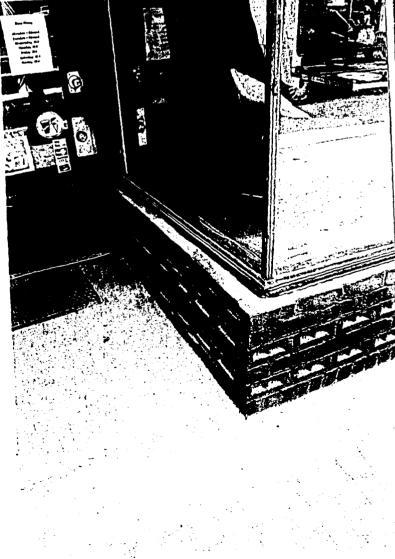
same angle and point as the previous picture. PICTURE 39 ->>

THIS picture WAS taken approximately 10 feet closen than the previous two pictures.

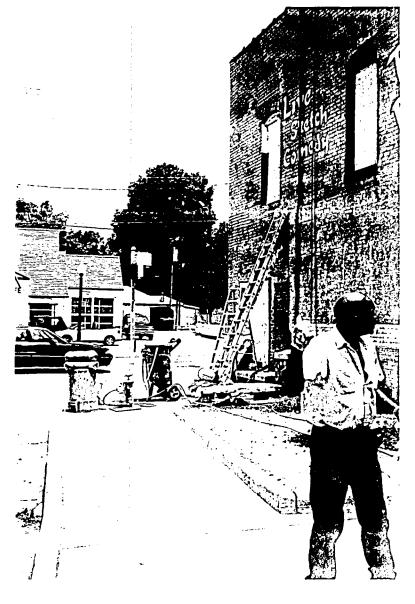
Picture 43

This picture documents the Southern and Eastern outside walls of Heaven Clothing. AN unknown amount of material was left on the top of the building.

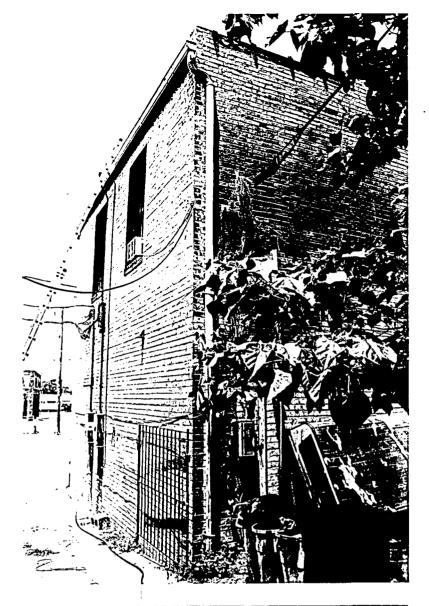
RETURE 44

Picture of the Southean and EAstern outside walls of Menner Clothing.
