FACILITY COMPLIANCE INSPECTION REPORT
Division of Waste Management
Solid Waste Section

COUNTY: Edgecombe
PERMIT NO.: 3302T-MSW-TRANSFER
FILE TYPE: COMPLIANCE

Date of Site Inspection: July 25, 2014 **Date of Last Inspection:** June 10, 2014

FACILITY NAME AND ADDRESS:
Edgecombe Co. MSWLF Transfer
2797 Colonial Road
Tarboro, North Carolina 27886

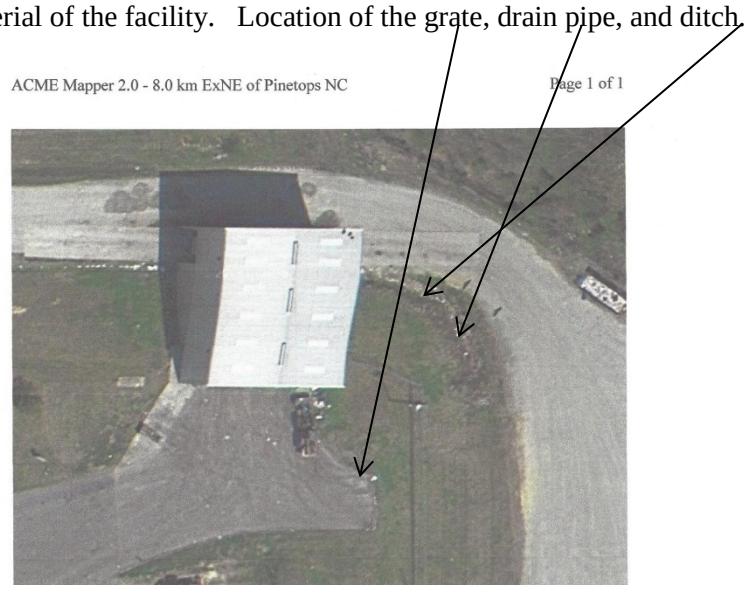
4. The drainage way along the base of the structure has been cleaned of waste but needs to be piped or configured in some way to prevent waste from accumulating.
5. The grate that drains the turn ramp collects trash and other material. This drain conveys runoff into the ditch in the above photos. Any trash that flows through the grate ends up in this ditch. **A method needs to devised to prevent clogging of the grate from the accumulation of trash.**

Aerial of the facility. Location of the grate, drain pipe, and ditch.
