FACILITY COMPLIANCE INSPECTION REPORT
Department of Environmental Quality
Division of Waste Management - Solid Waste Section

Date of Site Inspection: August 24, 2015 **Date of Last Inspection:** Initial

FACILITY NAME AND ADDRESS:
Roxboro Plant Coal Pile Storage Pad Structural Fill
Duke Energy Progress, Inc. - Roxboro Steam Electric Plant
1700 Dunnaway Road
Semora, NC 27343

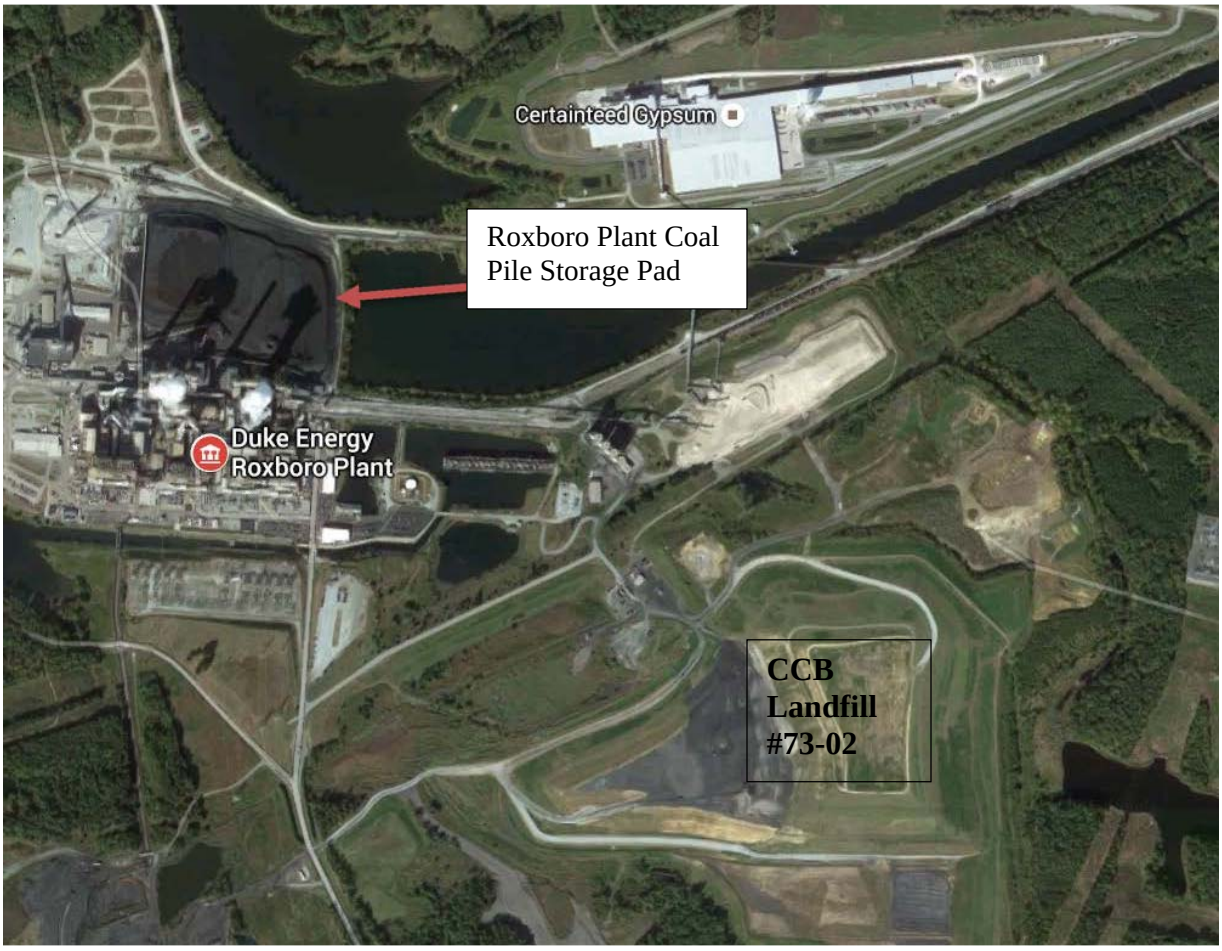
Northest side of storage pad

3. The Coal Pile Storage Pad was being well maintained at the time of the inspection. No erosion or ponded water was observed during the inspection.
