FACILITY COMPLIANCE INSPECTION REPORT
Division of Waste Management
Solid Waste Section

Date of Site Inspection: 29 May 2015 **Date of Last Inspection:** 20 February 2015

FACILITY NAME AND ADDRESS:
Miller Farm LCID Landfill
Miller Farm Road
Morehead City, NC 28557

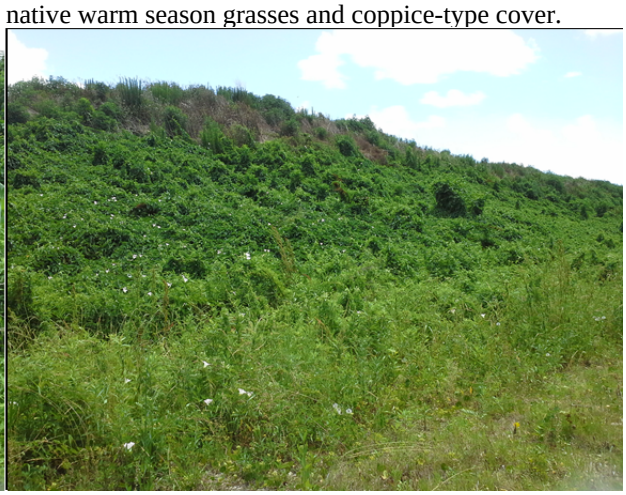
7) Proper signage is posted at the Facility entrance stating the Facility emergency contact number and types of waste accepted.
8) The access road to the Facility is of all-weather construction and is being managed properly at this time.
9) The perimeter road is well maintained, providing for clear access around the Facility.
10) Permanent markers have been installed around the perimeter of the Landfill to identify the Landfill disposal boundaries.
11) The secondary landfill access road has been blocked at the landfill entrance to prevent unauthorized access to the Facility.
12) Overall, this Facility has a well-established cover crop of native warm season grasses and coppice-type cover.

13) *Please monitor the landfill cover crop. Mowing activities will soon be necessary to properly maintain the landfill cover crop and to prevent the growth of trees and other woody vegetation on the landfill sideslopes.
14) The access ramp to the upper lift of the landfill has been blocked to prevent unauthorized disposal of waste in the inactive areas of the landfill.
15) The active disposal area has been relocated from the upper lift of the landfill to the toe of the eastern sideslopes adjacent to the landfill access ramp.
16) *Please ensure that the active working area is well defined and maintained in a compact and manageable size.
17) The waste type was reviewed, the waste type being disposed was vegetative waste only and no unpermitted materials were observed during this Facility Compliance Inspection.
