UST CLOSURE INSPECTION CHECKLIST

Date January 14 93

Facility/Site Name: North State Telephone
City/Town: 500 Hamilton St. High Point
Owner: Brinson Diesel Sales and Service — County: Guilford
Operator: — Phone: (919) 844-2229
Contractor: Teague Pump Co. Inc. — Phone:
Laboratory: Burlington Labs. — Phone: (919) 882-2916
Directions: — Phone:

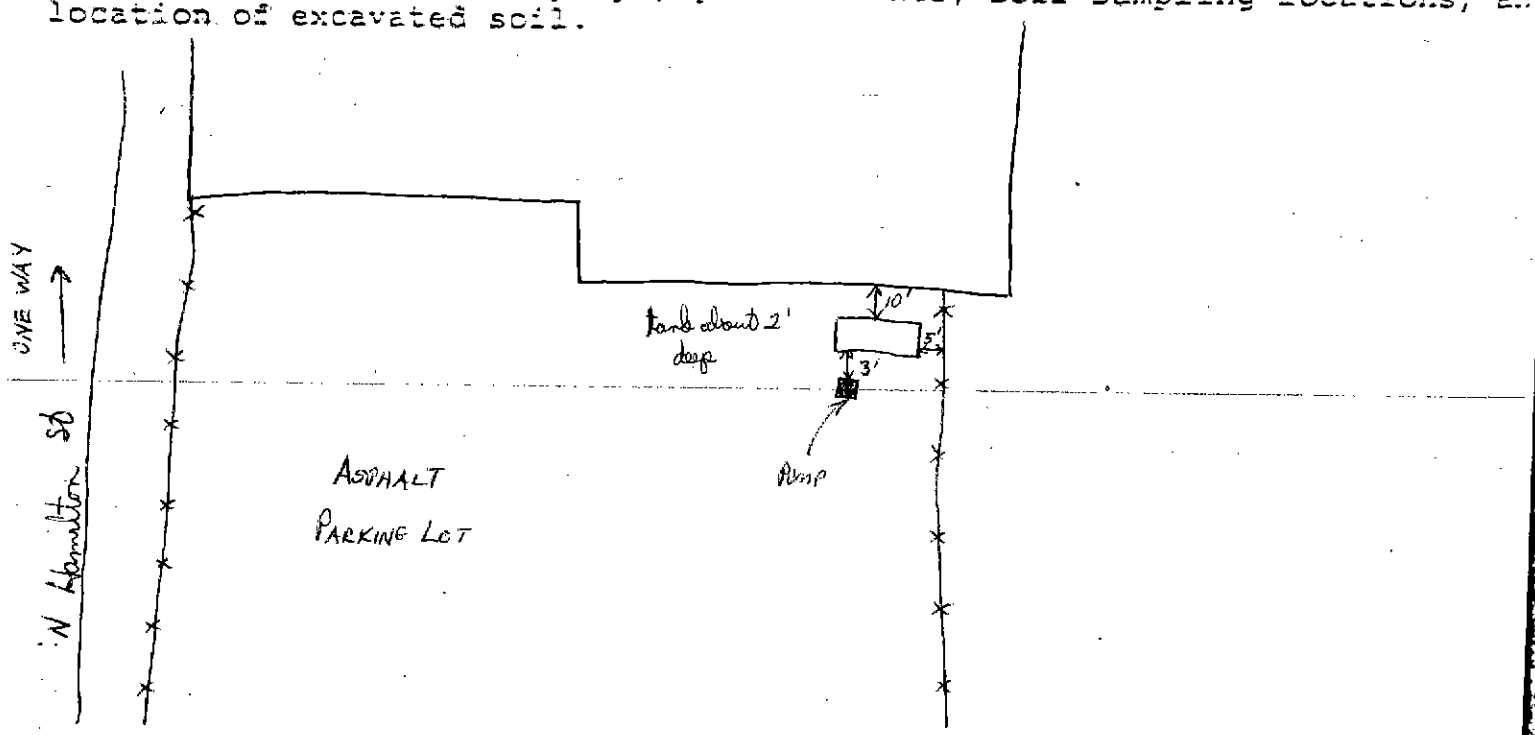
DIAGRAM OF SITE INVESTIGATION AT UST CLOSURE

Jim Bell on site for High Point fire.
Tank was in very good condition, no pitting or holes and very minimal corrosion.
The soil that came from on top of the tank had a strong odor of gas, it was also stained green.
They removed the fill from around the tank and cleaned out the hole to native soil and the soil was clean.
I could not see or smell any evidence of contamination in the native soil.
