Re: 30,000 Gallon Fuel Oil UST Excavation
Draper Corporation, 5644 Hornaday Road
Greensboro, North Carolina

Report of Findings
Draper Corporation
5644 Hornaday Road
Greensboro, North Carolina

Closure Report
30,000 Gallon Fuel Oil UST
Draper Corporation
Hornaday Road
Greensboro, North Carolina

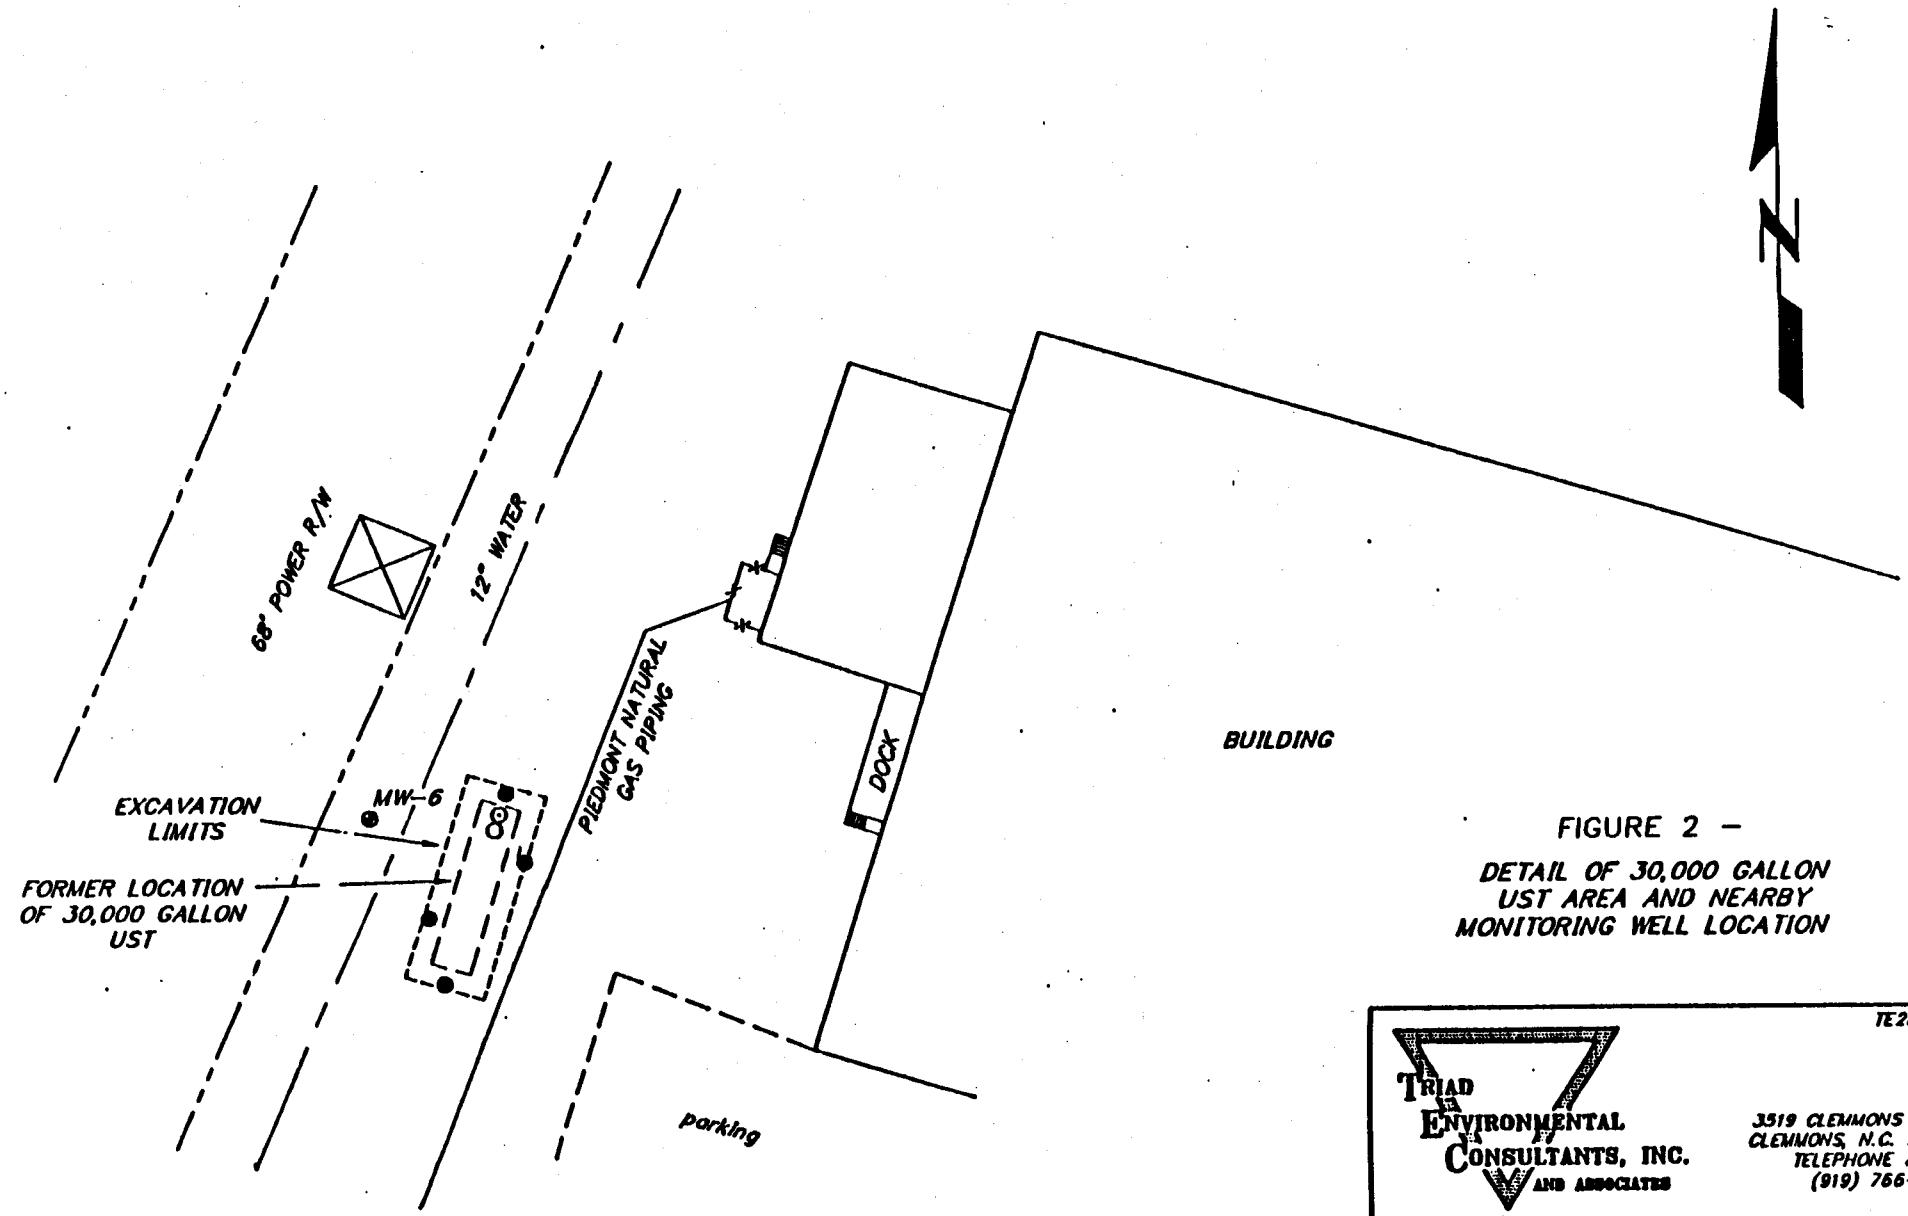
FIGURE 2 –

On January 7, 1993, a groundwater monitoring well was installed adjacent to the former tank location as shown on Figure 2. Details of well construction are shown in Appendix II. Groundwater was encountered at a depth of 9.87 feet on January 13, 1993 and a depth of 10.72 feet on January 25, 1993.

DETAIL OF 30,000 GALLON UST AREA AND NEARBY MONITORING WELL LOCATION

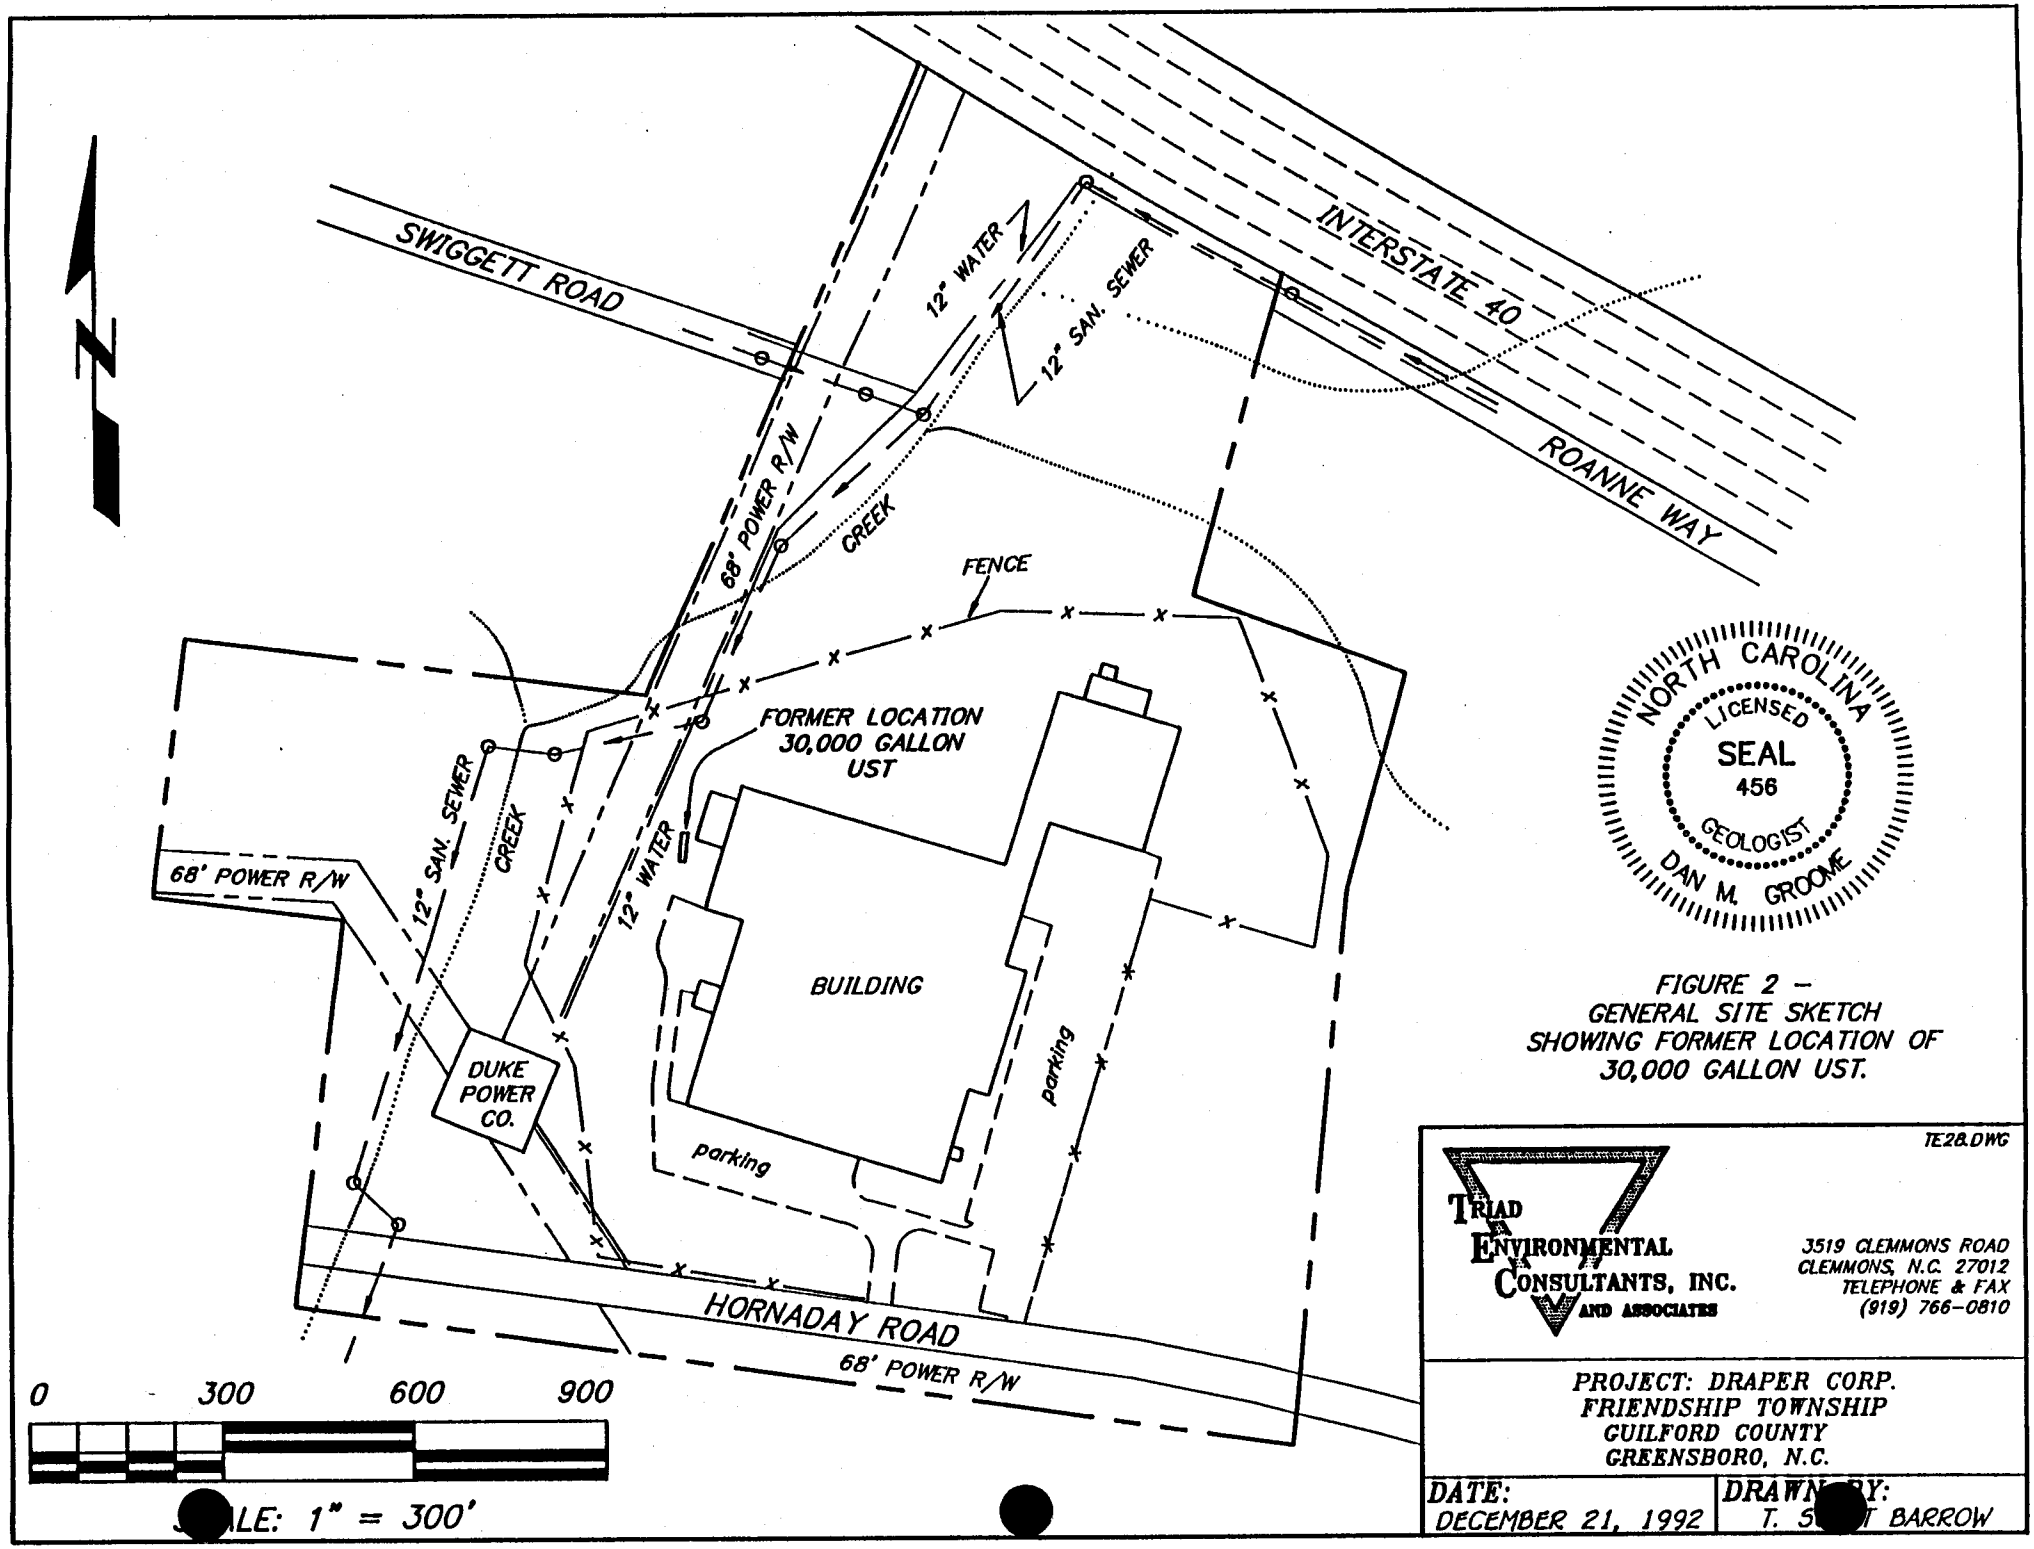
FIGURE 2 –
GENERAL SITE SKETCH
SHOWING FORMER LOCATION OF
30,000 GALLON UST.

On December 16, 1992, a 30,000 gallon steel UST (Underground Storage Tank) was removed from the referenced site. A location map of the site is included in this report as Figure 1 and a general site sketch is included as Figure 2. The UST had been used to store #4 fuel oil. The dimensions of the tank were 10.5 feet in diameter by 46.5 feet in length. The top of the tank was approximately three feet below the ground surface. No evidence of perforations in the surface of the UST was visible. The tank was transported to an approved disposal facility and a certification of disposal is provided as Appendix I.

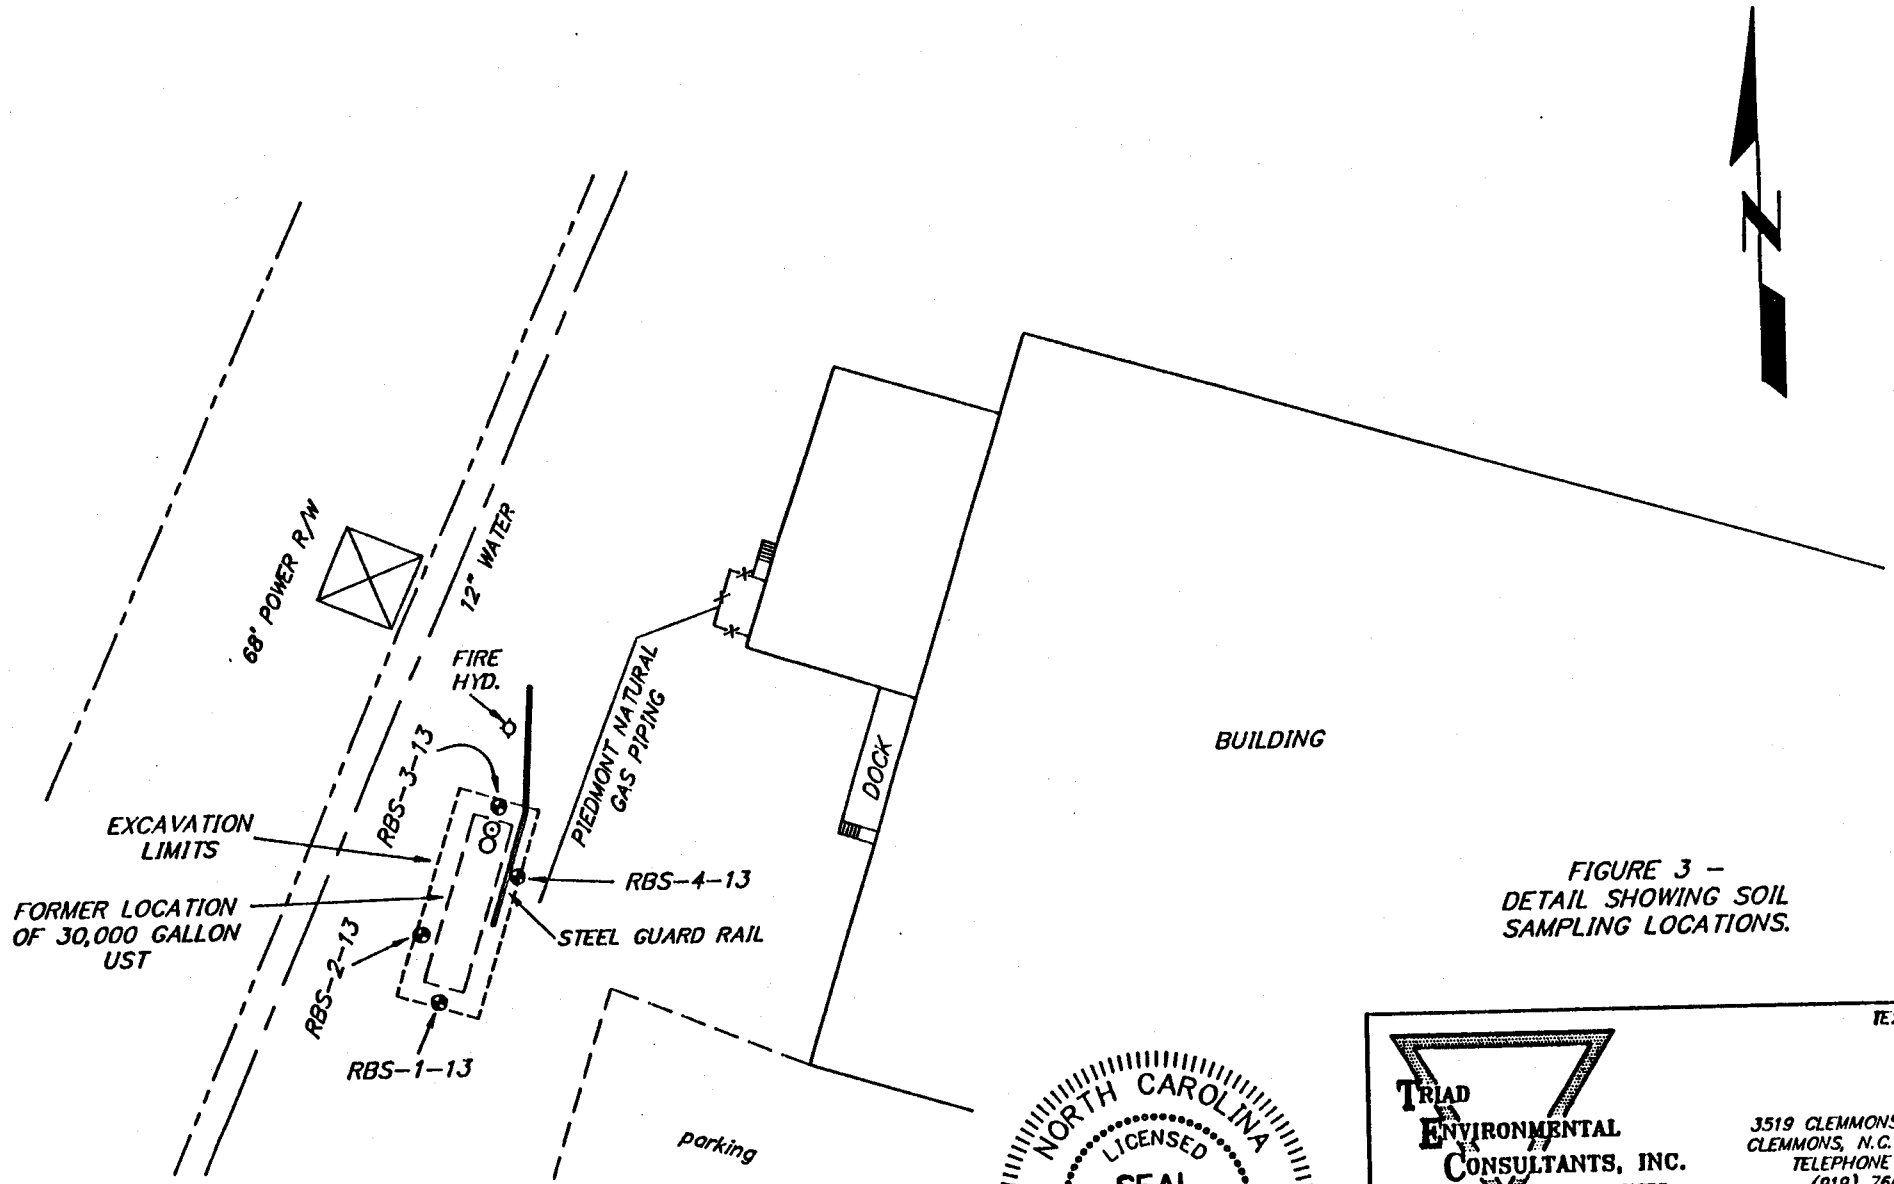
FIGURE 3 –
DETAIL SHOWING SOIL
SAMPLING LOCATIONS.

Upon excavation of the soil surrounding the UST, evidence of product leakage was observed. The source of the leakage appeared to be from the product lines. It was elected to excavate as much impacted soil as possible in an attempt to remove the contamination. However, the presence of an underground natural gas line, underground fire protection lines, overhead power lines and a concrete anchor pad limited excavation. The excavated soils were stockpiled on site in containment areas constructed of polyethylene sheeting. Subsequent to soil excavation, soil samples were obtained from the sidewalls of the excavation. Safety considerations and restricted access limited soil sampling. New, disposable latex gloves were worn during sampling in order to reduce the risk of accidental contamination. Triad Environmental Consultants, Inc.'s standard equipment decontamination and sample handling procedures are included as Appendix III. The locations of the soil samples are shown on Figure 3. The samples were split into duplicates with one part evaluated with an Organic Vapor Analyzer (OVA) and the other part placed in a new, clean jar for laboratory analysis. The results of the OVA analyses are included in Table 1.

The laboratory analyses indicate that petroleum hydrocarbons remain in place in the area where the UST was previously mounted. The concentrations indicated by the laboratory analyses are above the action levels currently established by the North Carolina Division of Environmental Management, and remedial action of some form is likely to be required.
