UST CLOSURE INSPECTION CHECKLIST

Date February 9, 93

Facility/Site Name: Southeast Airport
City/Town: 6328 Monnett Road, Climax
Owner: Southeast Airport — County: Guilford
Operator: — Phone: (919) 674-7663
Contractor: 4 Seasons Industrial Services — Phone:
Laboratory: — Phone: (919) 273-2718
Directions: — Phone:

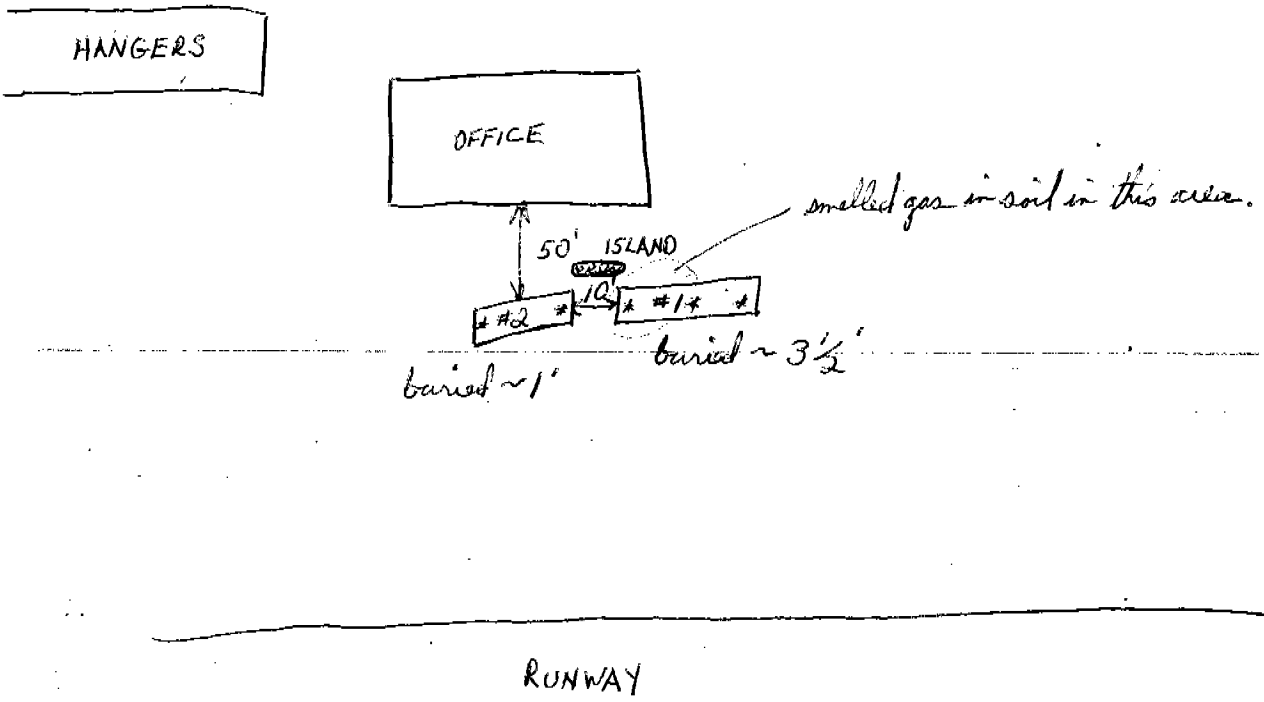
DIAGRAM OF SITE INVESTIGATION AT UST CLOSURE

Tank #2 19% LEL. Tank in good shape, minimal corrosion, no holes noted. No odor of gas in soil

Tank #1 5% LEL. Some pitting & corrosion, no holes noted. Smelled gas on island side of tank. Also smelled gas under island 2' deep
