UST CLOSURE INSPECTION CHECKLIST

Inspector's Name K. Gage Date 4·27·93

Facility/Site Name: Elm St. Sunoco
City/Town: Greensboro County: Gu
Owner: Sunoco - Mid State Oil Phone:
Operator: Phone:
Contractor: Griffith Enterprises Phone:
Laboratory: REK W. Va. Phone:
Directions: at intersection of Elm - Eugene and I-40

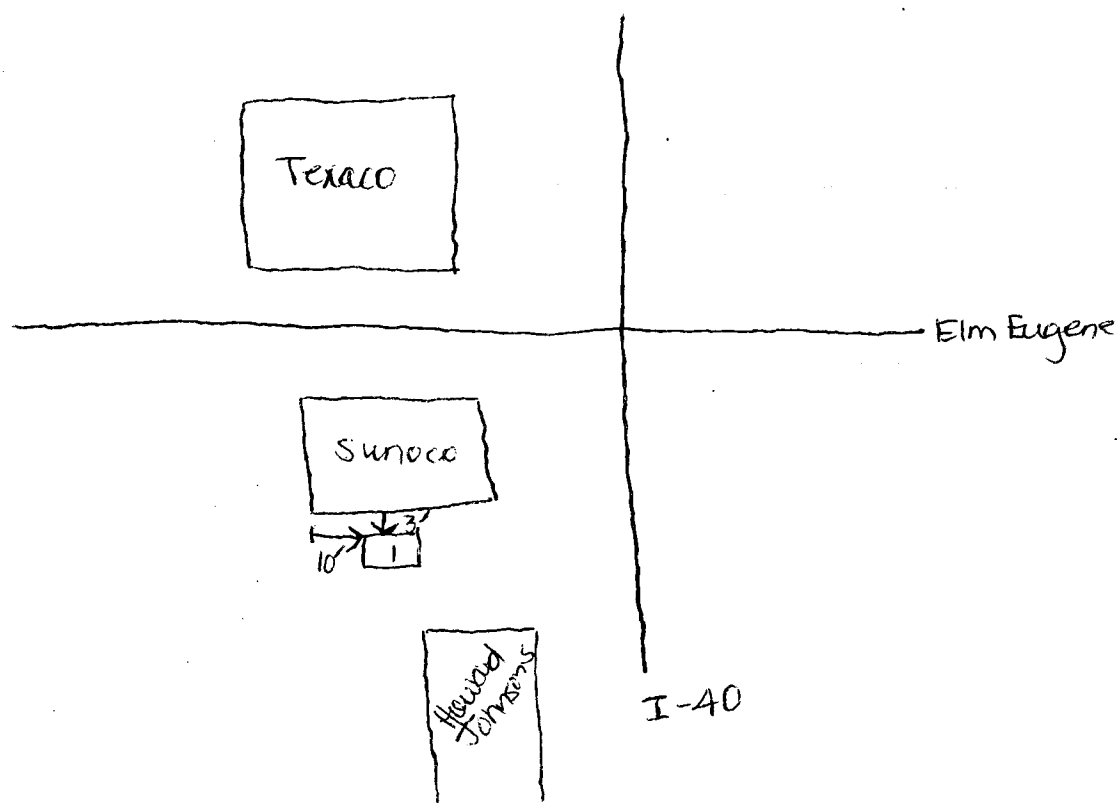
DIAGRAM OF SITE INVESTIGATION AT UST CLOSURE

64"d x 75" l tank dimensions
overburden returned to hole
