Reference: Report of Limited Asbestos Survey
The News and Observer Properties
215 South McDowell Street,
111 and 123 West Hargett Street,
Raleigh, North Carolina
ASE Project No. 1259A

REPORT OF LIMITED ASBESTOS SURVEY
NEWS AND OBSERVER PROPERTIES
215 SOUTH MCDOWELL STREET,
111 AND 123 WEST HARGETT STREET,
RALEIGH, NORTH CAROLINA

ASE PROJECT NO. 1259A

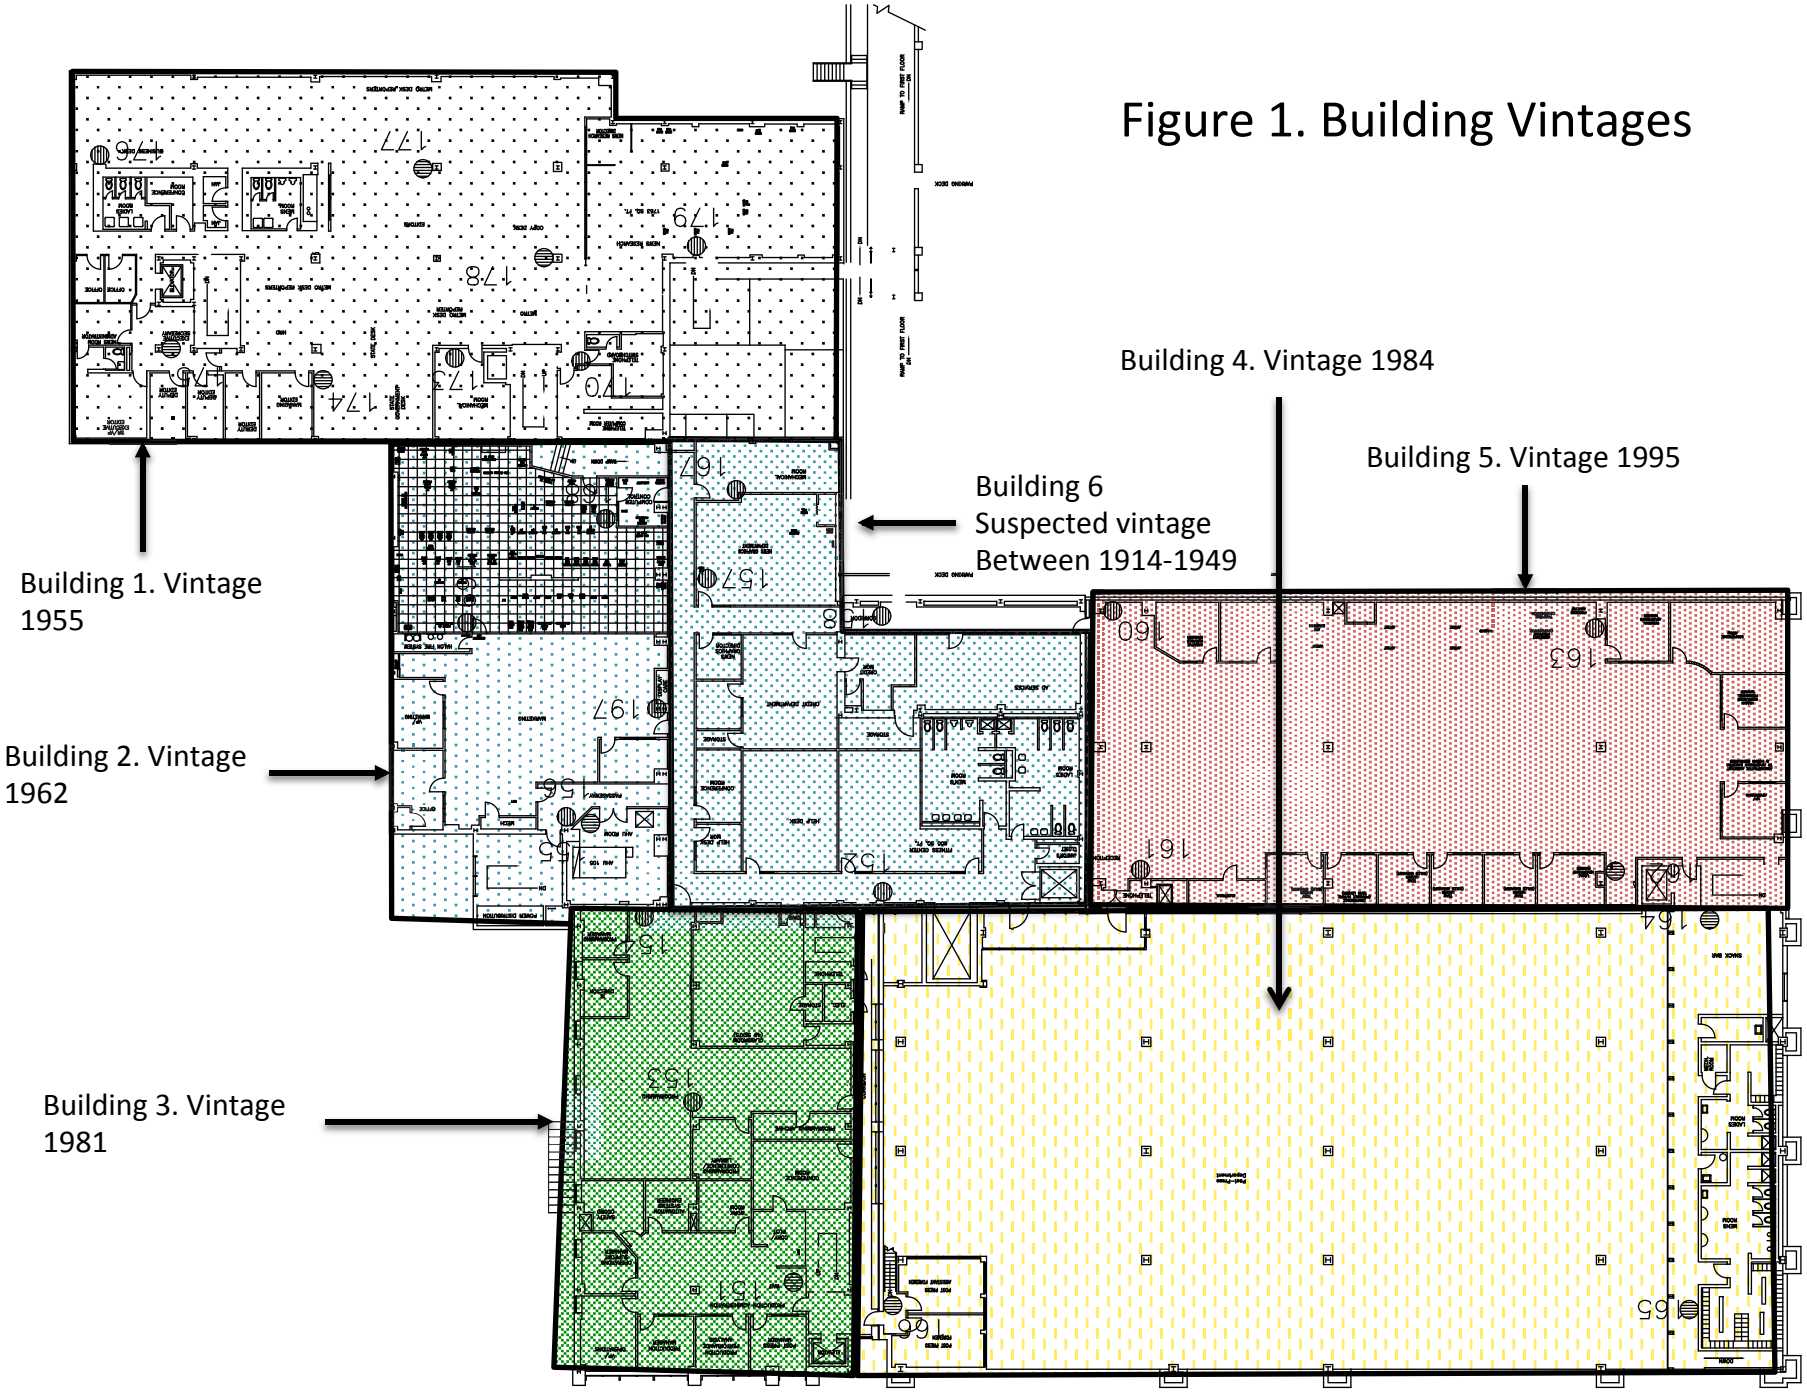
Figure 1. Building Vintages

The above referenced property is located in downtown Raleigh at the intersections of South McDowell Street, West Hargett Street, South Salisbury Street, and West Martin Street. The site includes approximately 3.3 acres of land occupied by approximately 248,103 square-feet of mixed commercial and office building space. The News and Observer Company currently occupies a three-story brick building with a basement at this address. This building is currently used as office space and printing/publishing operations for The News and Observer Newspaper and encompasses several contiguous structures. A parking deck is also located on this parcel. Suspect material was not observed in the parking deck. According to the Key Manager for the property, Edwin F. (Pete) Caison, the building has had five additions throughout the years (from 1955 to 1984). The facility appears to have been built around a building of unknown vintage. However ASE believes that this building was constructed between 1914 and 1949. Figure 1 illustrates each building and lists its construction date.

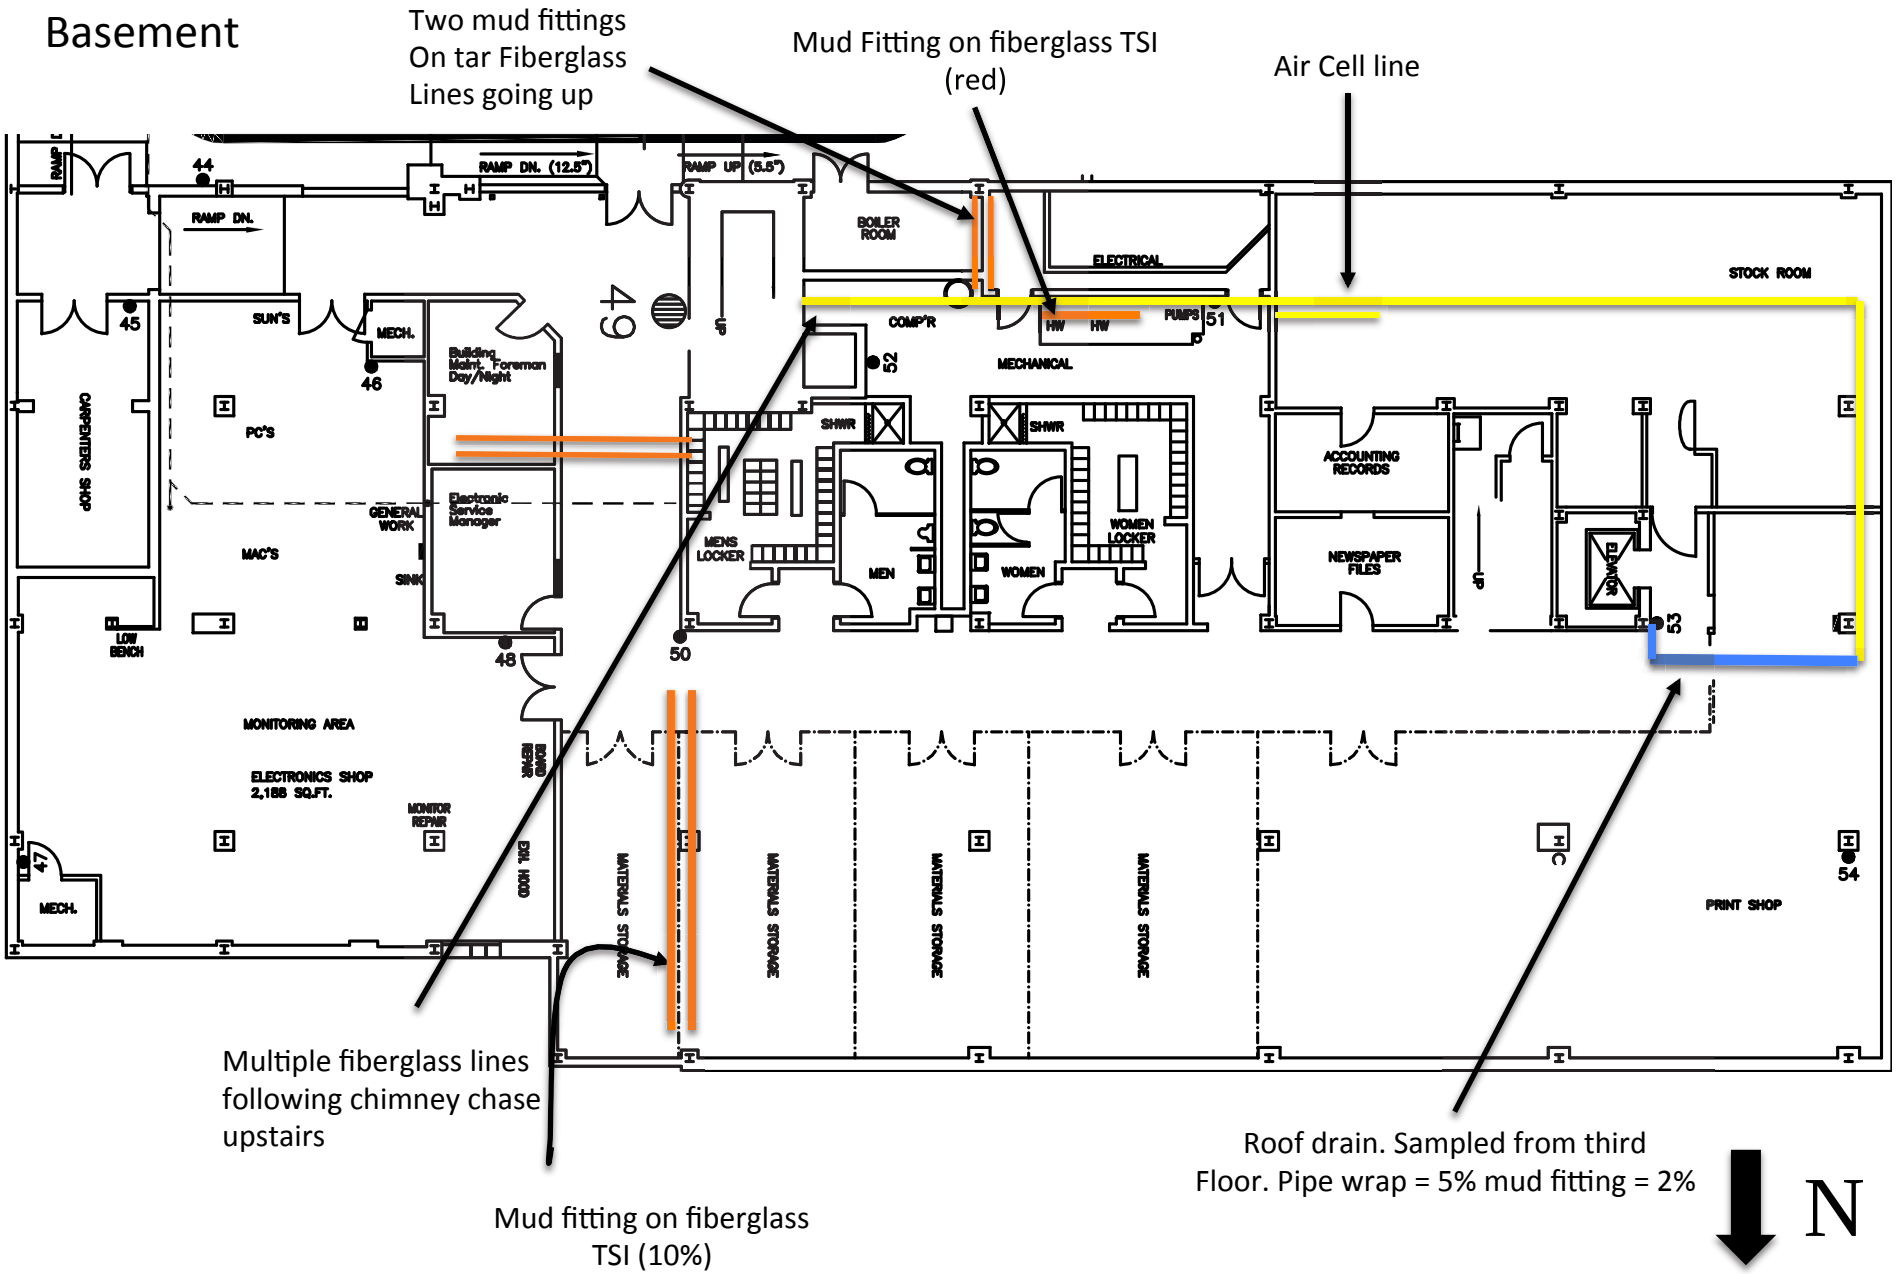
Figure 2 Building 1. Basement

Please refer to Table 1 for a detailed description of the positive ACM samples for Building 1 and mailroom, Table 5 for estimated quantities, and Figures 2-6 for illustrations of positive sample locations.

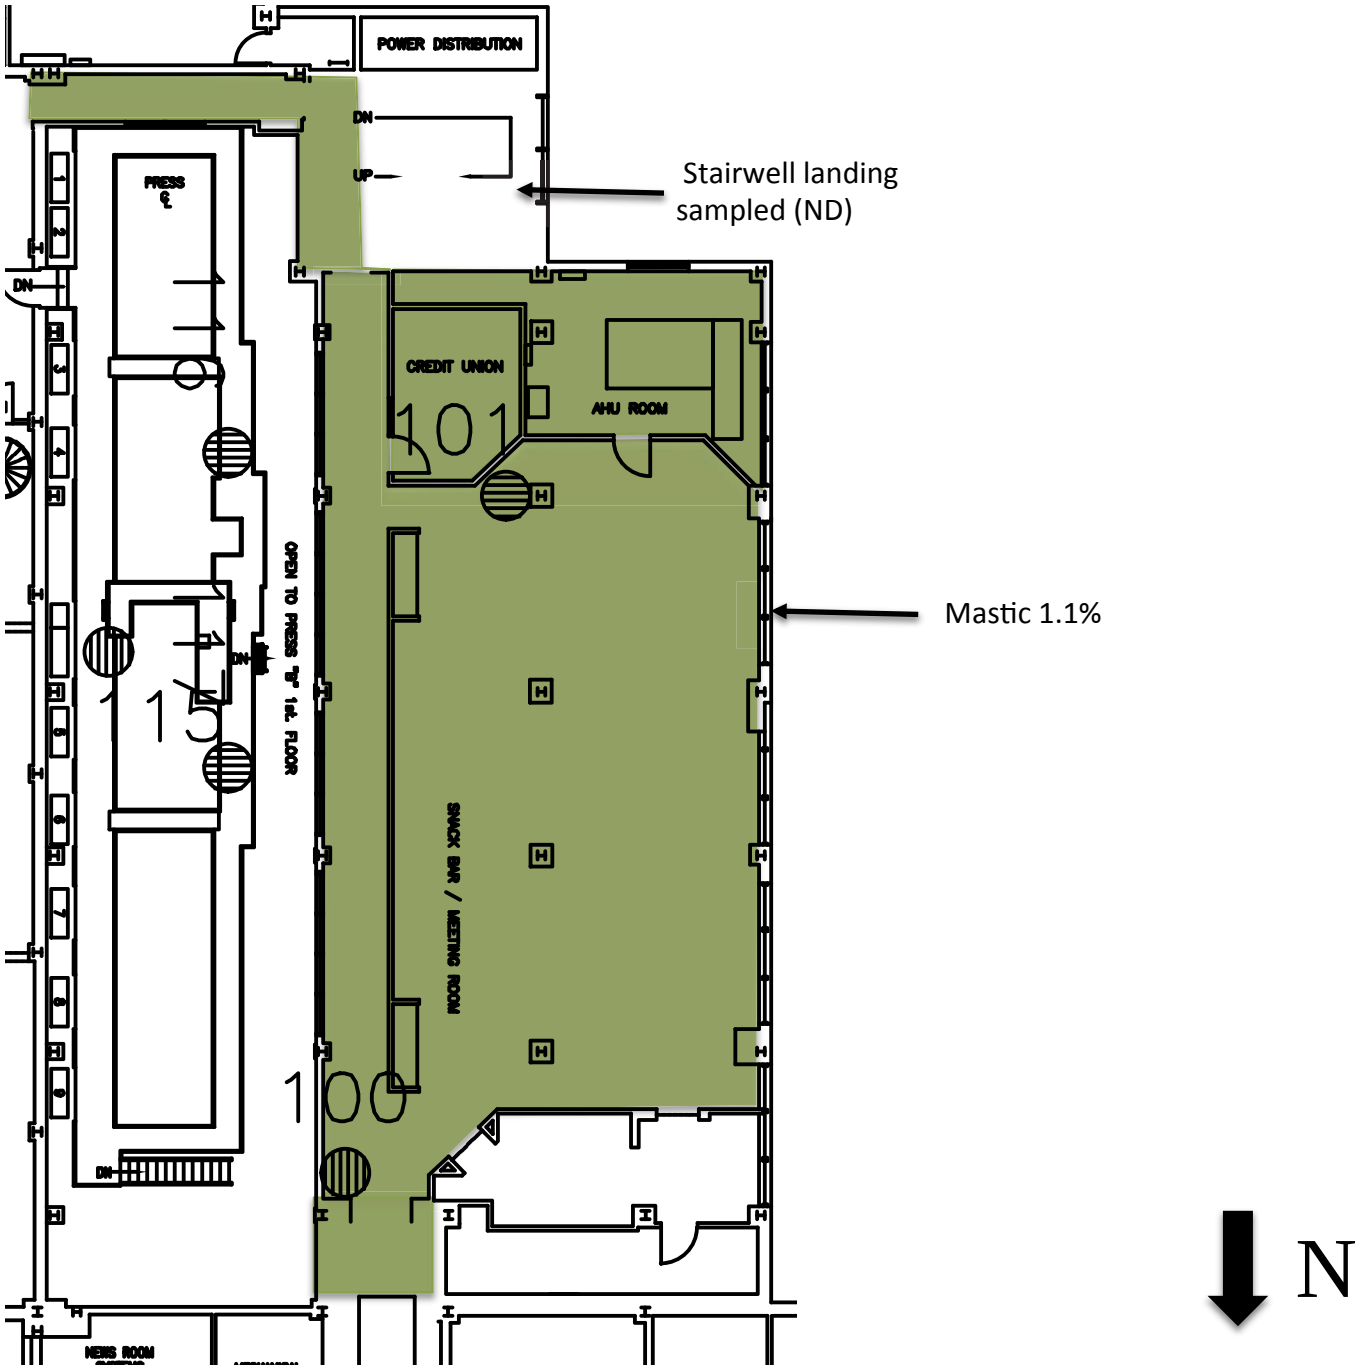
Figure 7 Building 2.
Second floor

Please refer to Table 2 for a detailed description of the positive ACM samples for Building 2, Table 5 for estimated quantities and Figures 7-9 for illustrations of positive sample locations.

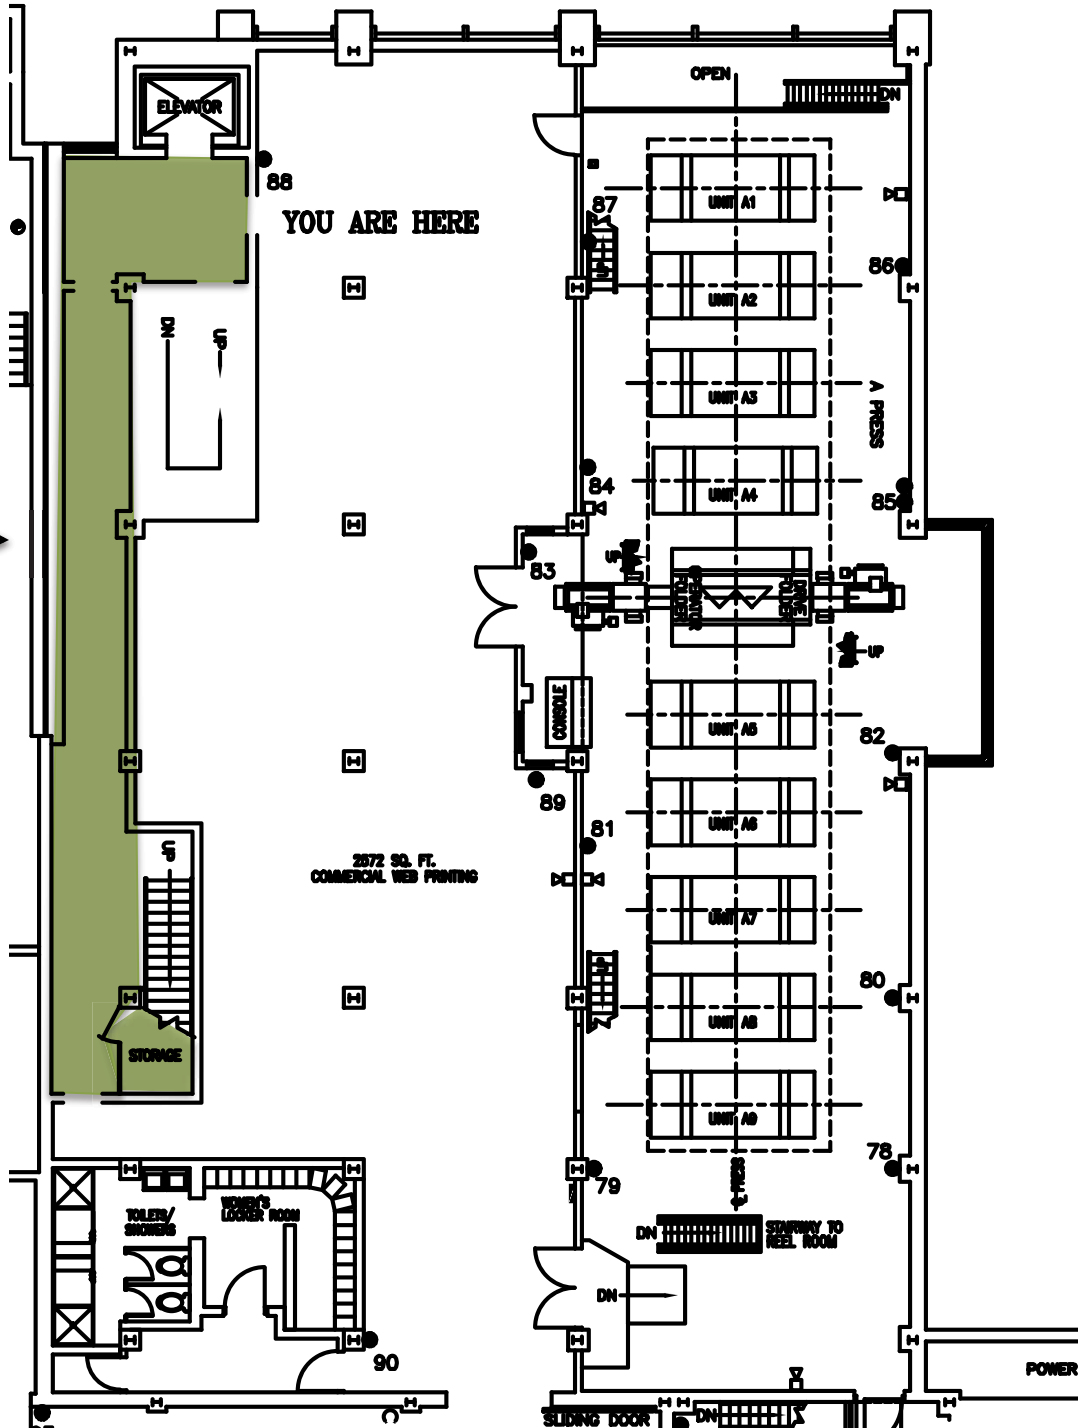
Figure 10 Building 3. First floor

Please refer to Table 3 for a detailed description of the positive ACM samples for Building 3, Table 5 for estimated quantities and Figures 10 and 11 for illustrations of positive sample locations.

12x12 tile, 2.9%
Mastic <1%

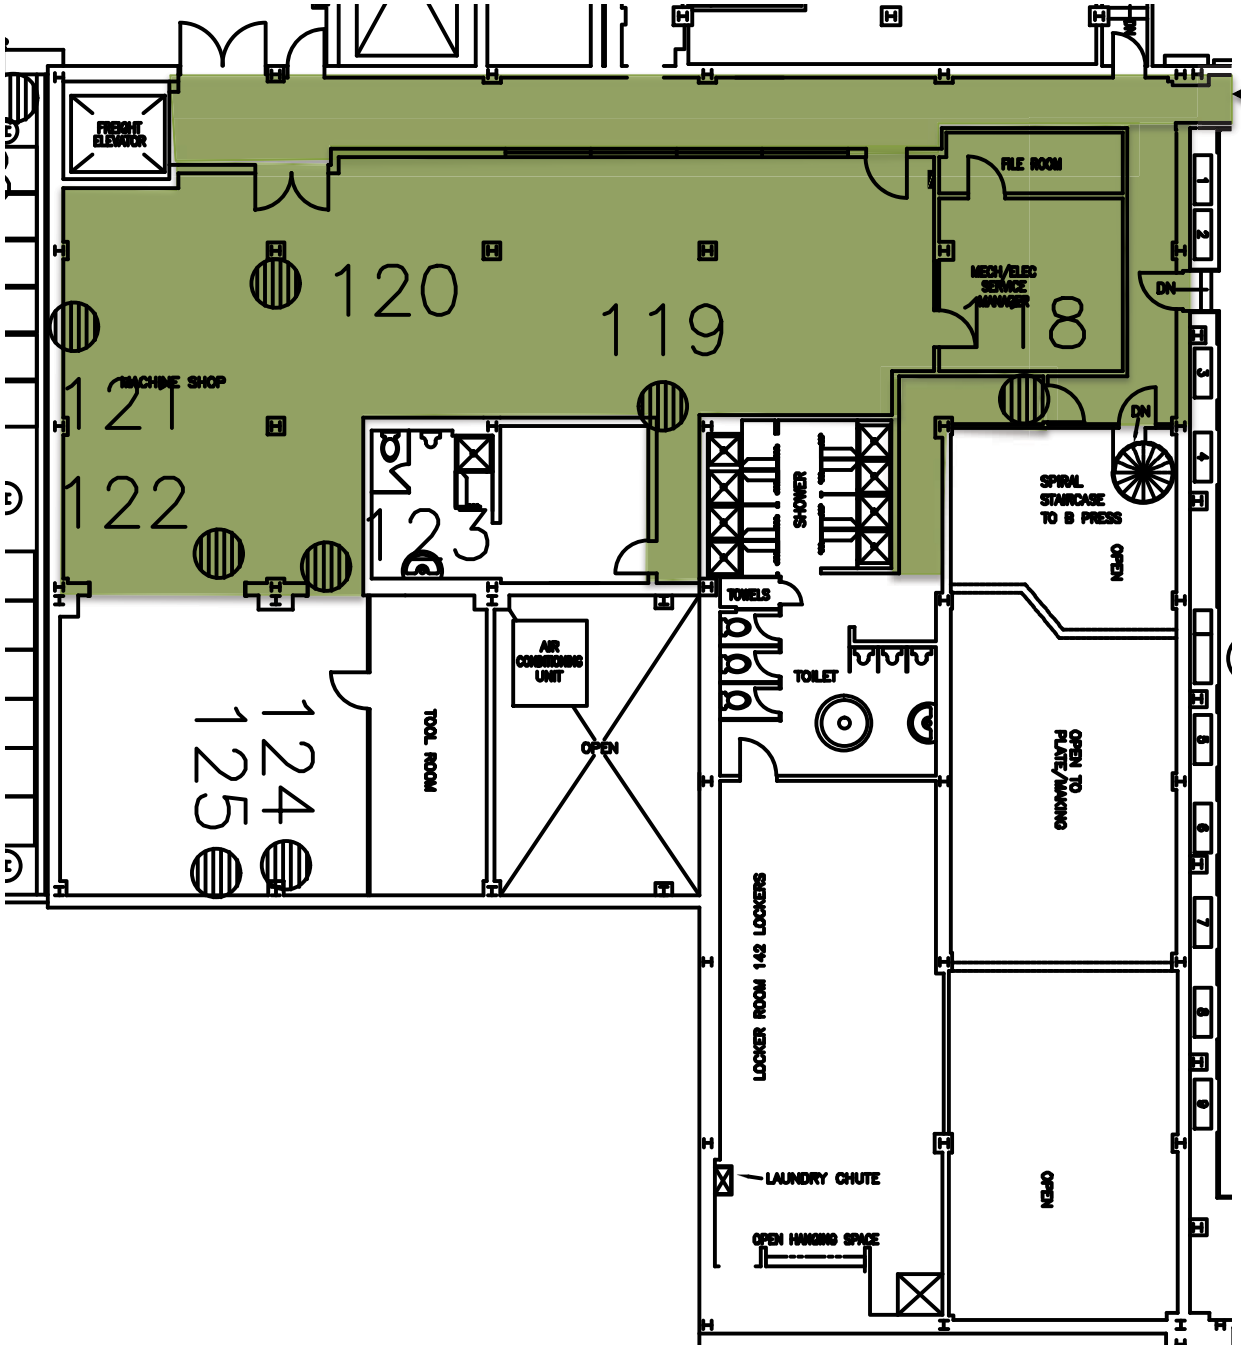
Figure 12 Building 6.
Second Floor

Please refer to Table 4 for a detailed description of the positive ACM samples for Building 6, Table 5 for estimated quantities and Figures 12-14 for illustrations of positive sample locations.

Two layers of tile.
Layer 2, 12x12
5%

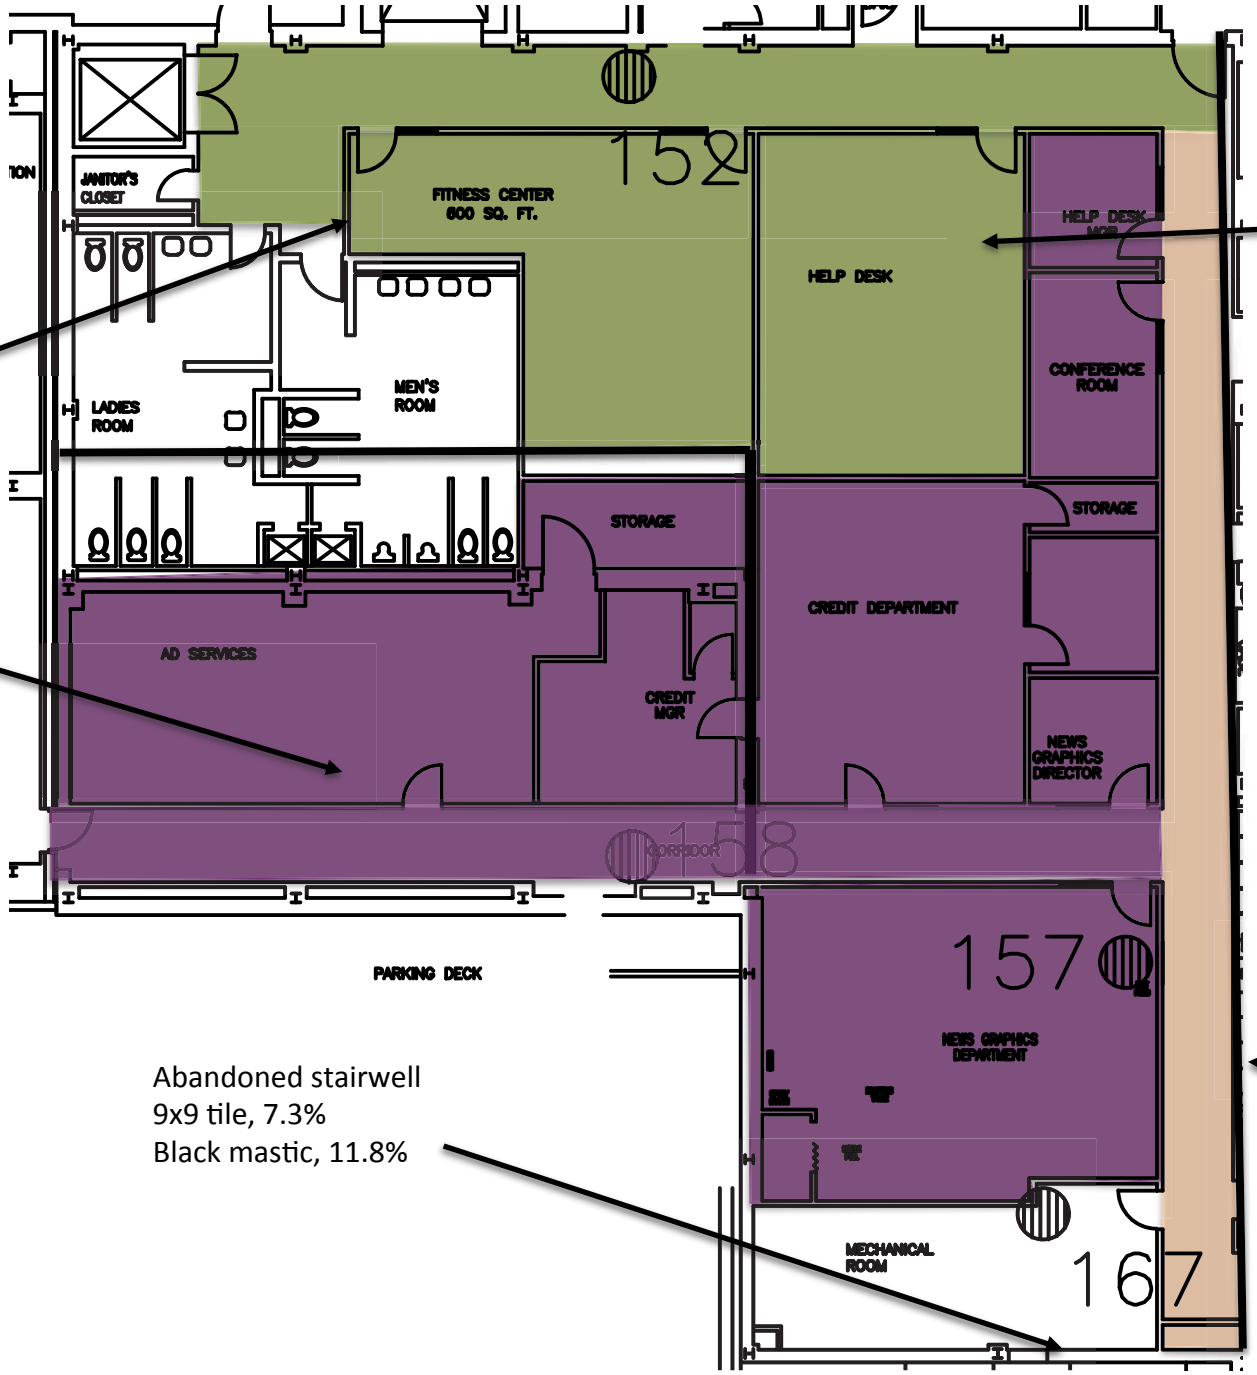
Figure 13
Building 6.
Third floor

Mastic under tile, 2.3%

Tile under Carpet, 3%
Mastic under Tile, 5%

Assumed ACM positive.

Tile was ACM negative, however possible remnant mastic might remain.

Abandoned stairwell
9x9 tile, 7.3%
Black mastic, 11.8%

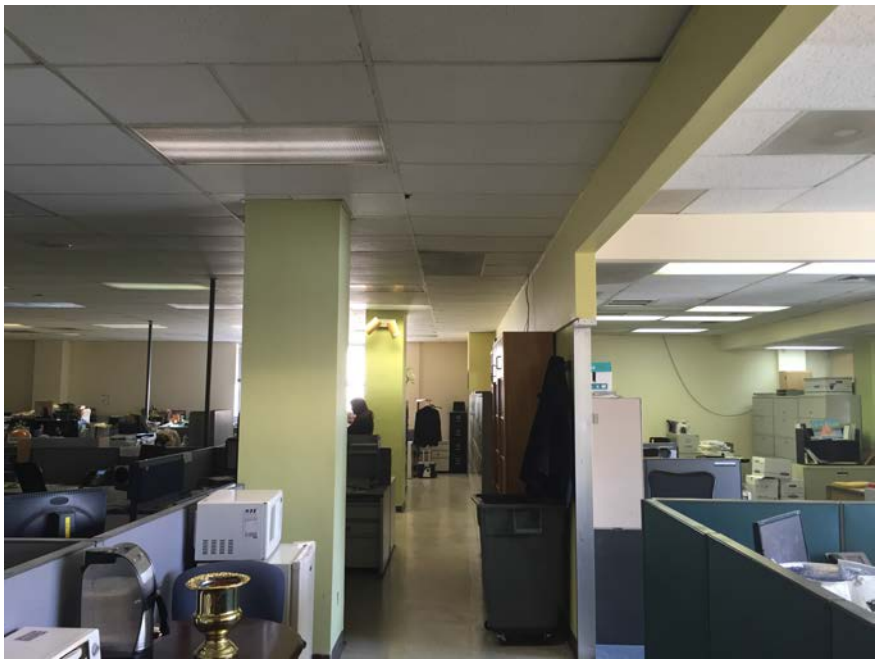
Photograph 13 – Building 1 third floor hallway between main office space and addition floor tiles.

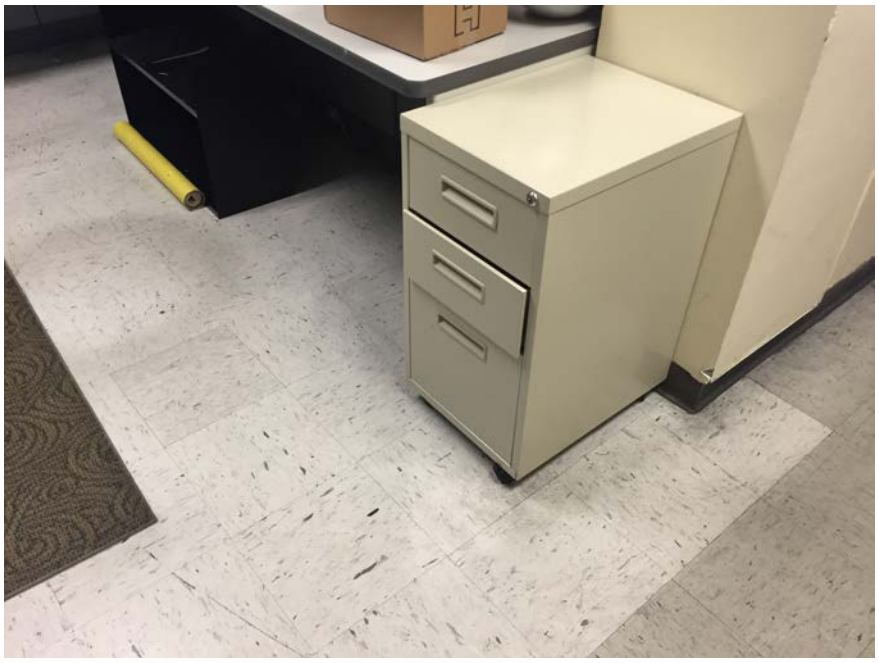
Photograph 14 – Building 1 third floor hallway between the main office space and Building 1 office space addition (right of photo).

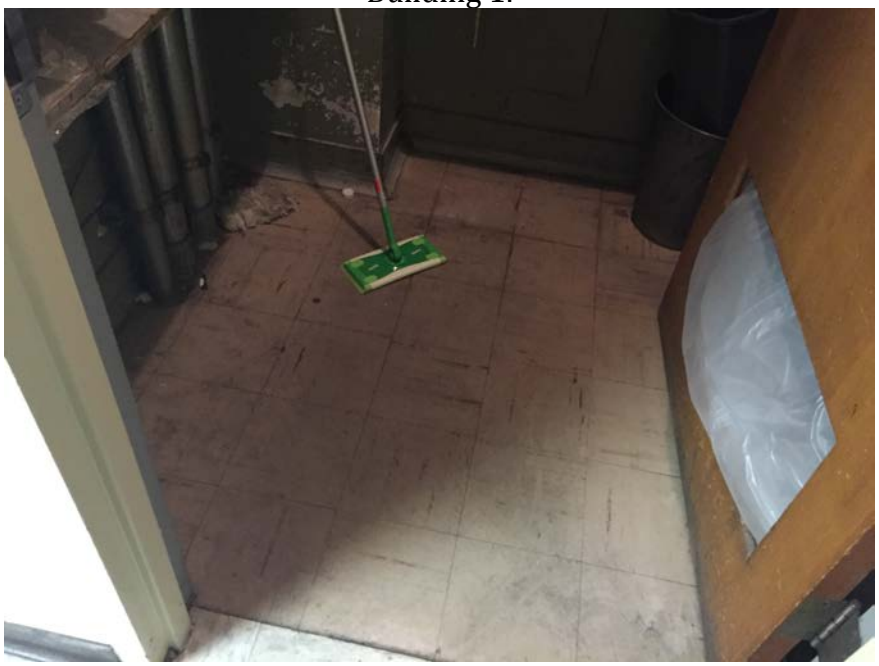
Photograph 15– Different style of floor tile found in office space area in on third floor of Building 1.
