Subject: Combined Preliminary Assessment/Site Inspection (PA/SI)
Triad Used Auto Sales (a.k.a. Triad Used Auto Parts, Triad Auto Parts)
Greensboro, Guilford County, North Carolina
US EPA ID: NCN 000 407 333

COMBINED PRELIMINARY ASSESSMENT/SITE INSPECTION (PA/SI)
VOLUME I

Triad Used Auto Sales
(a.k.a. Triad Auto Parts and Triad Used Auto Parts)
NCN 000 407 333
Greensboro, Guilford County, North Carolina

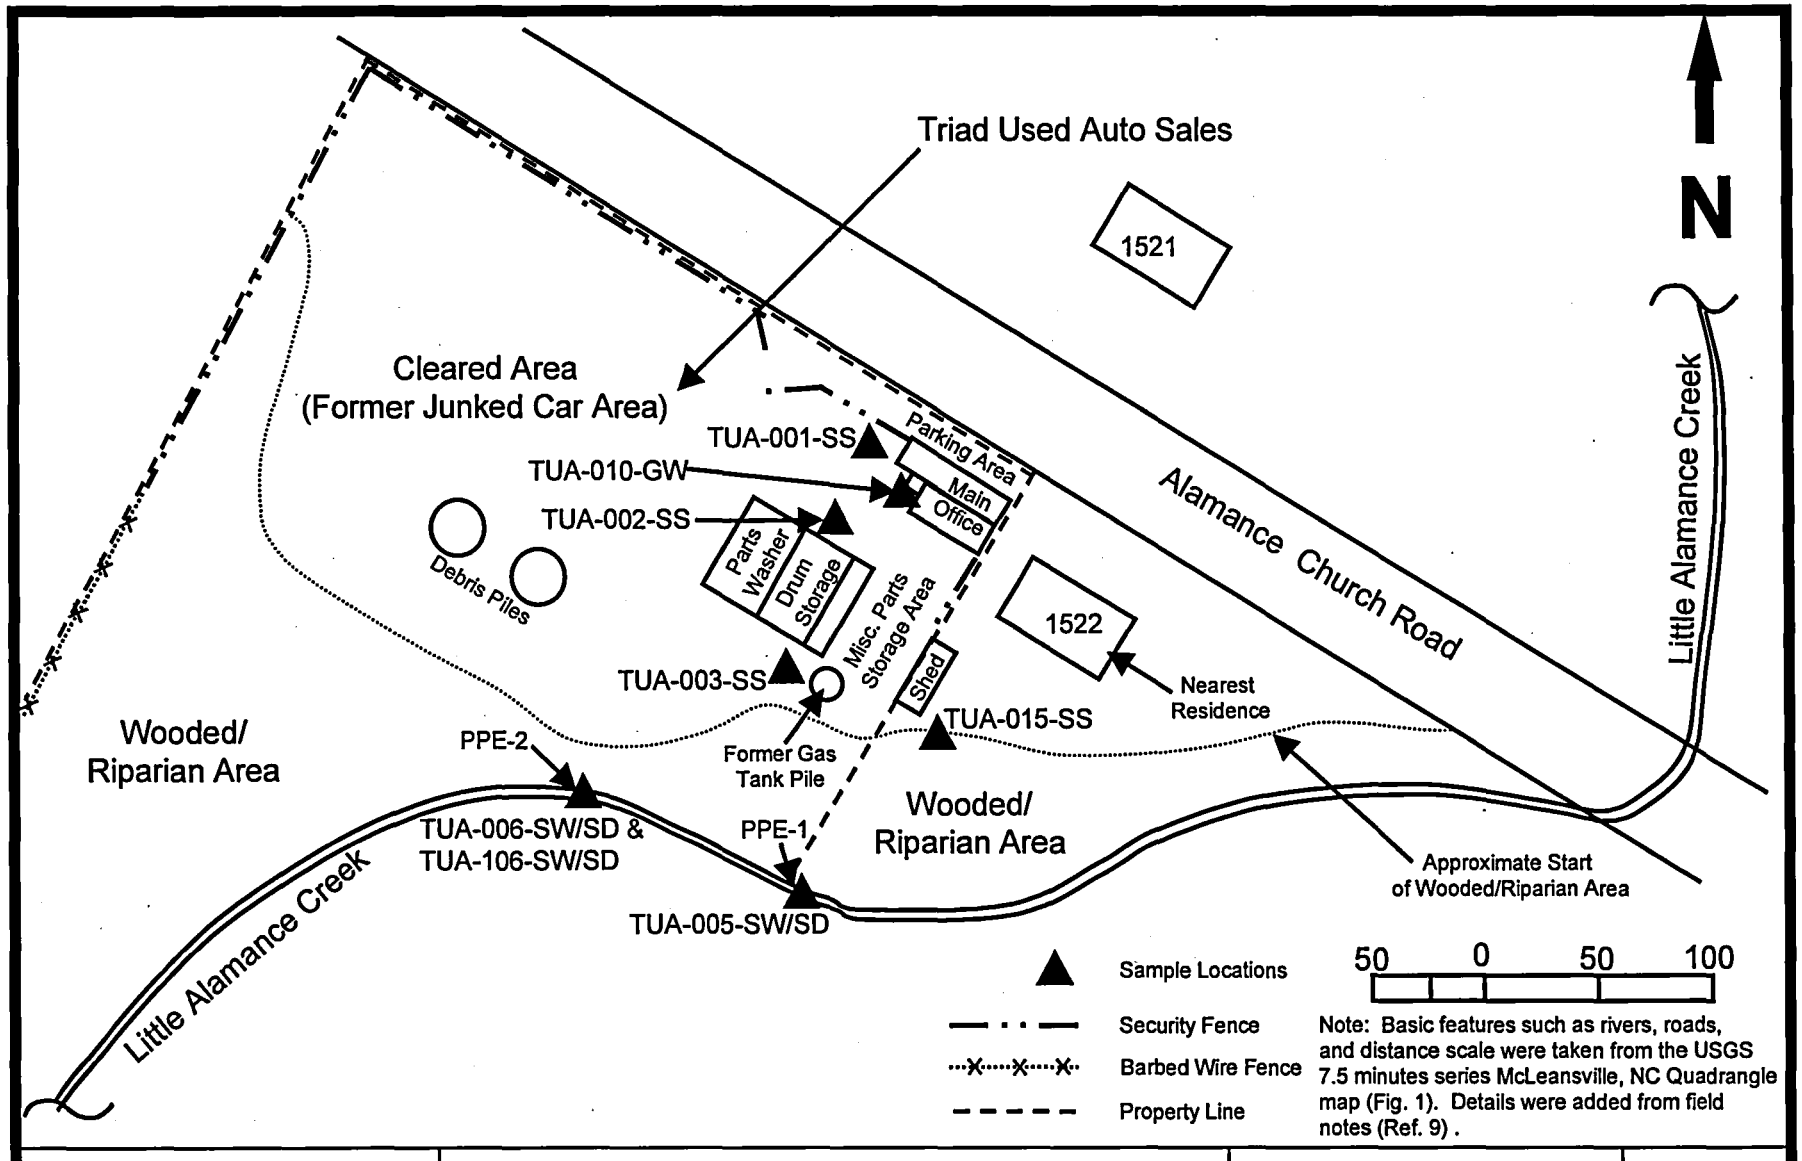
FIGURE
2

The site is a 2.55-acre property that Triad Auto Parts leases from the Hartley Dodge Causey Testamentary Trust which is managed by co-trustees Herb Causey and Charles Causey (Ref. 6, 7, 8). The site reconnaissance performed on June 12, 2002, verified that the facility is an operating junkyard and used auto parts facility and consists of various wrecked and disassembled cars and car parts stored and spread throughout the site (Ref. 9, Photo 1-5). The site also includes the Triad office/storage building, a separate set of four storage buildings and sheds for used oil and antifreeze collection drums and various car parts (Fig. 2) (Photos 1-5, 10-12).
