REPORT OF LIMITED PHASE II ENVIRONMENTAL SITE ASSESSMENT

VOLVO CONSTRUCTION EQUIPMENT
2169 HENDERSONVILLE ROAD
ARDEN, BUNCOMBE COUNTY, NORTH CAROLINA

June 24, 2011

BLE Project No. J11-7389-03

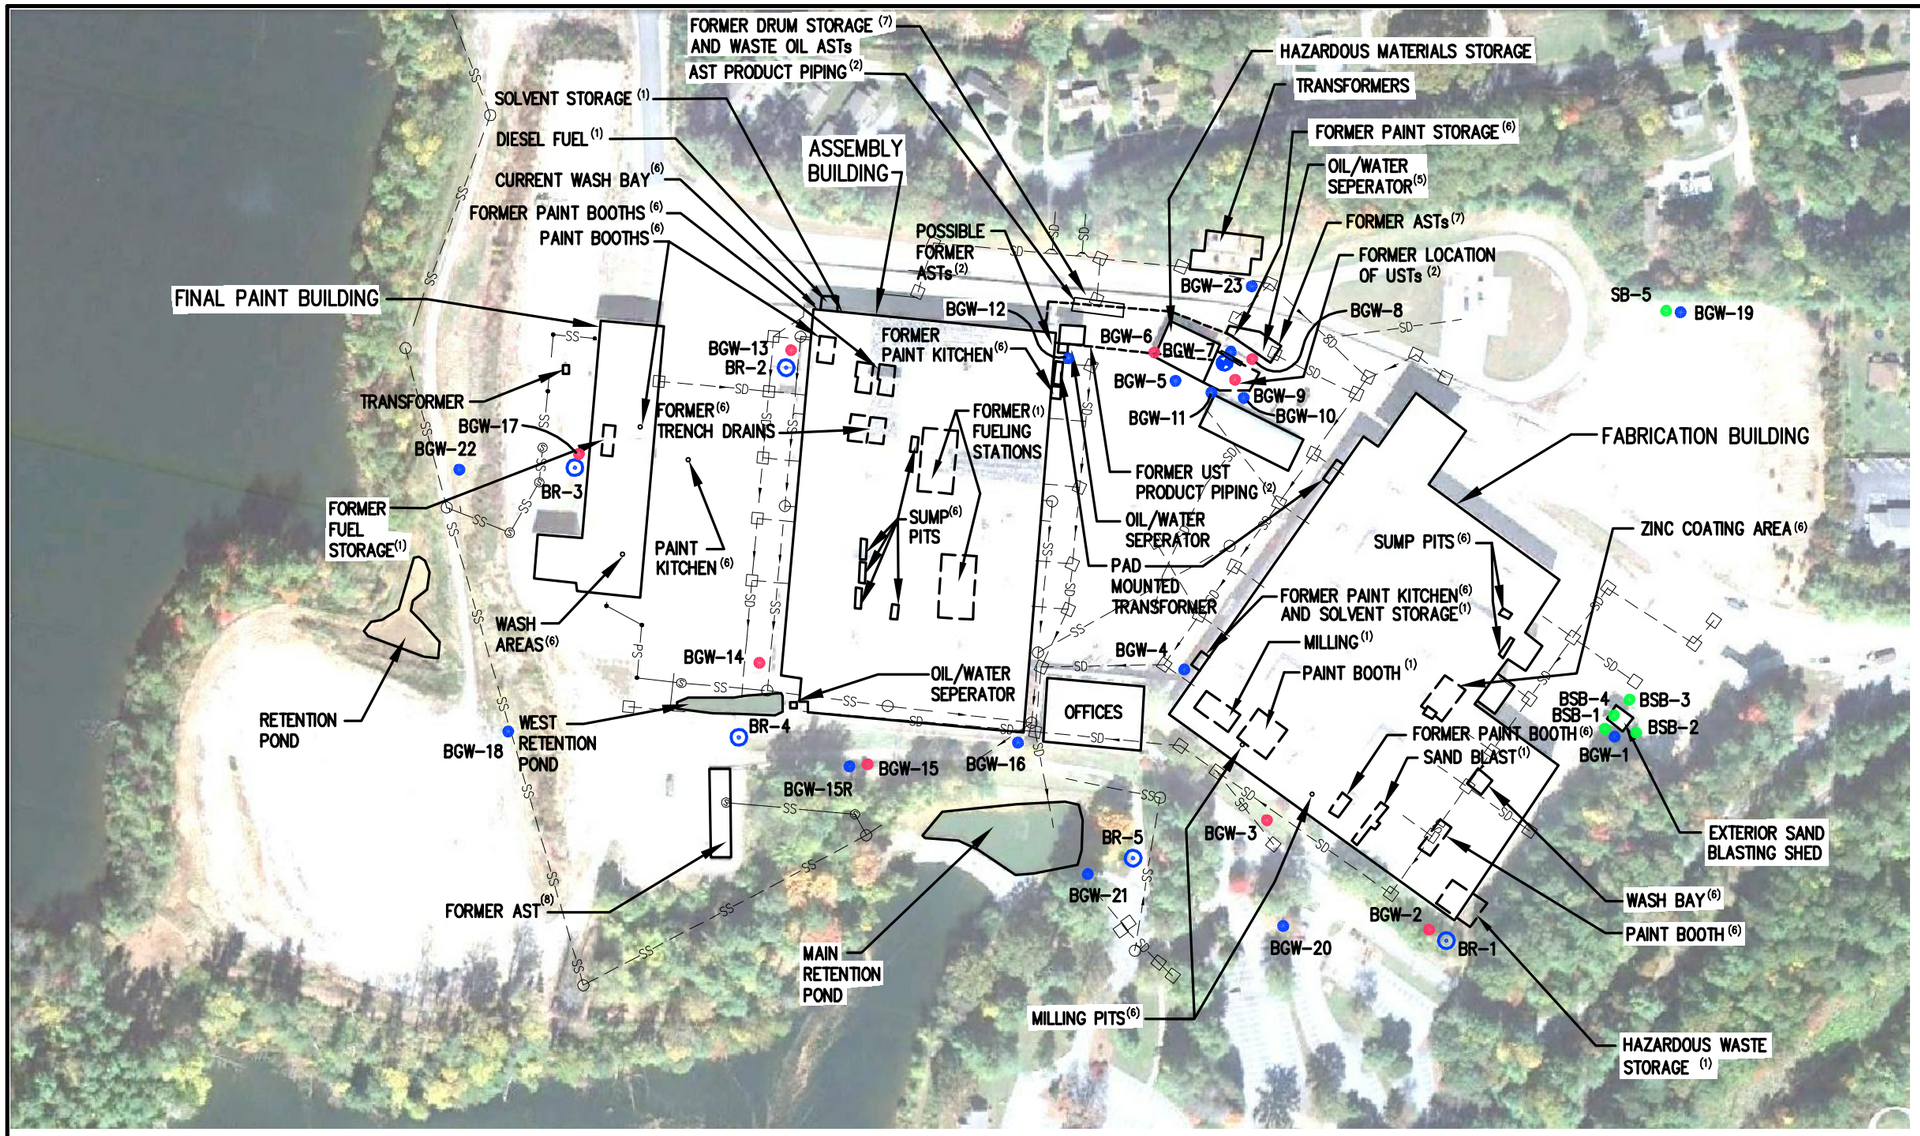
Seven borings (BGW-2, BGW-3, BGW-4, BGW-20, BGW-21, BR-1, and BR-5) were performed adjacent to and downgradient of the *Fabrication Building* to investigate historical facility operations including a zinc phosphate coating area, sump pits, paint booths, a sand blast pit, a milling pit, a paint kitchen, a wash bay, and hazardous waste and solvent storage. The approximate locations of these operations and the boring locations are shown on Figure 2. A description of each boring location is included below:

Eight borings (BGW-5, BGW-6, BGW-7, BGW-8, BGW-9, BGW-10, BGW-11, and BGW-23) were performed adjacent to and downgradient of the former hazardous waste storage area, paint storage area, former USTs and associated product piping (containing hydraulic oil, diesel fuel, waste/hydraulic oil, engine oil, and antifreeze), and ASTs and associated product piping (containing diesel oil, hydraulic oil, motor oil, transmission fluid, and antifreeze). An oil/water separator and possible AST location (unknown contents) in the area of the current power substation transformers were also located in this area. The approximate locations of these operations and the boring locations are shown on Figure 2. A description of each boring location is included below:

1. A GROUNDWATER SAMPLE FROM BGW-22 (FINAL PAINT BUILDING) WAS NOT SUBMITTED FOR LABORATORY ANALYSIS.
2. THE SOIL SAMPLE CONTAINER FROM BSB-1 (SAND BLASTING SHED) WAS DAMAGED IN TRANSIT FROM THE SITE TO THE LABORATORY AND WAS NOT SUBMITTED FOR LABORATORY ANALYSIS.
