Vapor Intrusion Assessment Report
Former Volvo Construction Equipment Facility
2169 Hendersonville Rd
Asheville, North Carolina

H&H Job No. PPA-040

August 17, 2011

Hart & Hickman

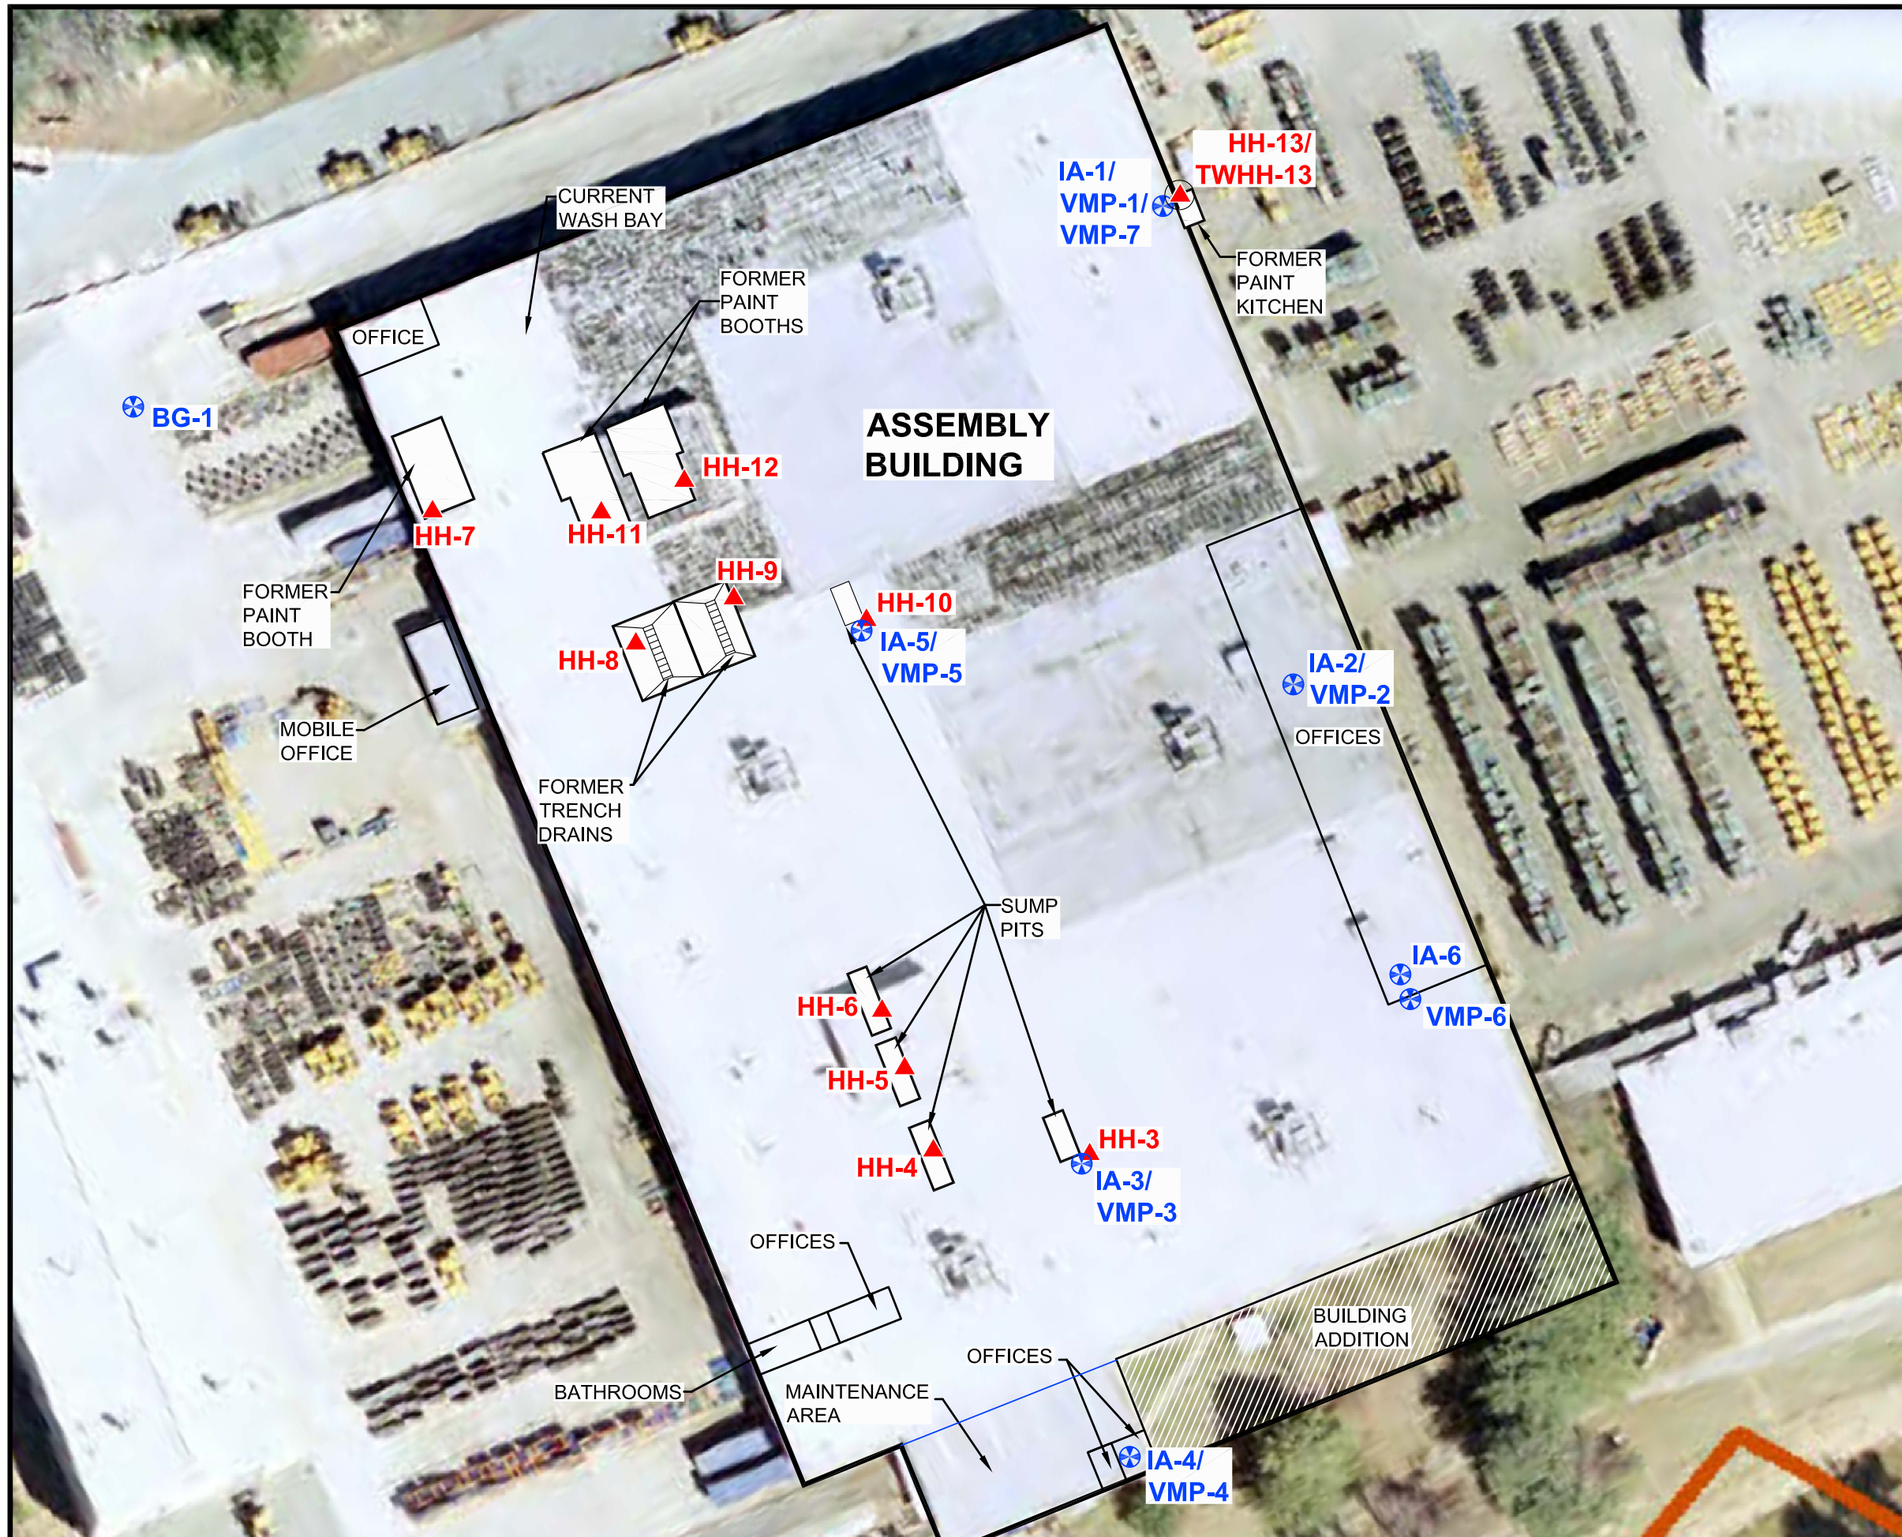
DATE: 8–2–11	REVISION NO. 0
JOB NO. PPA–040	FIGURE NO. 2

On July 25 and 26, 2011, H&H collected co-located indoor air and sub-slab vapor samples from six (6) locations from the interior of the Assembly Building. In addition, one exterior background sample was collected from an upwind location outside of the Assembly Building. The locations of the indoor air samples, sub-slab soil vapor samples, and background sample are indicated in Figure 2.
