FACILITY COMPLIANCE AUDIT REPORT
Division of Waste Management
Solid Waste Section

Date of Audit: 23 November 2010 **Date of Last Audit:** 16 August 2010

FACILITY NAME AND ADDRESS:
R&R Farms LCID Landfill
Sparrowhawk Lane
Newport, NC 28570

PURPOSE OF AUDIT:
Follow up audit

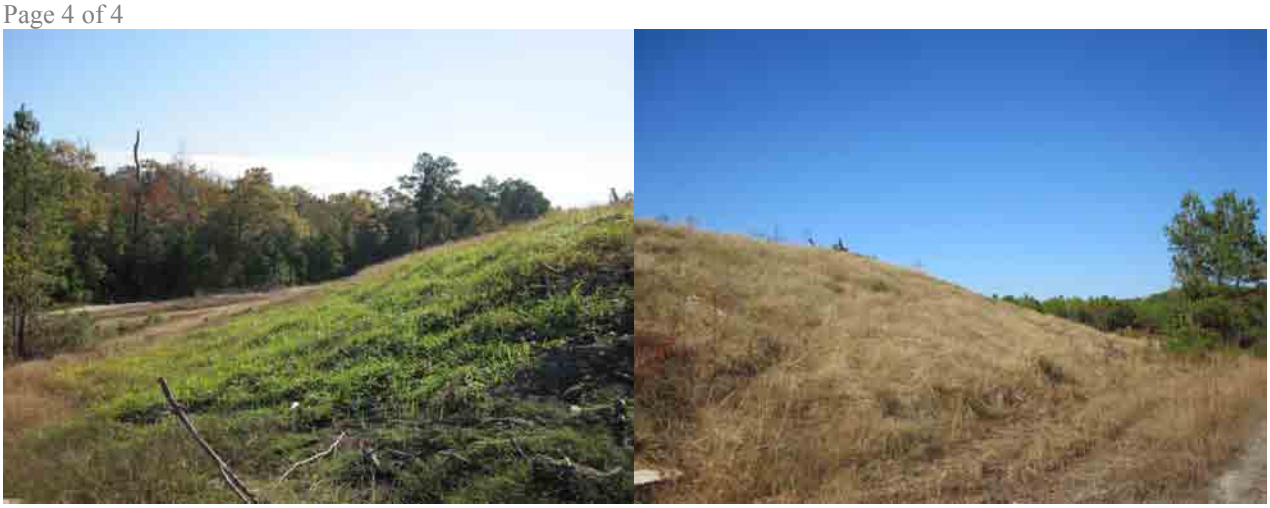
Areas on sideslope needing continued attention: cover, grading, and seeding necessary

Soil stockpiled for cover behind landfill Compact working face

Improved sideslopes with suitable cover and proper grade

5. *Please continue to work on the application of adequate soil cover and the grading of all facility sideslopes to a slope of not greater than 3:1.
6. *As the facility sideslopes are covered and graded, please seed and mulch to establish a groundcover suitable to prevent erosion of your landfill cap system.
