September 2009 Monitoring Event

Davidson County

Construction & Demolition Debris Landfill
Lexington, North Carolina
NC Solid Waste Permit # 29-06

Ground Water Monitoring Report
Davidson County Construction & Demolition Debris Landfill
September 2009 Semi - Annual Report

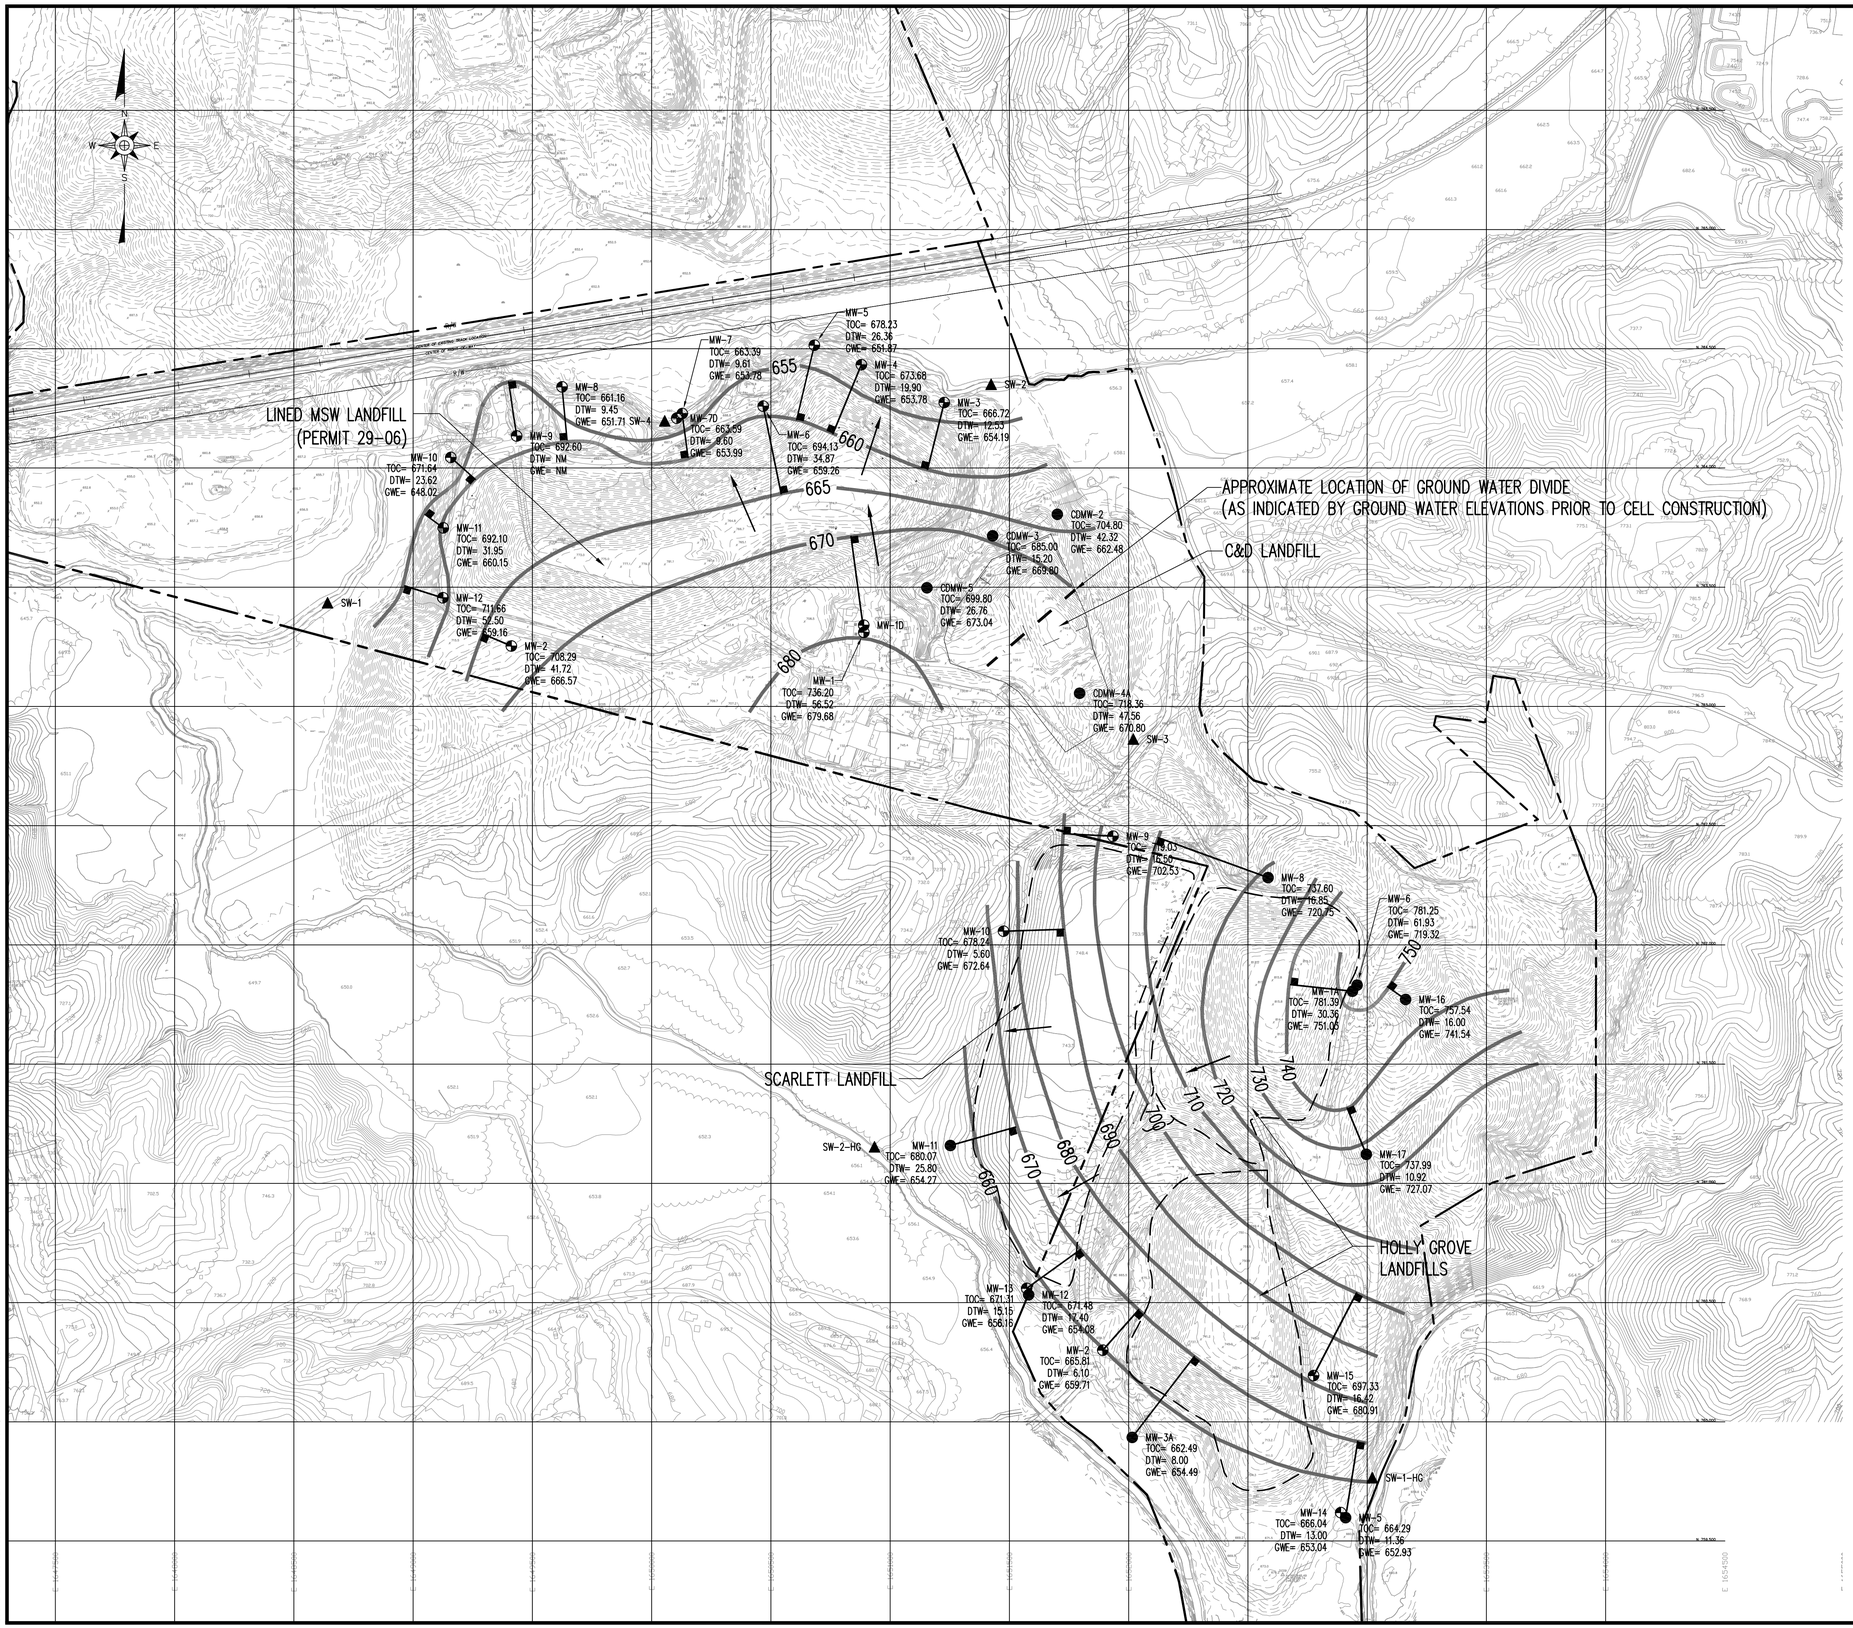
DESIGNED BY: J.A.S.	DRAWN BY: C.T.J.
CHECKED BY:	PROJECT NO.: DAVDCO-4
SCALE: AS SHOWN	DATE: NOV. 2009
FILE NAME: DAVDCO-D0517	
SHEET NO.	DRAWING NO. FIG.1

Ground water at the C&D landfill is migrating both to the northwest and southeast with a ground water divide located at the site. The ground water divide was made evident during site permitting when more piezometers were located in the area. The site topography also indicates a likely ground water divide across this site. The ground water to the north of the divide is likely influenced by the presence of the sedimentation basin adjacent to Phase 1. The potentiometric surface for the landfill property is shown on **Figure 1**.
