SUBGRADE CERTIFICATION - INITIAL PHASE 1A
LAKE NORMAN LANDFILL, INC.
LINCOLN COUNTY, NORTH CARLINA

SUBGRADE CERTIFICATION - INITIAL PHASE 1C
LAKE NORMAN LANDFILL, INC.
LINCOLN COUNTY, NORTH CARLINA

EXPOSED ROCK VERIFICATION
LAKE NORMAN LANDFILL

LAKE NORMAN LANDFILL
LINCOLN COUNTY, NORTH CAROLINA

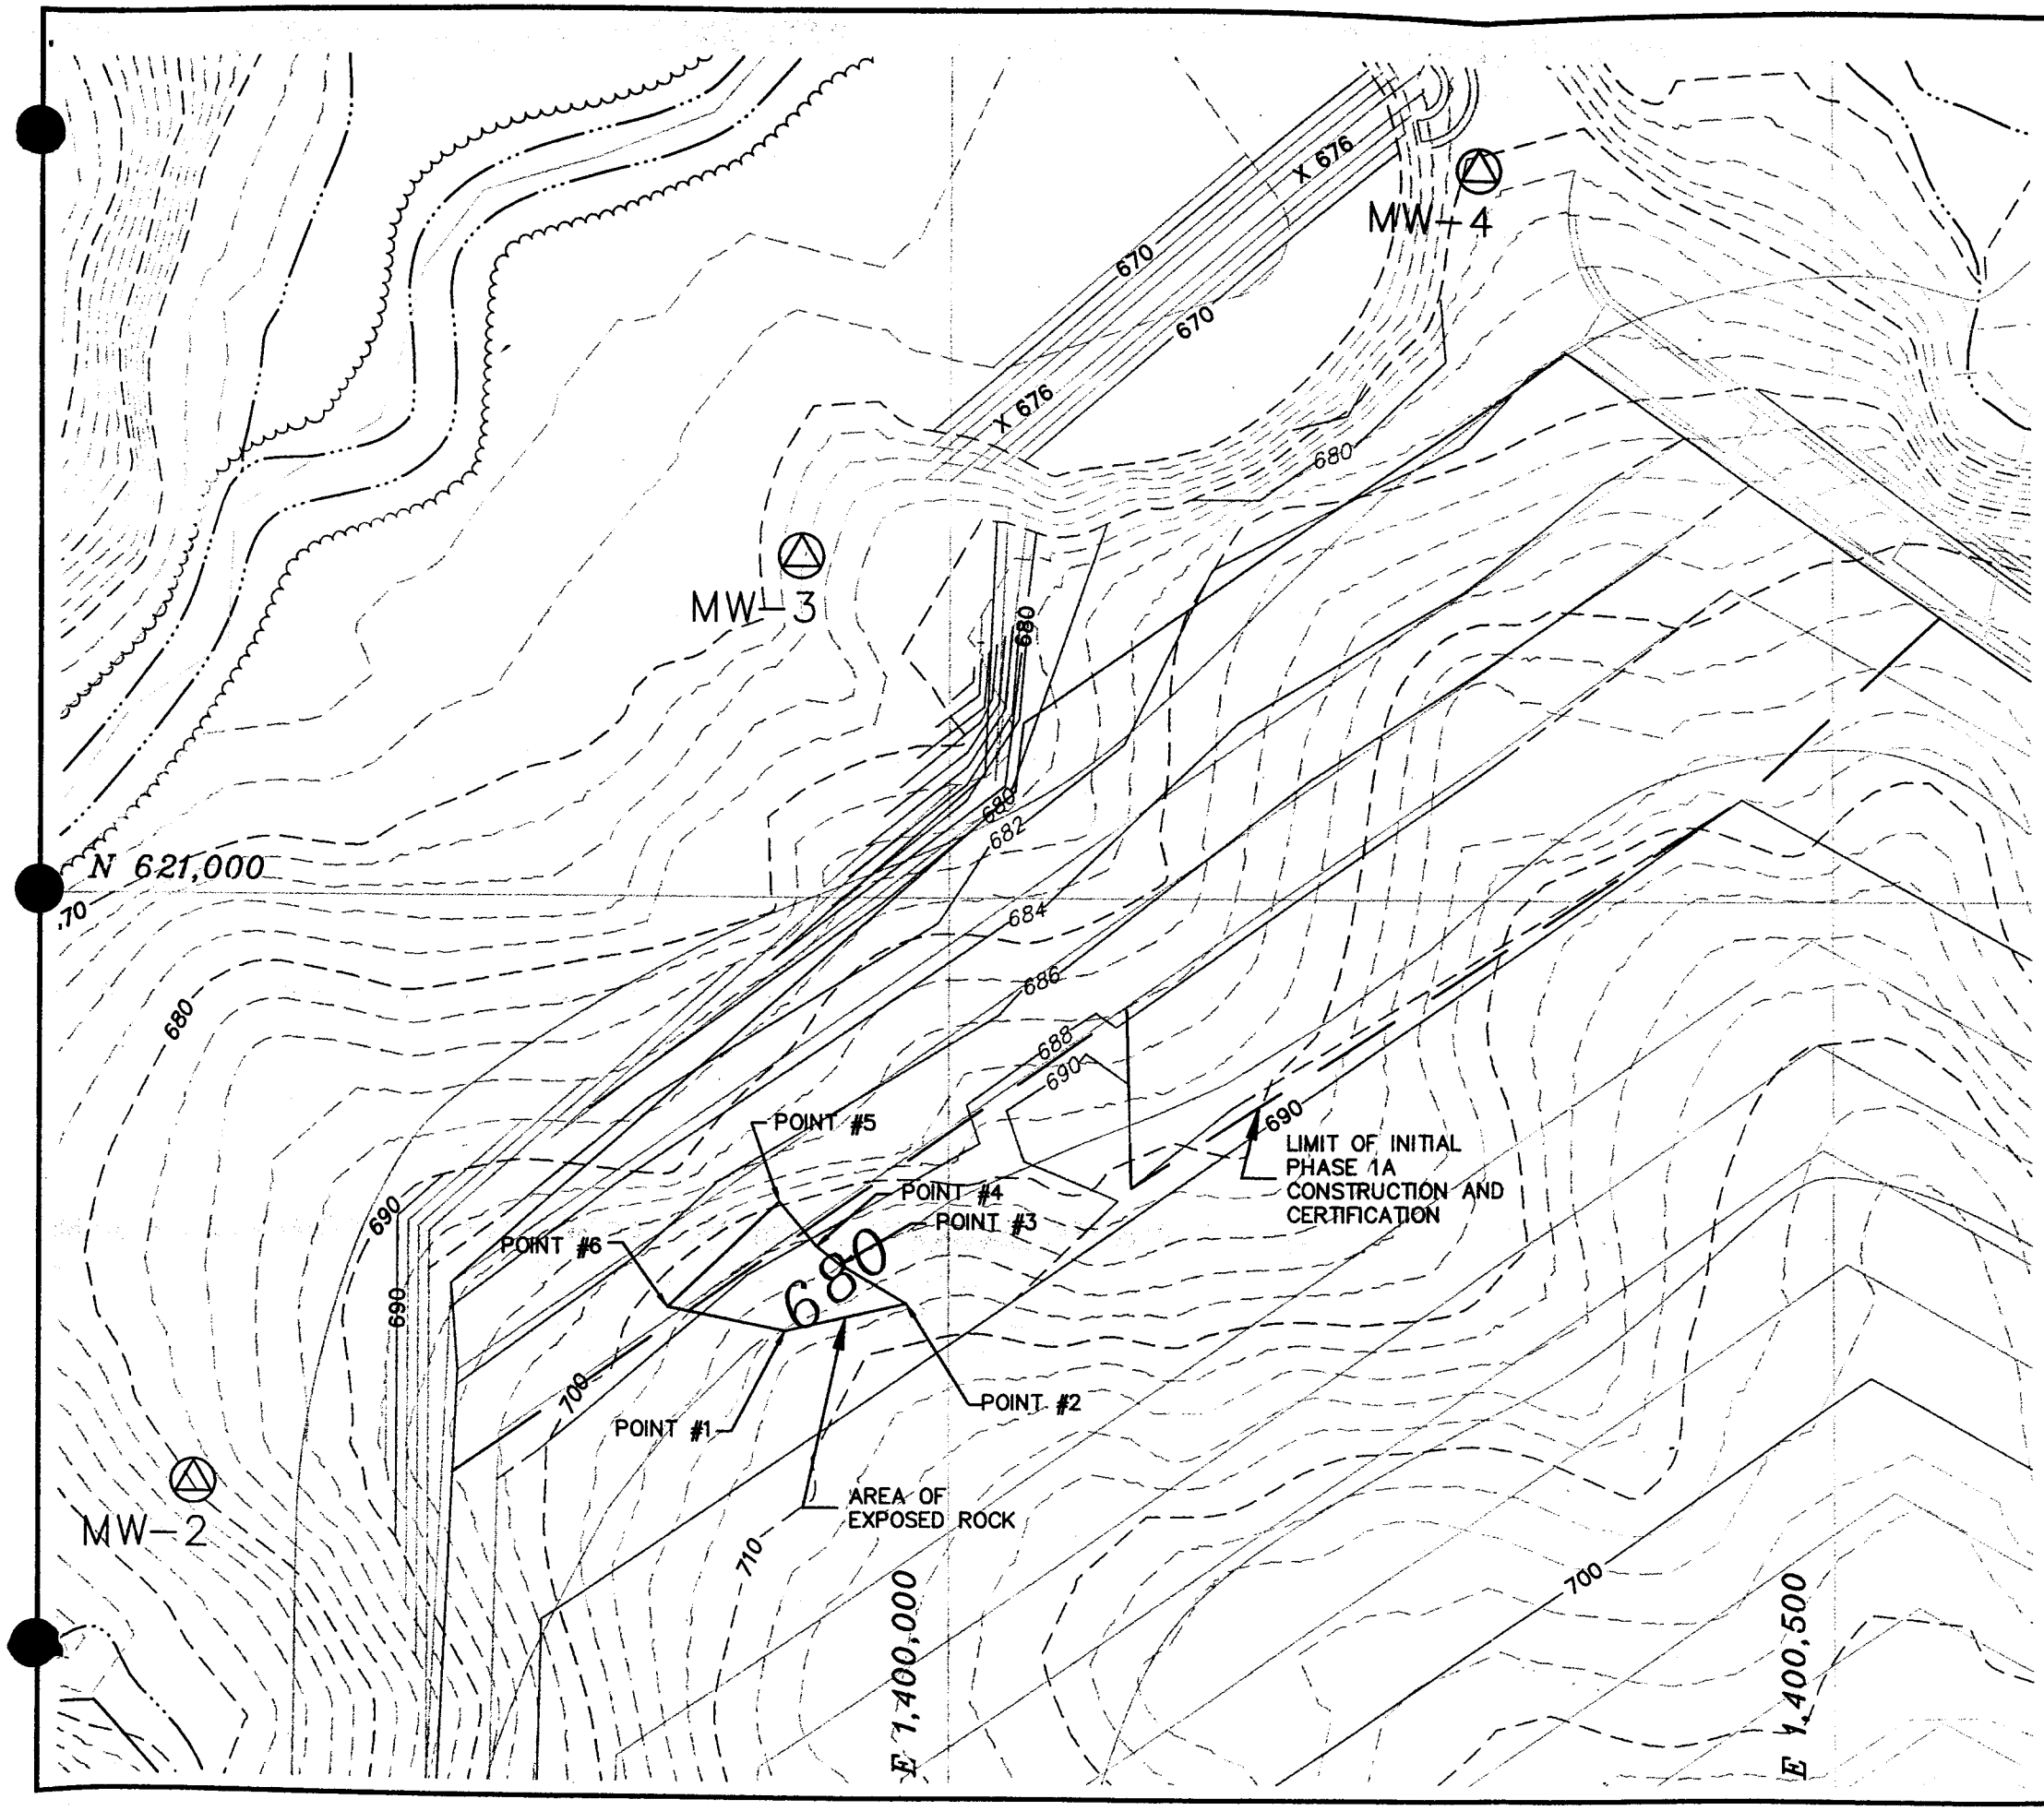
SCALE: 1" = 100'	DRAWN BY: SRN	CHECKED BY:
JOB NO. 1356-97-394A	DATE: 4/30/99	FIGURE NO. 1

POINT NO.	ROCK ELEVATION (FT.)	CLAY ELEVATION (FT.)	DEPTH OF CLAY (FT.)
1	689.19	693.23	4.04
2	689.97	694.17	4.20
3	690.07	694.17	4.10
4	688.95	693.05	4.10
5	687.47	691.51	4.04
6	688.01	692.03	4.02
