SITE VISIT REPORT

Project: Dunn Erwin Landfill CAP Projects

Job No.:	3002B	**Date:**	3-15-13
Location:	Dunn-Erwin Landfill, Dunn, NC		
Visit by:	C.T.C.	**Page:**	1 of 1

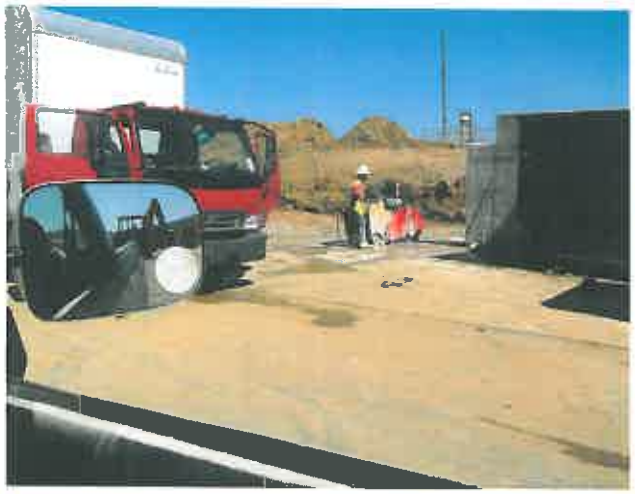
DELF CAP Project 3-19-13 PN 3002B

Partly Cloudy Temp in 50's
Contractor doing concrete sawcuts + Removing Walls

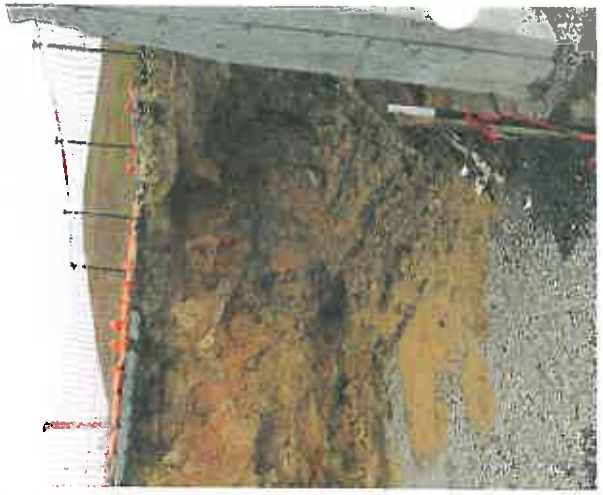
Site visit 3:30pm Contractor not working - talked with (Scott) him by phone earlier this morning - Said he had the site drained and would start back work Monday. Rain showers all day. Temp. in 80's - Standing water in the trenches. See photo's - Trench was not drained there was no outlet for the water - evidence of storm water entering excavation from paved area above the excavation

Summary of Problems and Resolutions: If the standing water has caused problems with subsoil it may need repair - check Monday befor starting work.

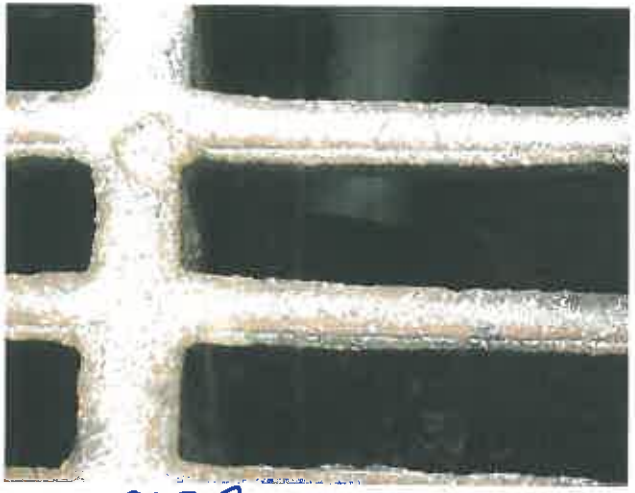
DELF CAP Project

Summary of Activities and Test Results: Sunny + Warm Temp. - 70's Contractor Not working 3:30pm. Work had been done to re-route storm water in parking above wall. See photo's, Groundwater had been routed to Catchbasin

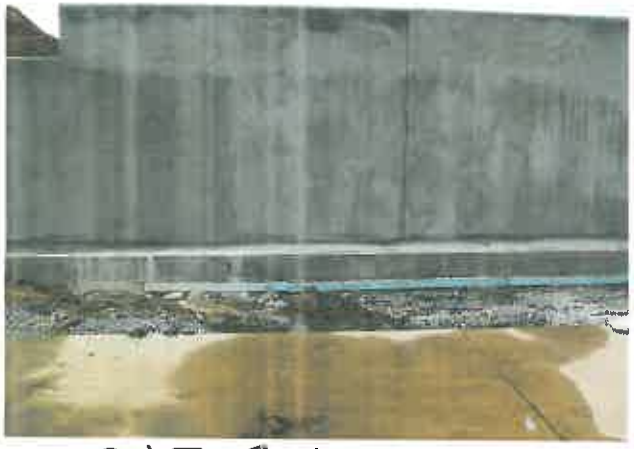
DELF CAP Project

Summary of Activities and Test Results: Rain approx. 2" today, No one working mid morning. Some storm water damage on the soil bank behind the concrete walls, catch basin wall exposed. Pressure on the HDPE pipe holding at 7 PSI. See Photos, Discussed w/ Tyrus.

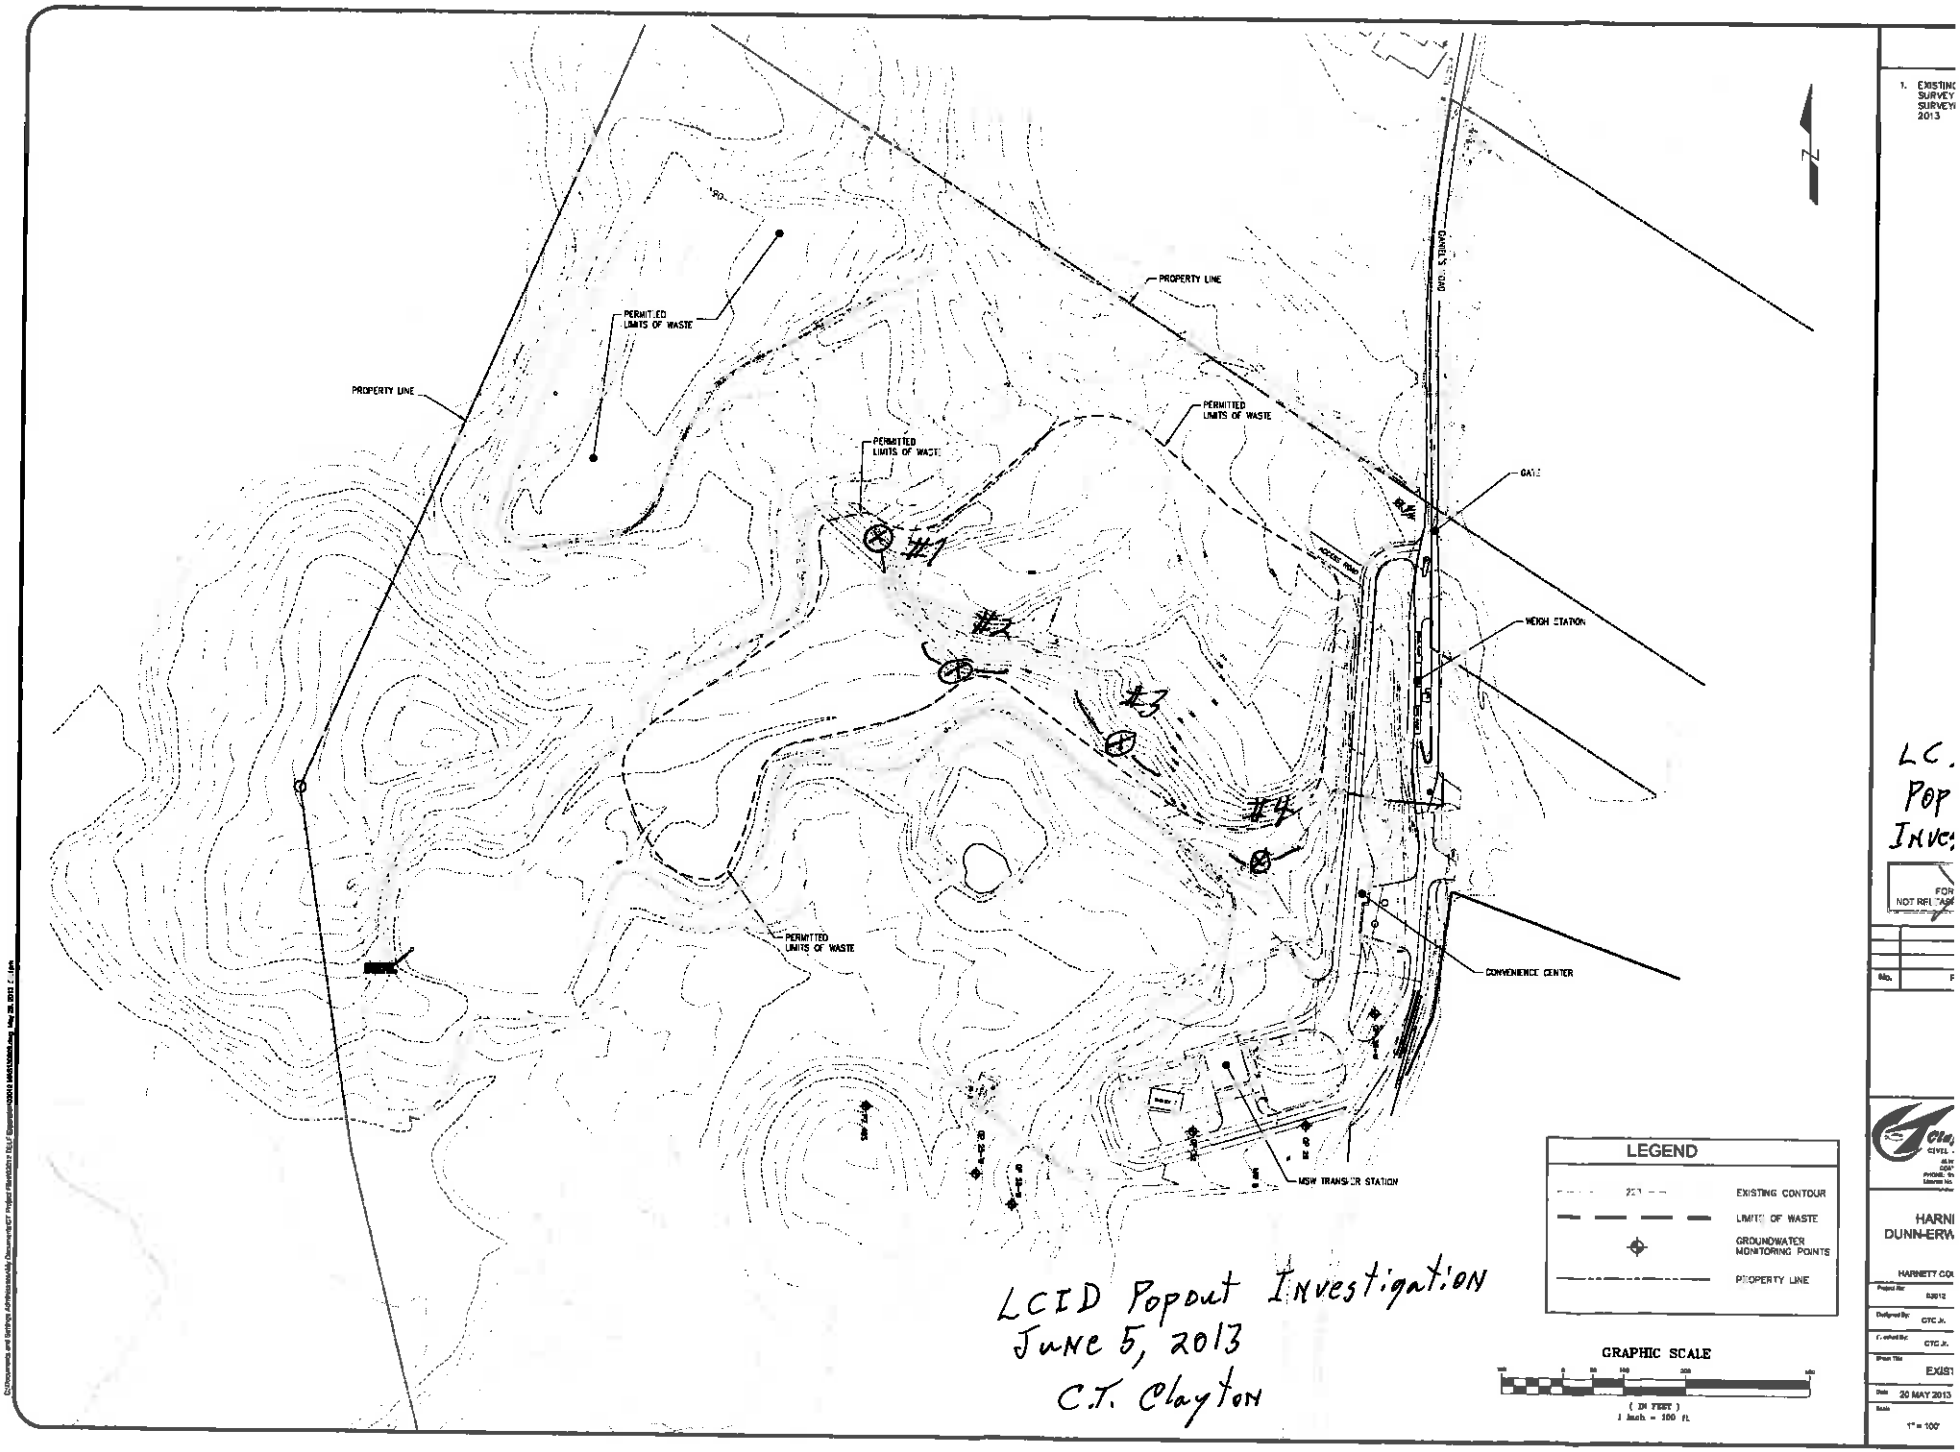
DELF CAP Project, Popout at LCID 6-5-2013 PN3002B

Summary of Activities and Test Results: Investigated LCID popouts, found four [4] major and evidence of sveral past minor popouts, see sketch and photos. Discussed w/ Tyrus.

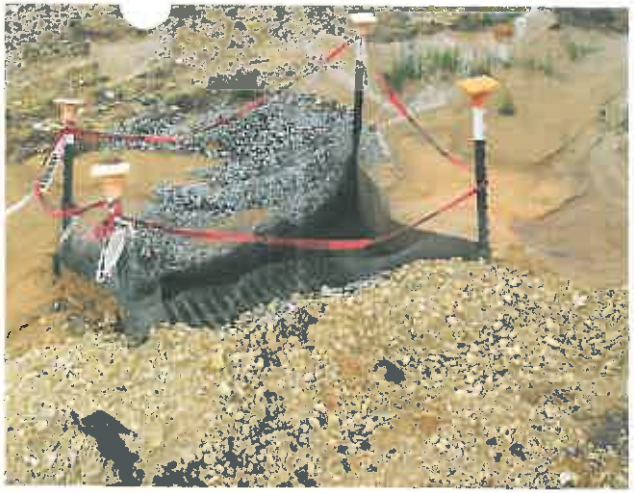
DELF CAP Project 6-7-13 PN 3002B

Summary of Activities and Test Results: Mtg. w/ Ralph on site, standing water in pad excavation, discussed grading. Checked patch paving at transfer sta. some settelment noted @ stop point, checked PVC force main location on Daniels Rd. See Photos, Discussed w/ Tyrus.

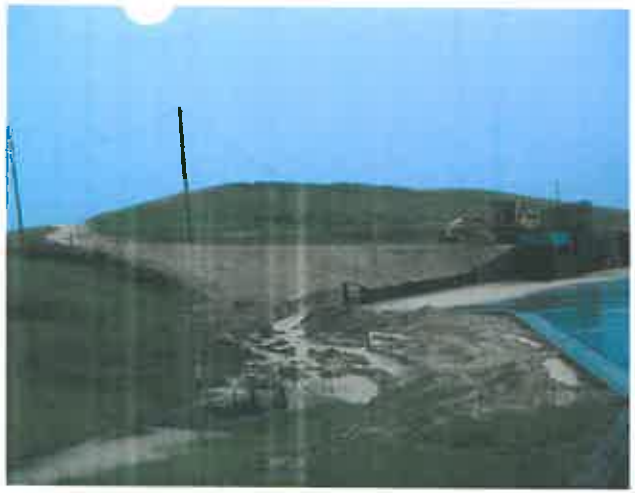
Site visit to check for any rain damage. No one working at site. See photos, Discussed w/ Tyrus

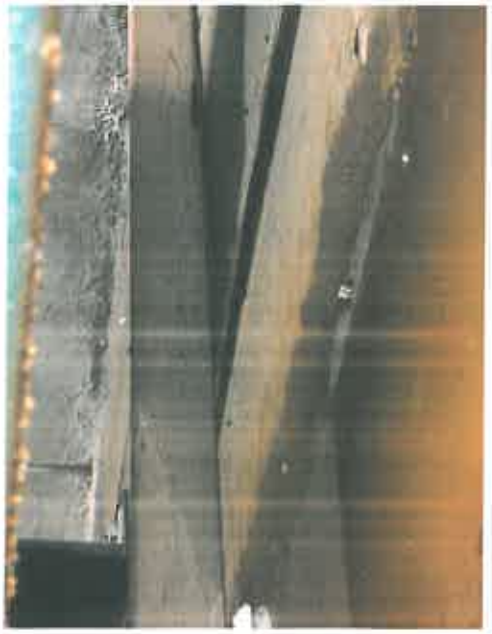
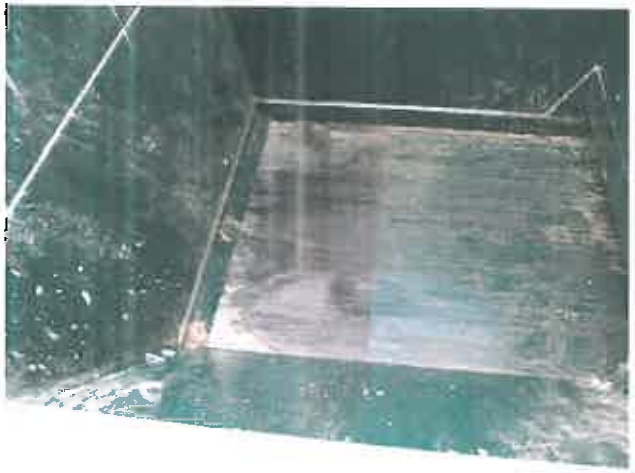
DELF CAP Project 7-8-13 PN 3002B

Summary of Activities and Test Results: Mtg. w/Greg on site, removing forms along front wall @ Trnsf. Sta. & grading. Met w/ Frank @ compaction sta. Met w/ Dennis Turlington concern silt dam repair & instal. of fabric in ditch line on Turl. Rd.. Checked vacum line assembly near trnsf. Sta.
See photos, Discussed w/ Tyrus
